# Building And Timber Pest Report

Property Address: 84 Hutton Street Thornbury 3071

Inspection Date: 3 Aug 2026

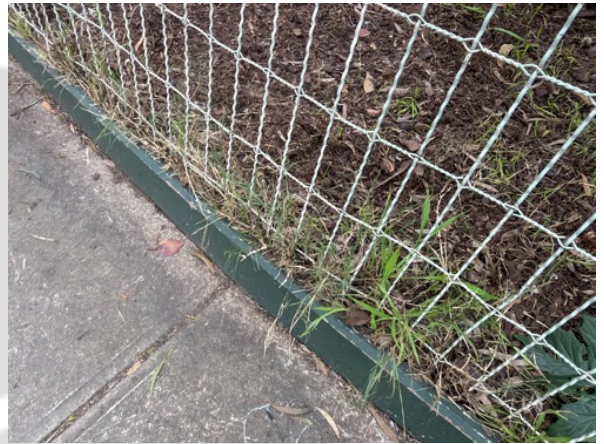
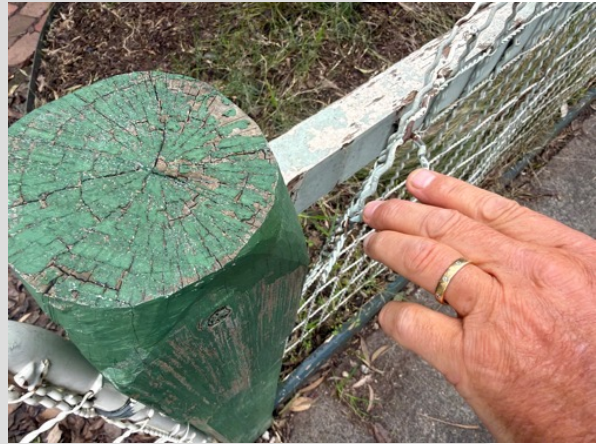
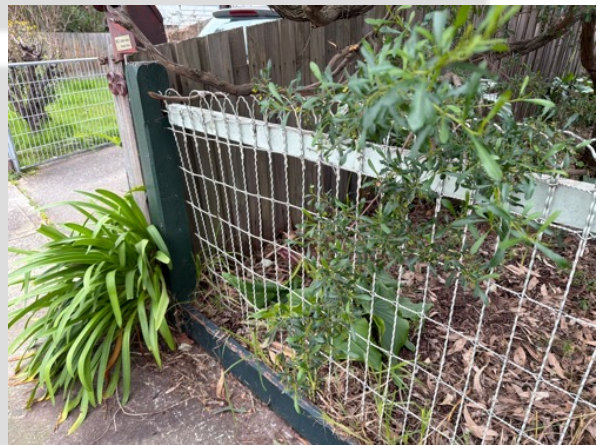
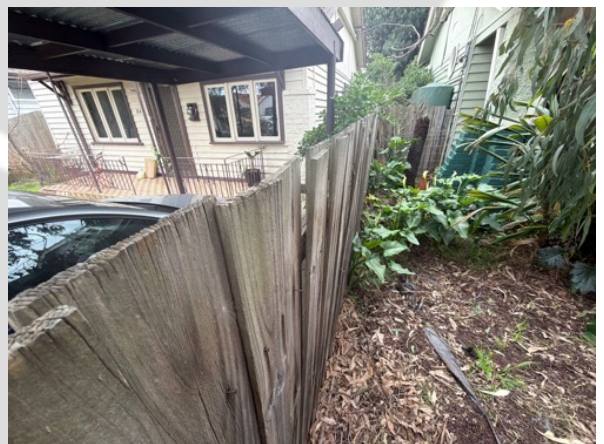
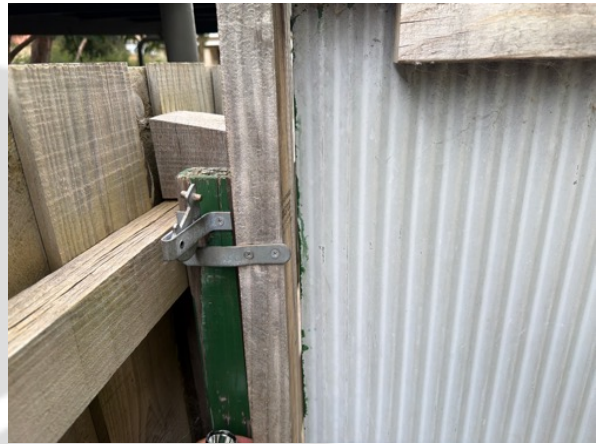
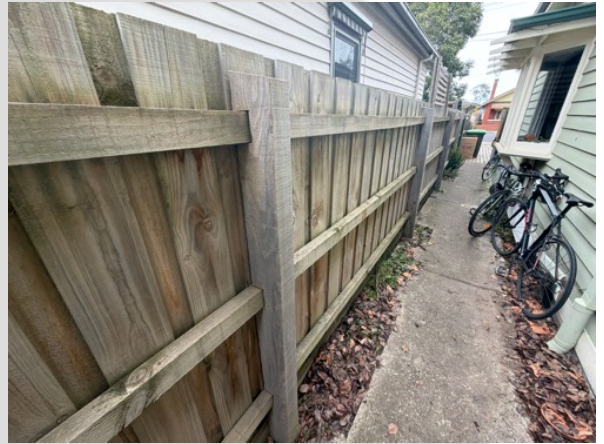
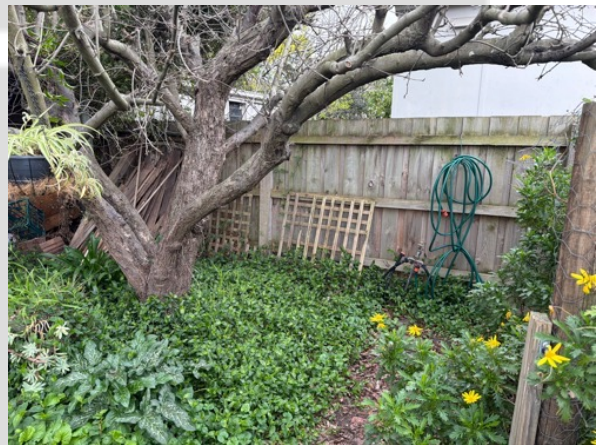
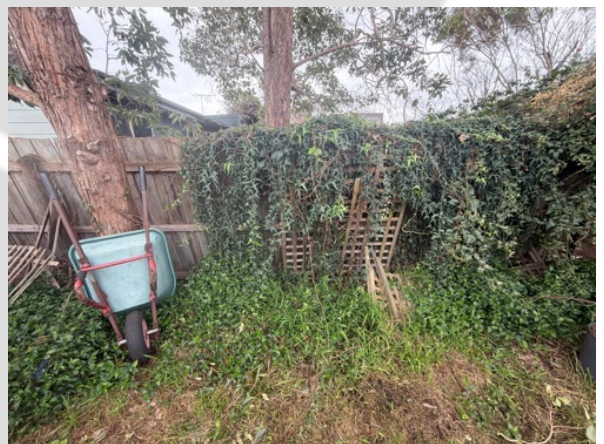
### Minor Defect 1.01

**Finding:** Fences and gates -deterioration

The boundary fence and gates have significant deterioration present. These sections will need to be replaced or repaired by a fencing contractor in the short to medium term.

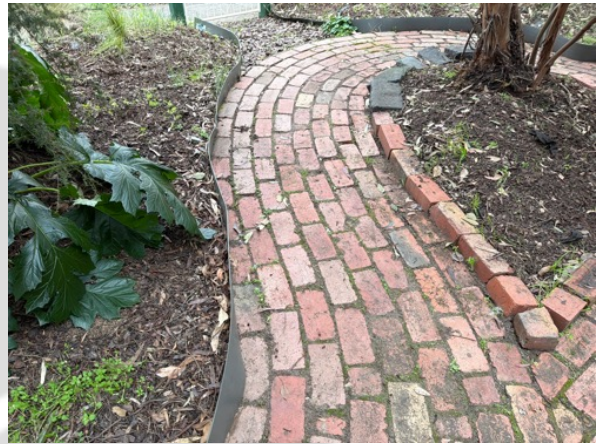
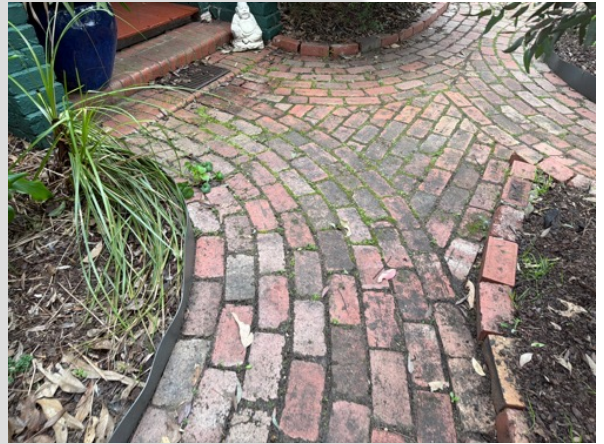
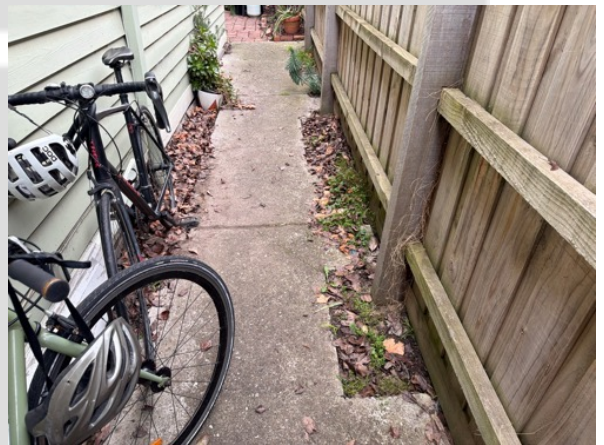
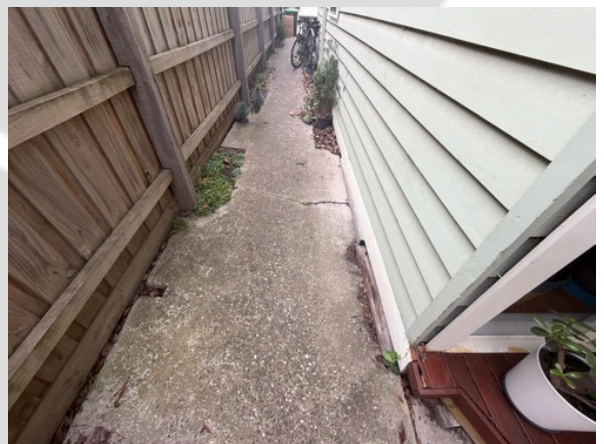
## Minor Defect 1.02

**Finding:** Paths - Cracking/trip hazard

Settlement cracks were observed in the concrete slab of the paths. It is recommended that these cracks be sealed and maintained by a qualified concreter.

Tripping hazards were observed through the paths. These should be repaired for safety. It is suggested that a qualified paver be contacted for further evaluation and repair.

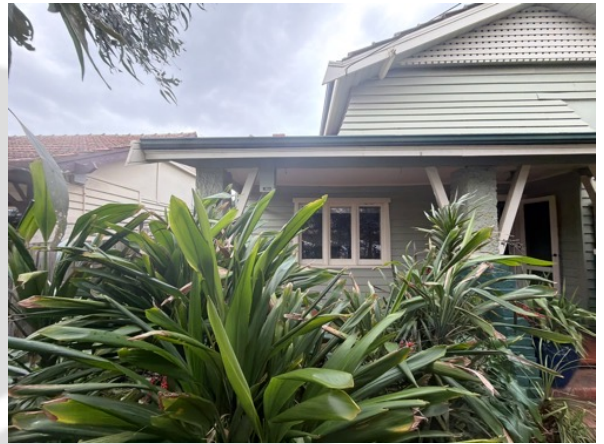
## Minor Defect 1.04

**Finding:** Verandah Timbers - rot/deteriorating

There are verandah Timbers that have rot and deterioration. A carpenter should be engaged for further advice and recommendations for rectification.

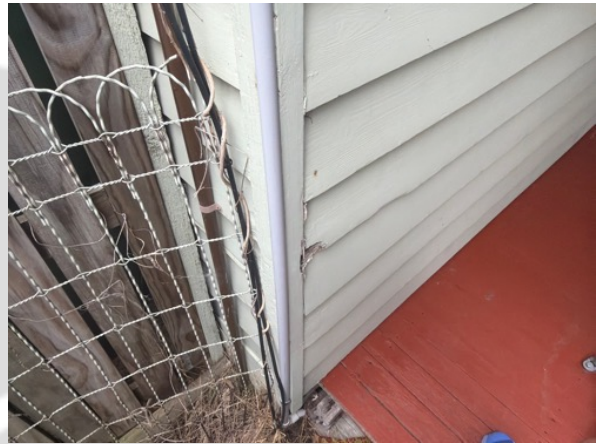
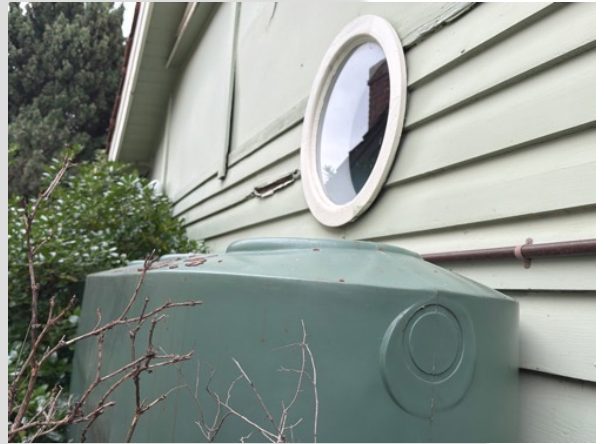
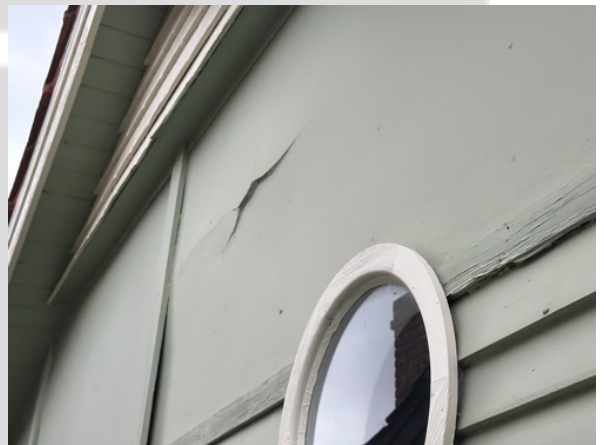
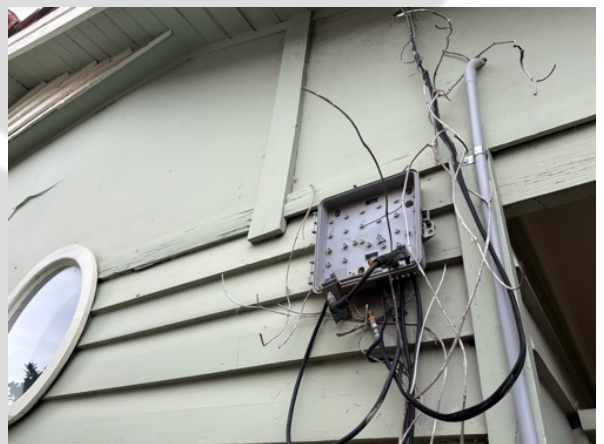
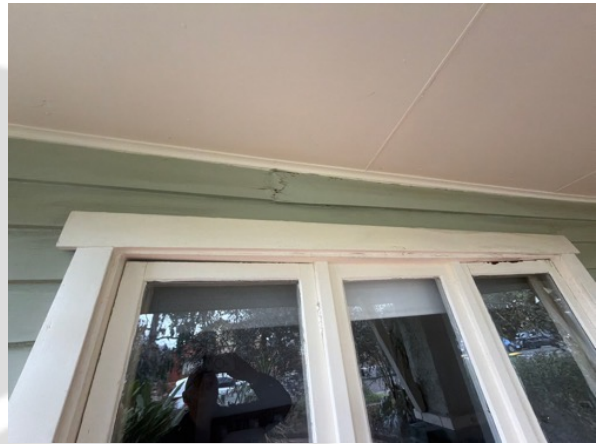
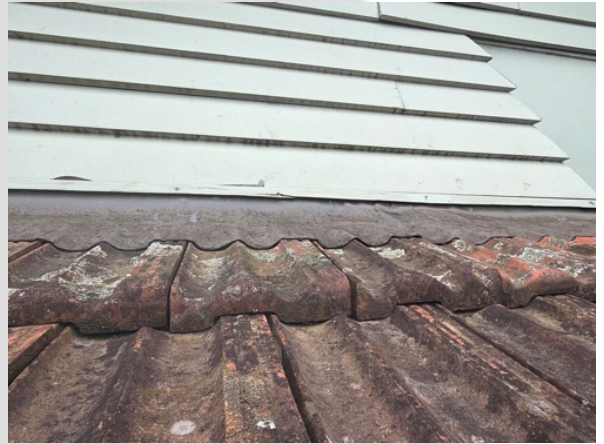
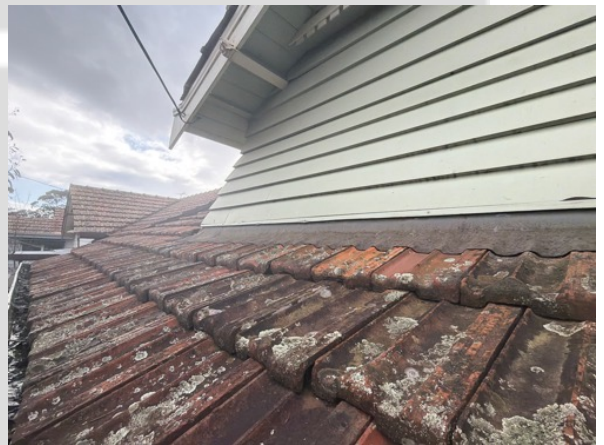
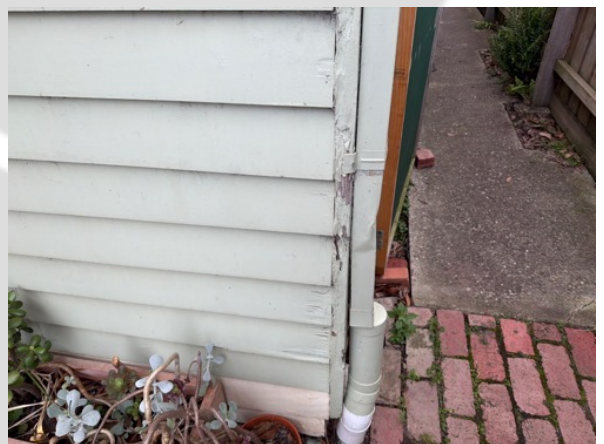
## Minor Defect 1.05

**Finding:** Cladding and Timbers - rot and deterioration

There is rot and deterioration through the external cladding and Timbers. It is strongly recommended that the affected areas be painted, and sections replaced by a qualified painter and carpenter. This should be done to ensure further rot doesn't occur.

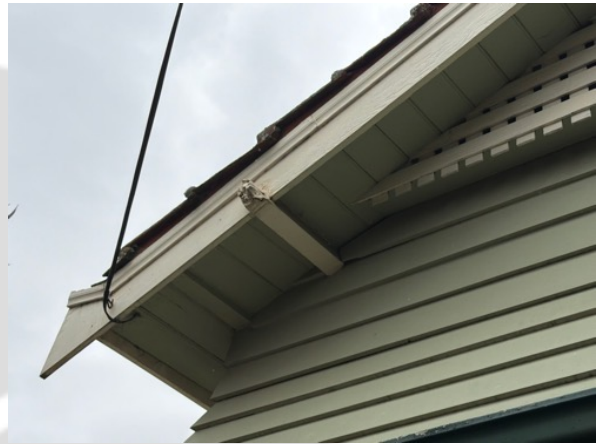
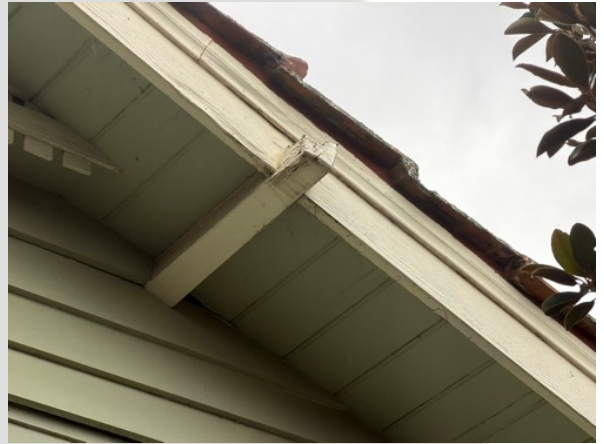
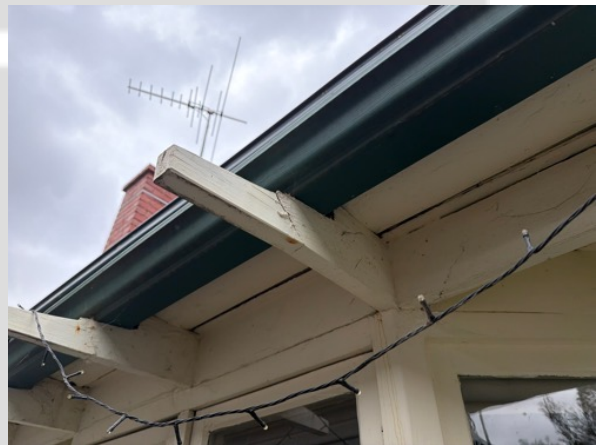
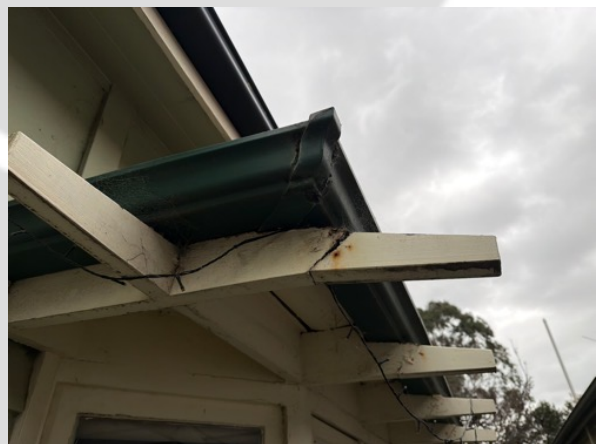
## Minor Defect 1.06

Fascia boards and feature Timbers -rot,deterioration

Sections of the fascia boards and feature Timbers are in poor condition as rot and deterioration is present. It is suggested that a "Licensed Builder/ Carpenter and Painter" be contacted for further evaluation and repair.

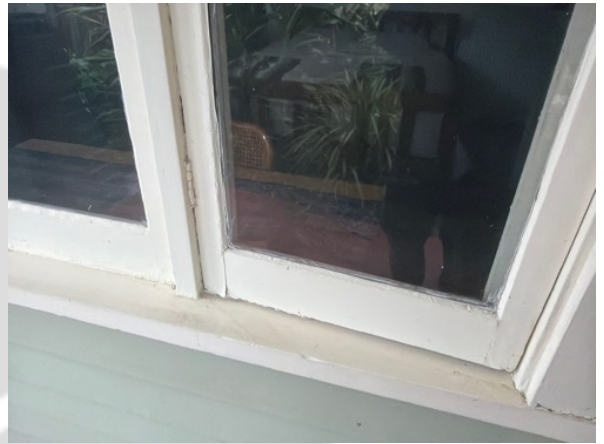
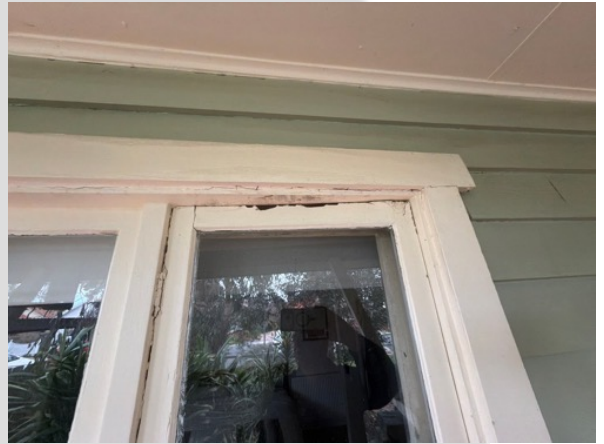
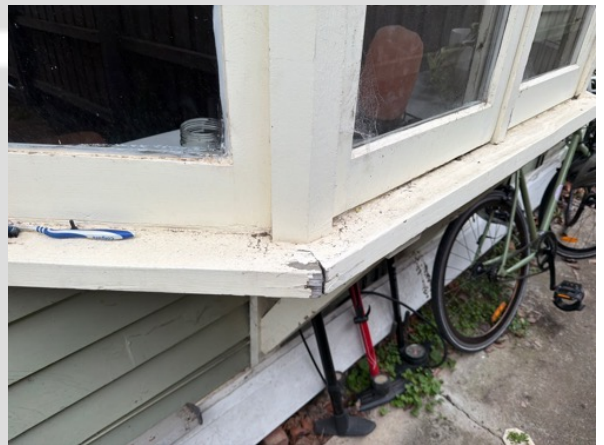
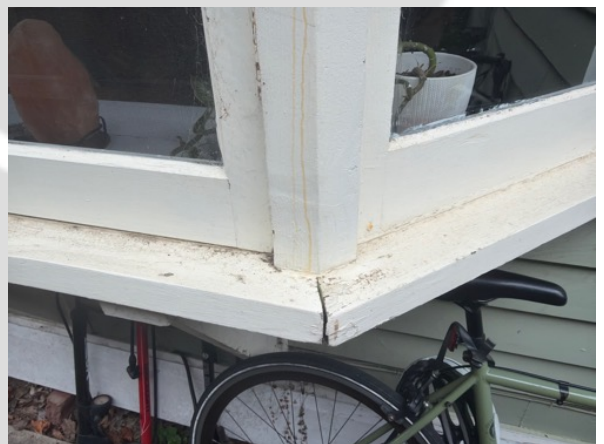
## Minor Defect 1.07

**Finding:** Windows - rot, deterioration

There are windows that are aging and deterioration is present. These windows and window jamb/frame needs to be urgently rectified by a qualified painter and carpenter. The timber needs to be sanded right back (remove rotting areas) and appropriately filled/repared and sealed to remove any further more significant rotting and deterioration occurring.

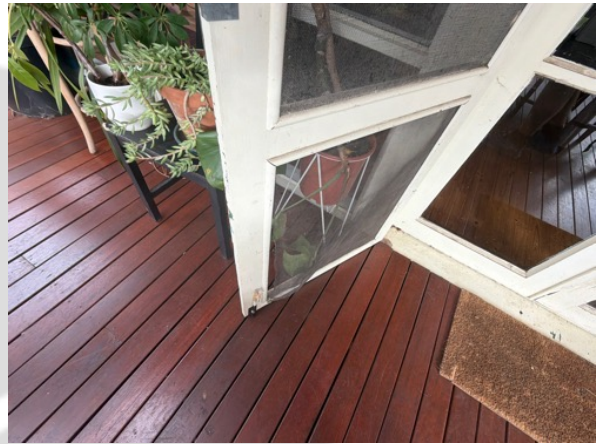
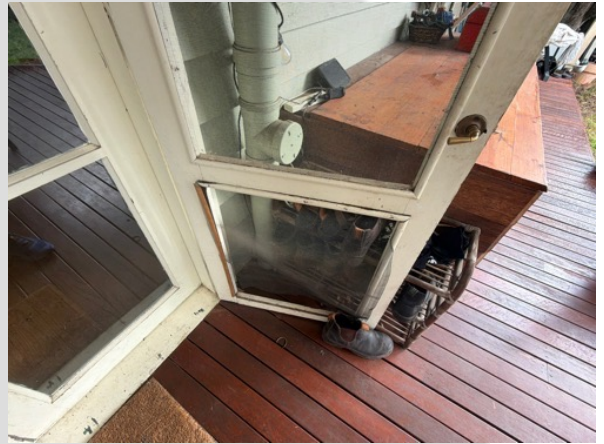
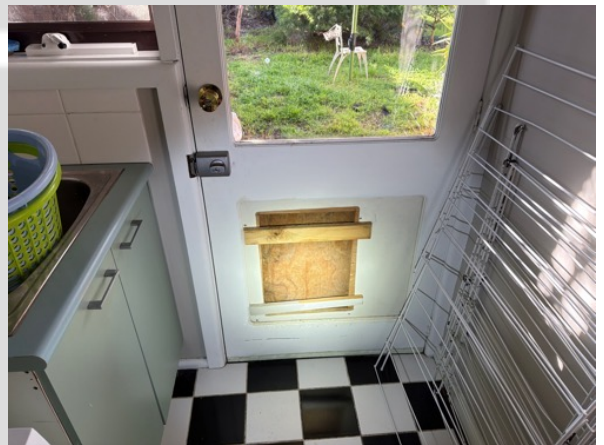
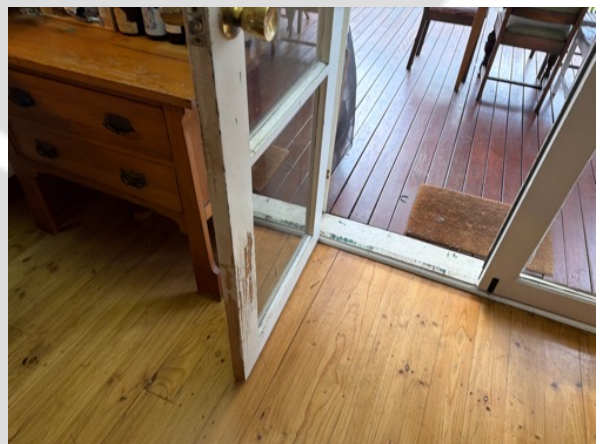
## Minor Defect 1.08

**Finding:** Doors-repaint/fill/damage/flywire

The door(s) are in need of sanding, filling/repairing and repainting. This should be undertaken by a qualified painter to prevent further deterioration occurring.

The rear door has been damaged/poorly repaired. Recommend repair or replacement as needed by a qualified carpenter.

The flywire screens need replacing to prevent insects entering the house. This should be done to also continue to enable good cross flow ventilation throughout the house during the warmer months.

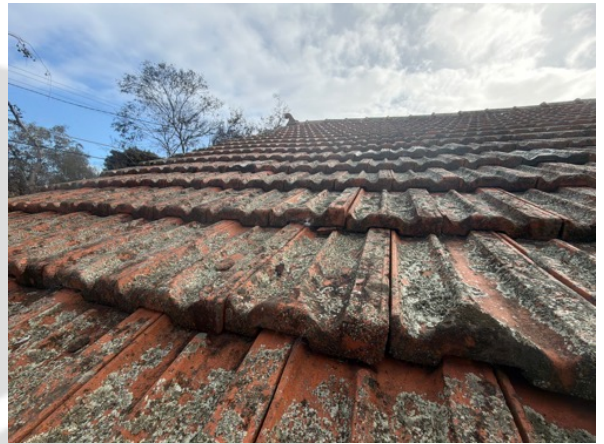
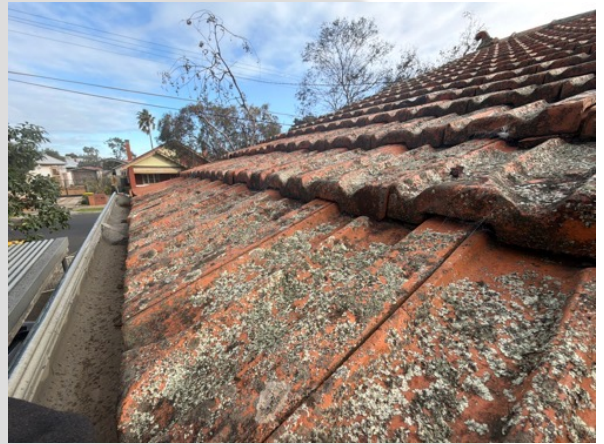
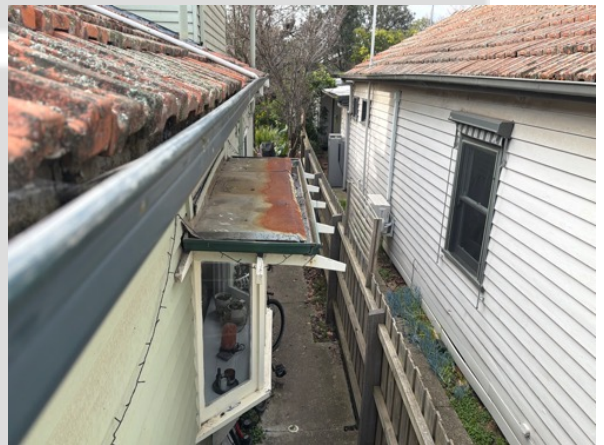
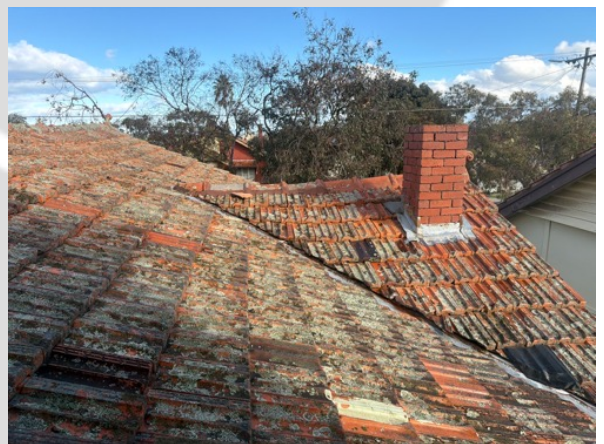
## Minor Defect 1.10

**Finding:** Roof Coverings-Sagging/ Rust / Loose / Cracked / Moss

There is minor sagging or depressions that were observed in the roof covering being caused by the lack of timber framing support or movement. It is recommended that you seek the advice and assistance from a qualified carpenter to rectify.

Sections of the exposed metal coverings have deteriorated (rusty) and in need of repair and/or replacement. It is recommended that this be undertaken by a qualified/licensed roof plumber.

There are loose and cracked tiles located through minor sections of the roof covering. These will need to be refitted by a qualified roof tiler to ensure moisture/water doesn't enter the roof interior causing damage.

There is a significant amount of moss that was observed throughout the roof covering. While mostly cosmetic and not immediately harmful, this condition can indicate a moisture related condition. This condition may also be seasonal depending on tree/leaf coverage and the position of the sun during the changing seasons. Client should consult a roofing contractor or roofing supply company regarding maintenance related issues and products that can reduce this condition.

There are early stages of rusting throughout the metal valleys that need to be sealed with a non-corrosive product. It is recommended that this be undertaken to prevent further rusting occurring and potential moisture penetration and/or damage throughout the roof interior.

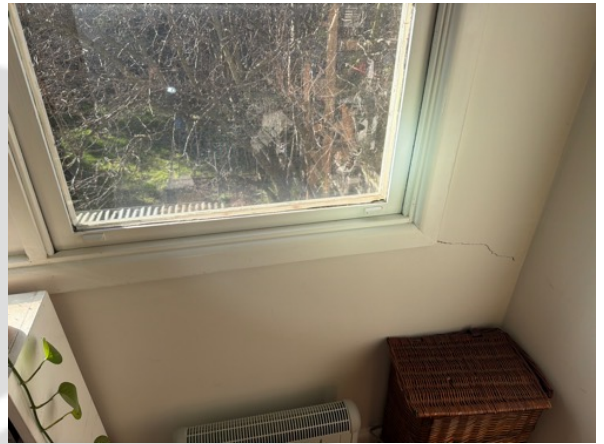
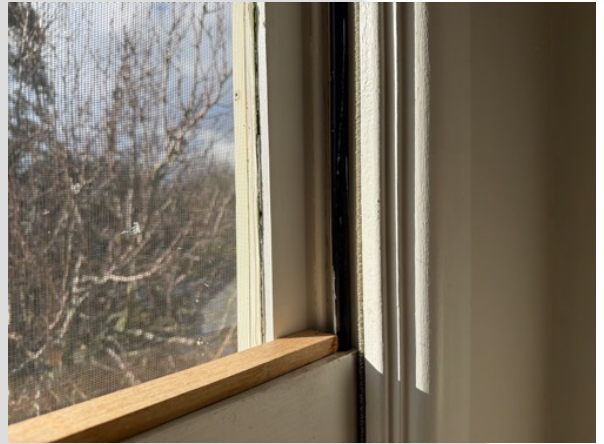
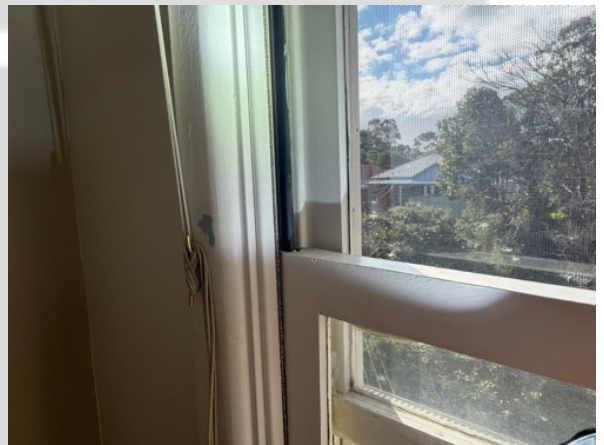
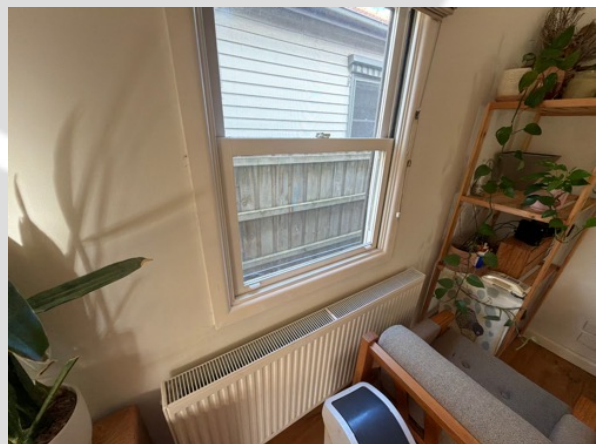
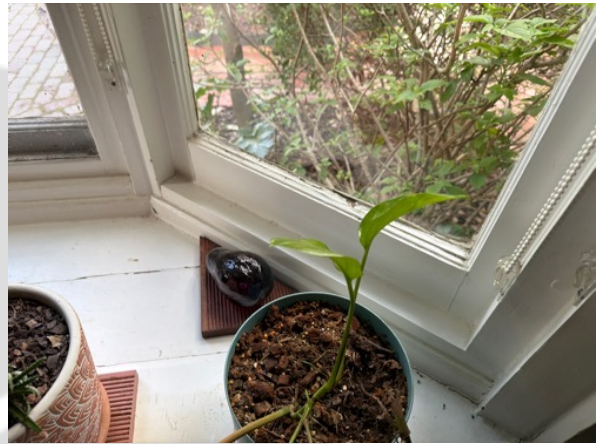
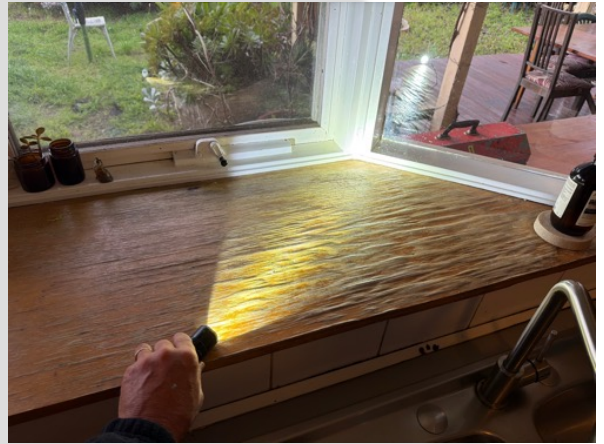
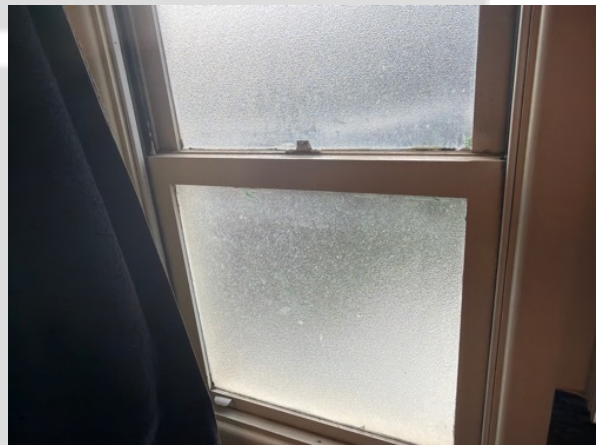
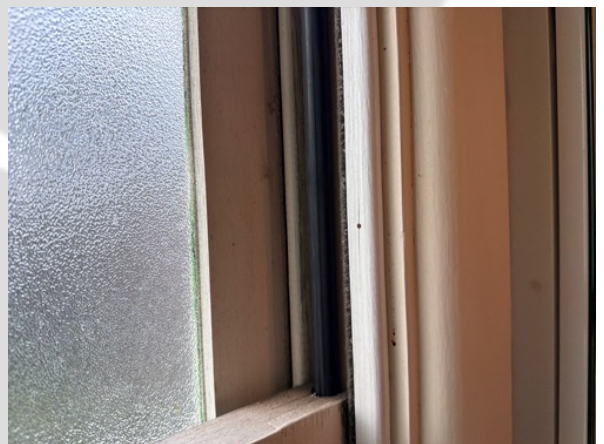
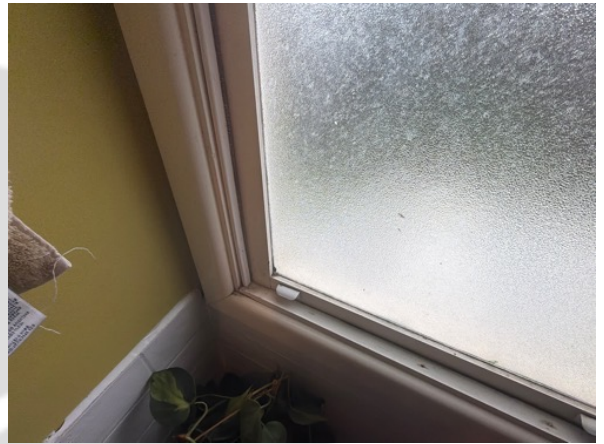
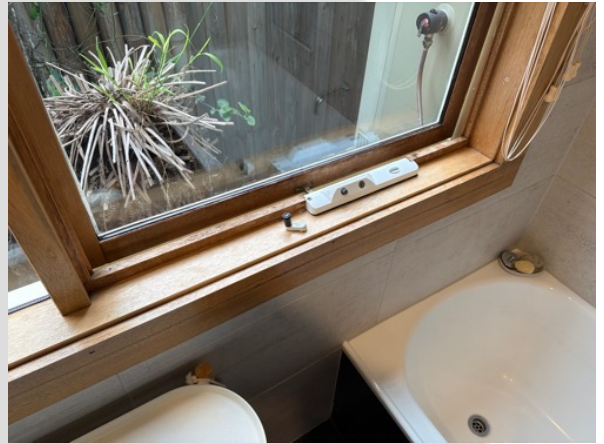
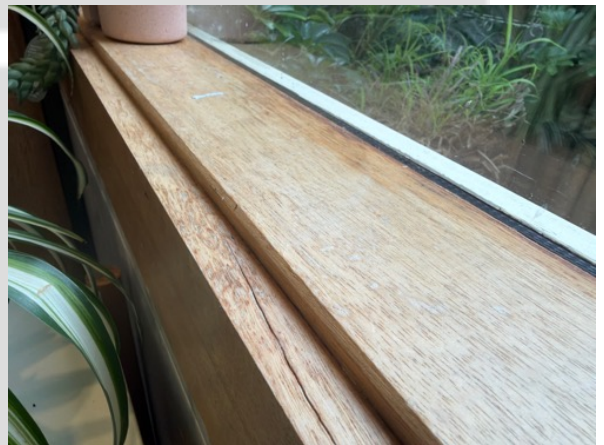
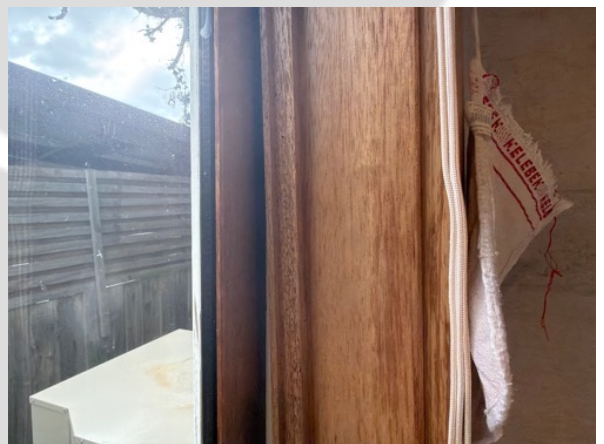
## Minor Defect 1.13

**Finding:** Windows-operation/missing lock/sand/seal/missing handle

There are windows that are difficult to or do not operate. It is recommended that adjustment and/or repairs be undertaken by a "Licensed Builder/ Carpenter".

The sash windows needs repairing as the spring balance or is not functional. This needs to be undertaken by a qualified carpenter to ensure that the window functions as originally intended.

There is a window lock that is missing or broken. For security reasons, it is recommended that the lock be repaired/replaced. It is suggested that a "Licensed Builder/ Carpenter" be contacted for further evaluation and repair.

There are a number of windows and surrounds that are in need of sanding back and sealing by a qualified painter to ensure deterioration doesn't occur.

There is a loose winder handle that will need rectification or replacement by a qualified carpenter.

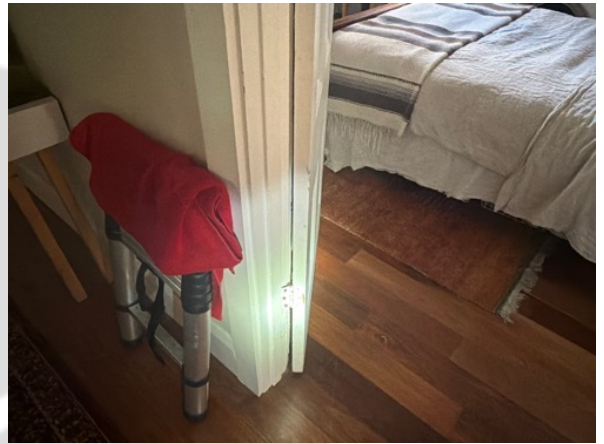
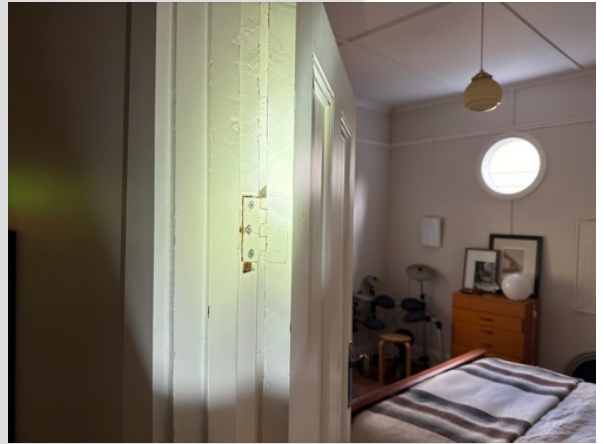
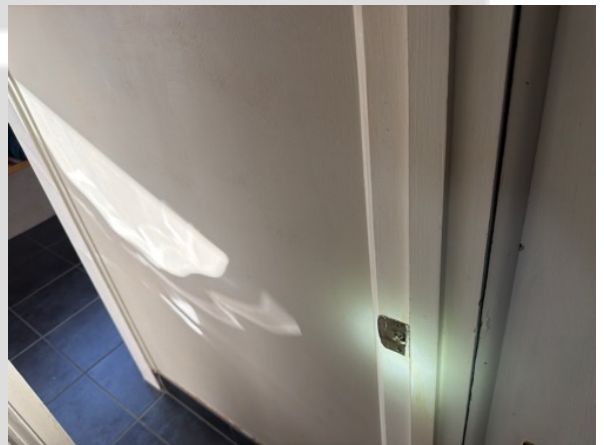
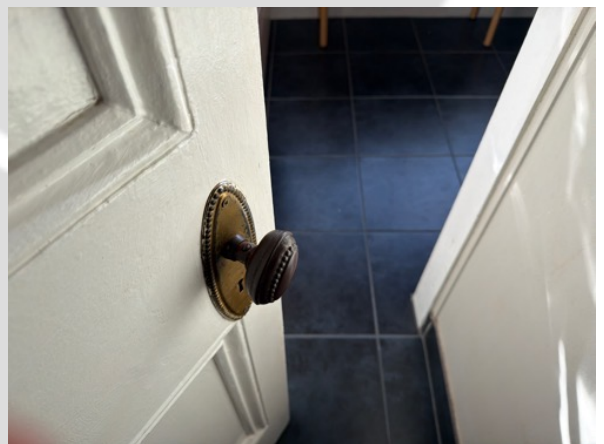
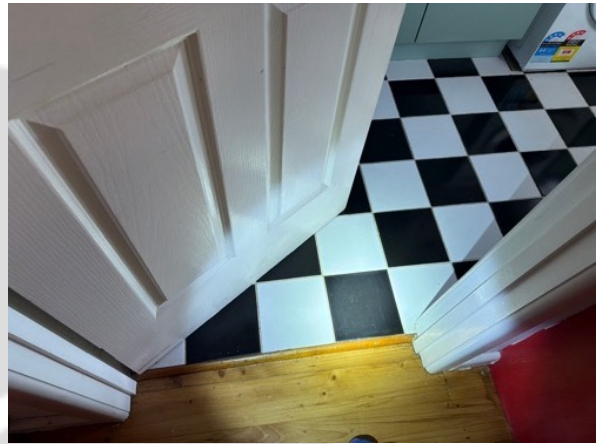
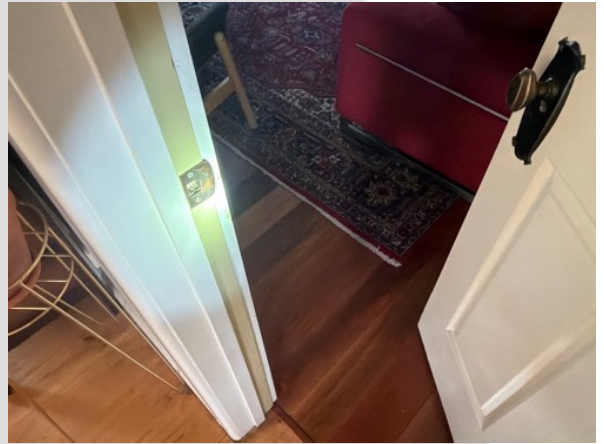
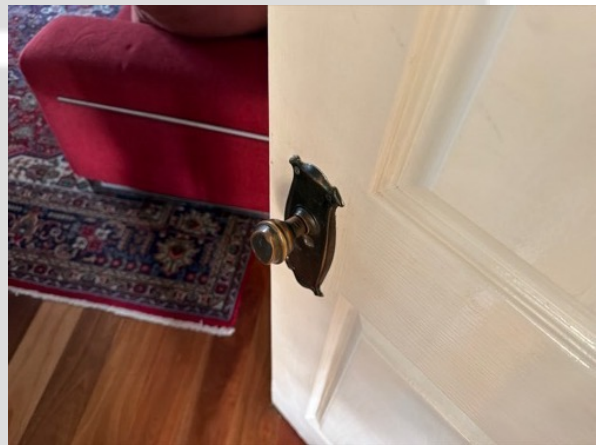
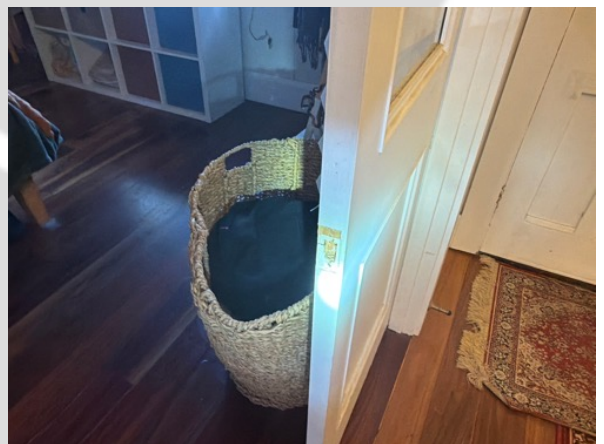
## Minor Defect 1.14

**Finding:** Door-damage, strike plates/latching/handles/paint/rubbing

The door latch/striker plate/s are missing. It is suggested that a "Licensed Builder/ Carpenter" be contacted for further evaluation and installation.

The door hinges are loose and requires refixing to the door frame/jamb. It is recommended that a qualified carpenter undertake this to enable the door to function properly.

There are door handles that need to be adjusted/reinstalled/replaced by a qualified carpenter or locksmith.

The door(s) are in need of repainting. This should be undertaken by a qualified painter to prevent further deterioration occurring.

The door rubs on the floor covering. Repairs and/or adjustments (planing) are recommended by a qualified carpenter to prevent potential deterioration.

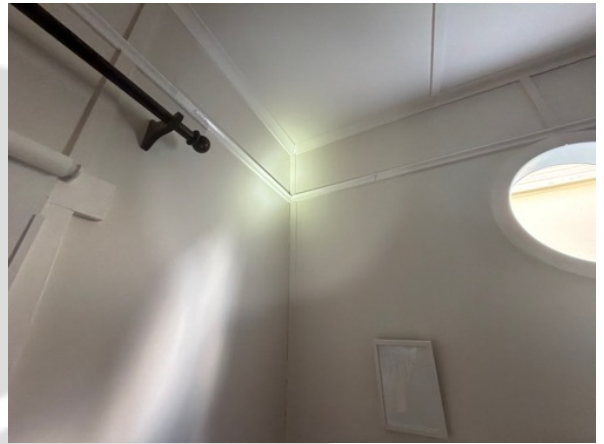
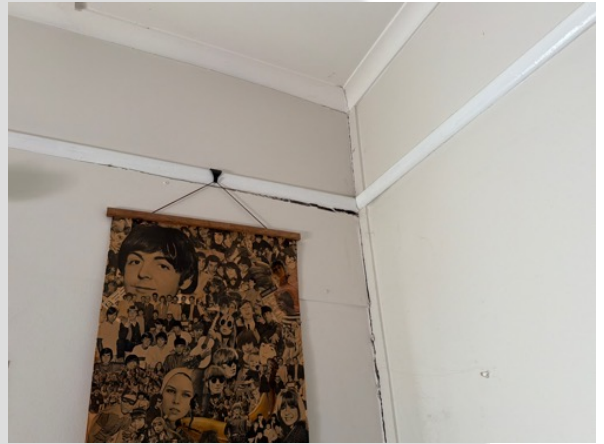
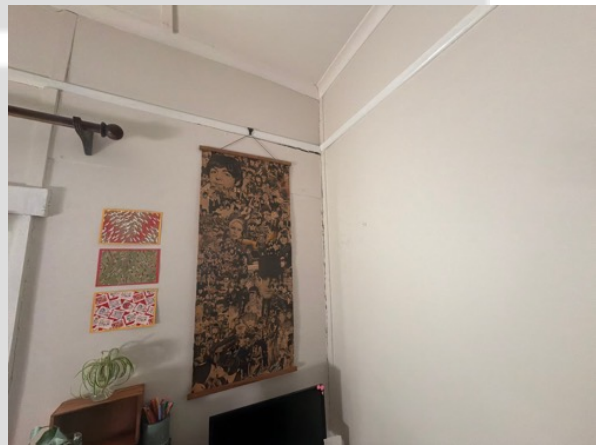
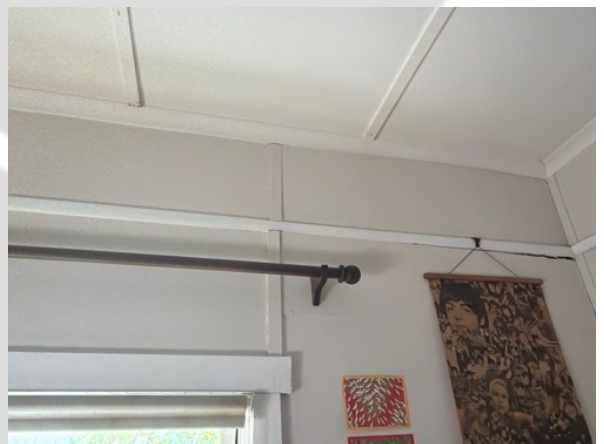
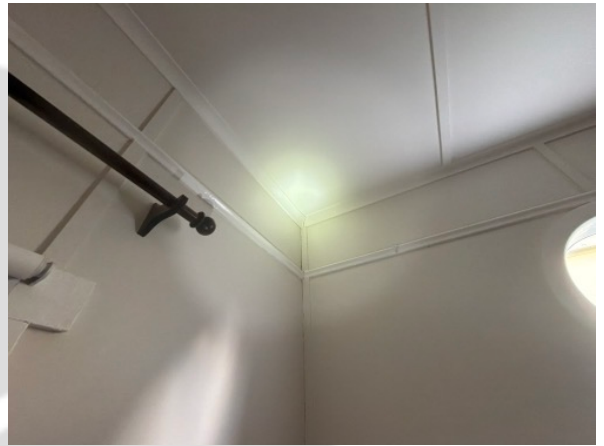
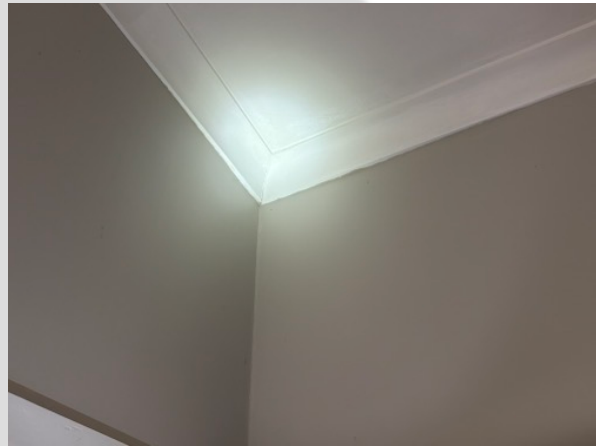
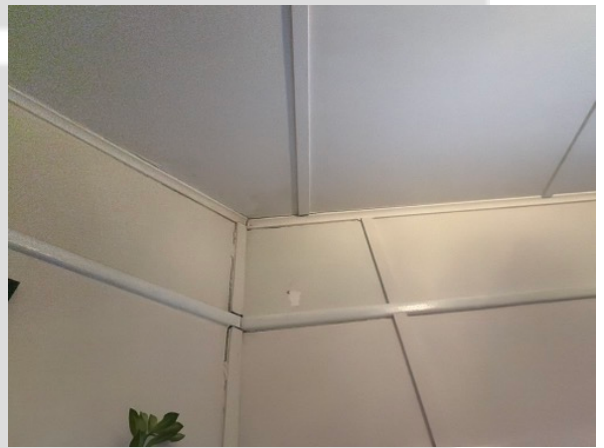
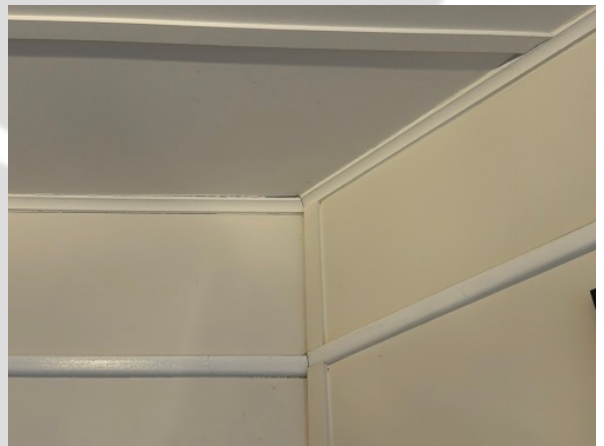
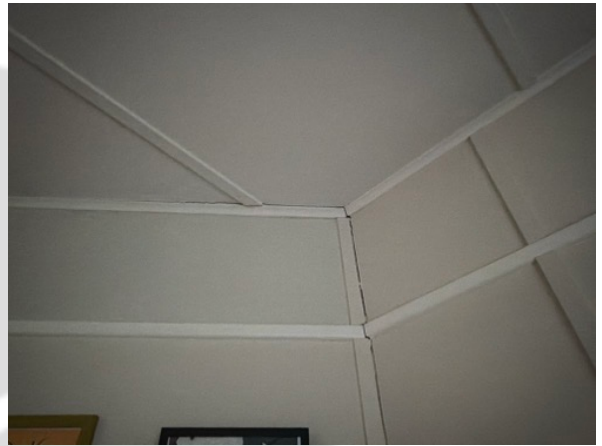
## Minor Defect 1.15

Wall and Ceiling covering- cracking

There is extensive movement cracking to the wall and ceiling linings throughout. Much of the movement is from wall and ceiling frame likely related to the subfloor structure. The subfloor will need to be attended to (refer other notes) and timber wall frames and ceilings may need to be braced further and reinstated by a qualified carpenter. Once all structures are rectified a qualified plasterer should be engaged to re-plaster, fill, and or replace all affected walls, ceilings and cornices.

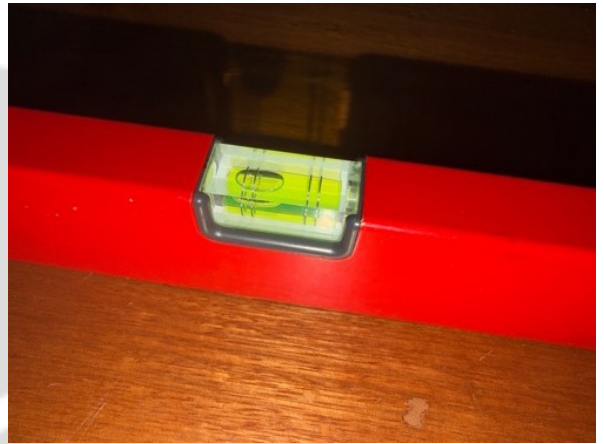
## Minor Defect 1.17

It is recommended that you seek the advice from a qualified Re-stumper to determine level of rectification required.

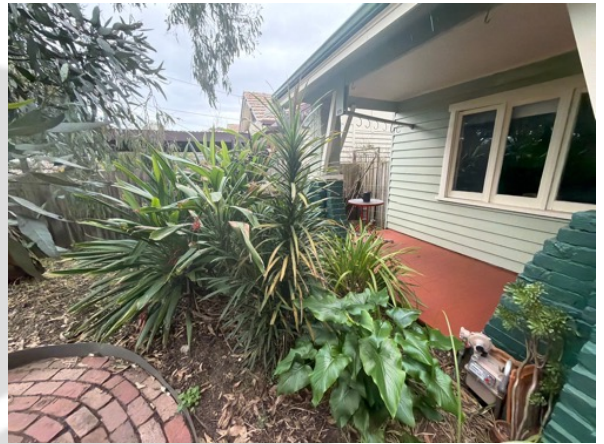
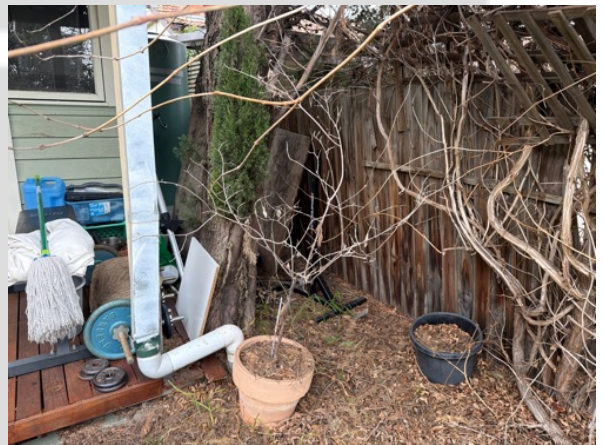
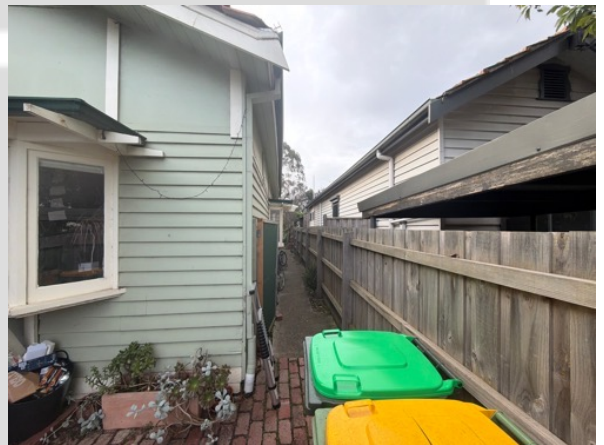
**Finding:** Additional Photos - Limitations and Obstructions

Additional photos are provided for your general reference. These photographs are an indication of the obstructions and limitations which impeded full inspection of the property at the time of inspection. These obstructions can hide an array of defects and should be removed to allow full inspection to be carried out. A re-inspection is recommended once the areas are made accessible.
