# Building And Timber Pest Report

Property Address: 84 Hutton Street Thornbury 3071

Inspection Date: 3 Aug 2026

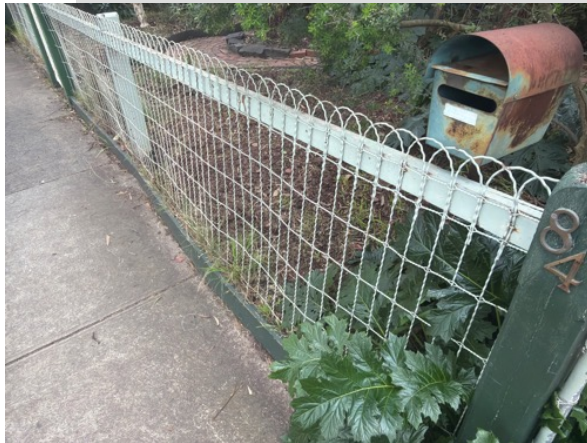
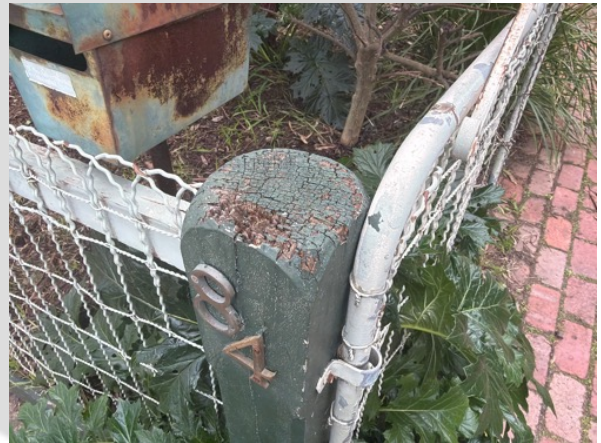
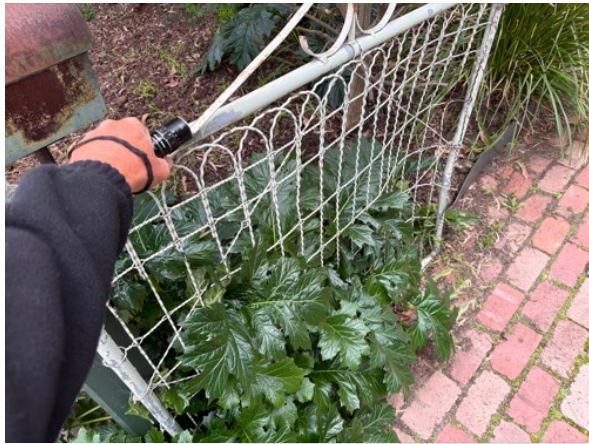
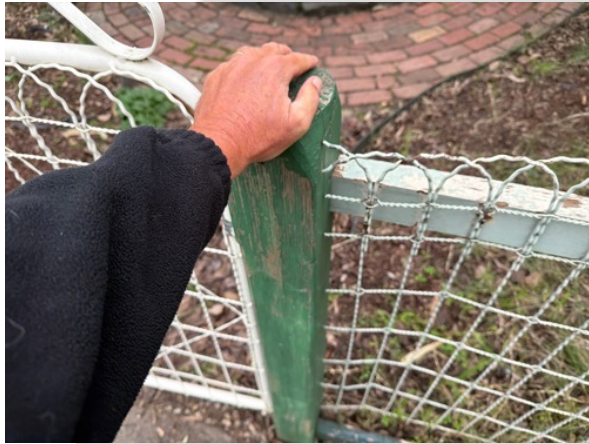
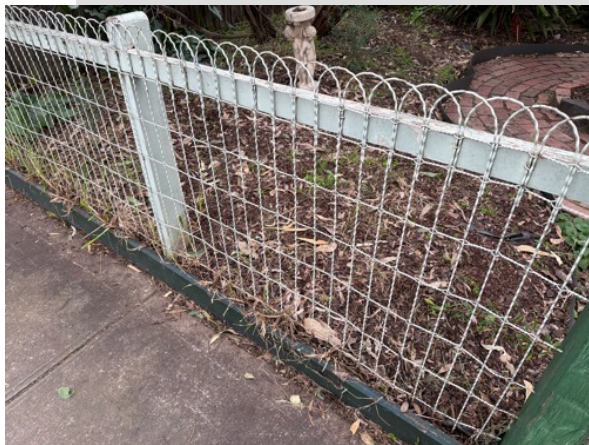
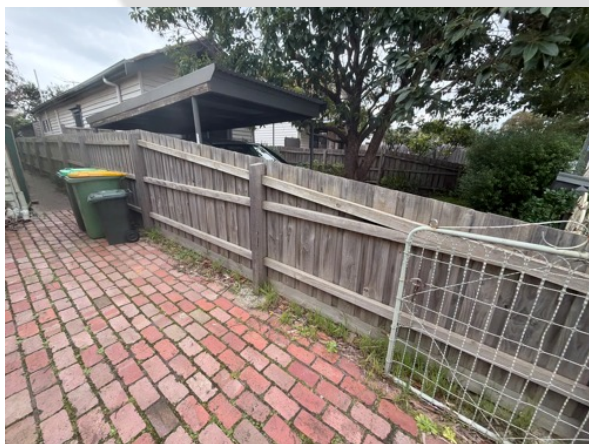
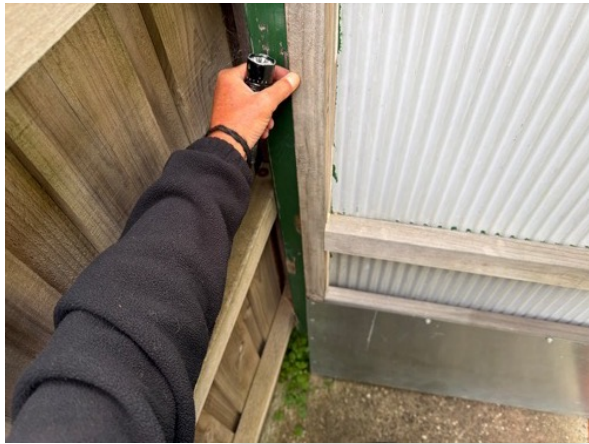
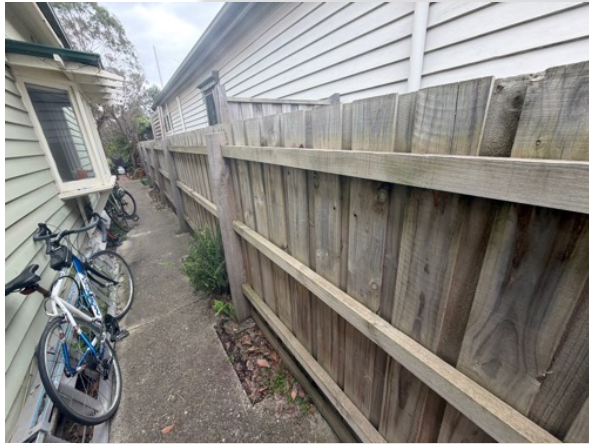
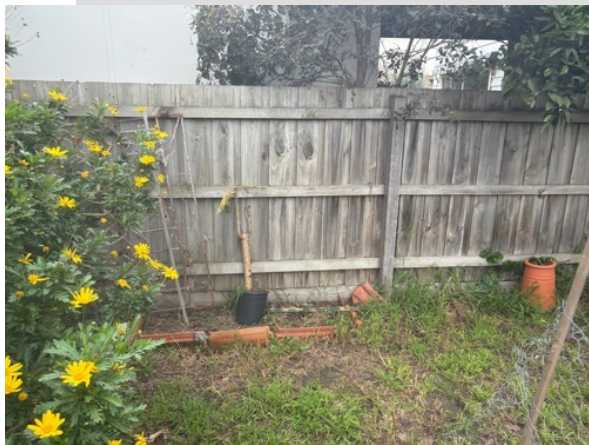
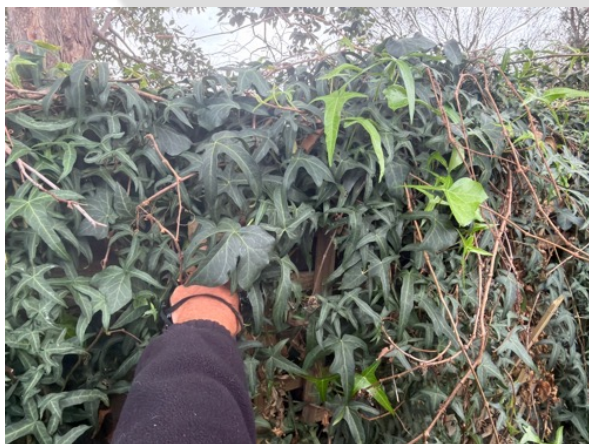
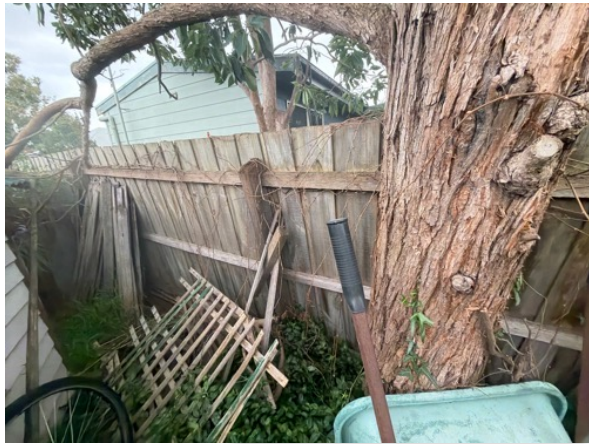
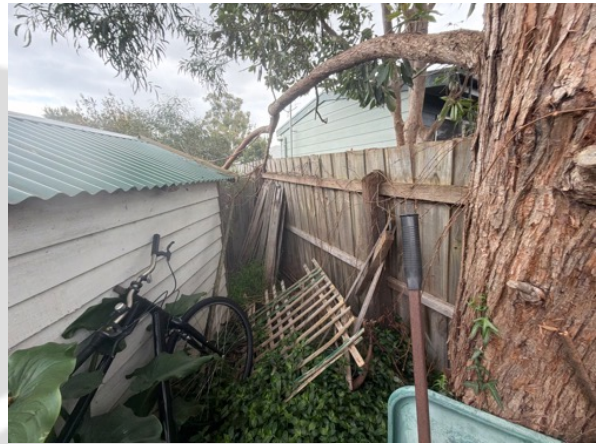
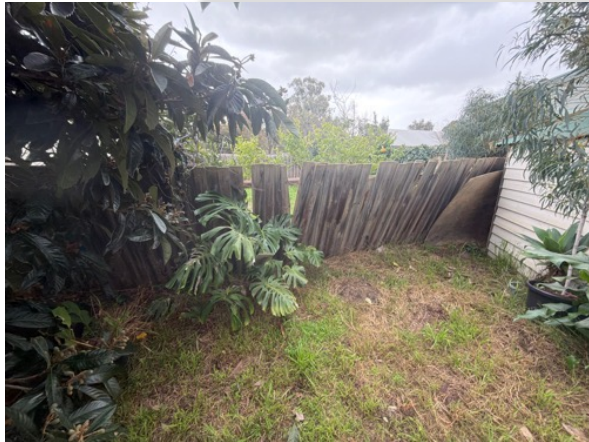
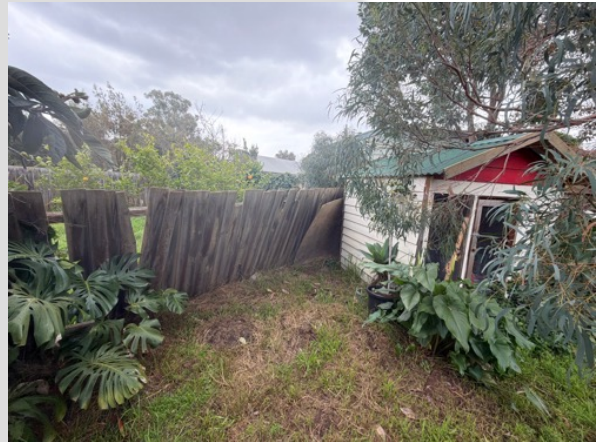
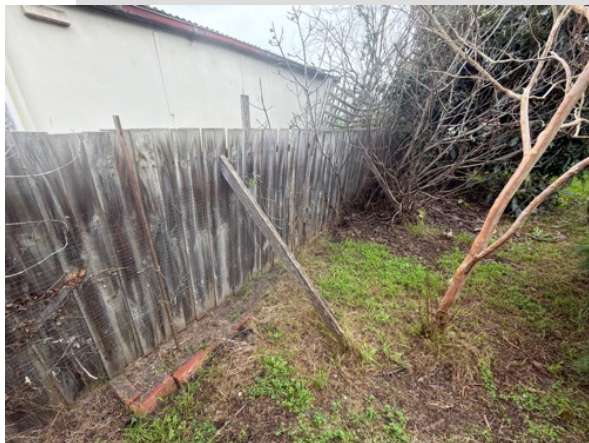
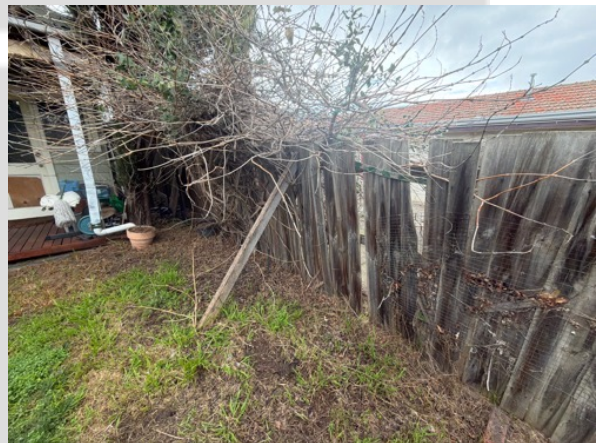
**Finding:** Fences and gates -deterioration

The boundary fence and gates have significant deterioration present. These sections will need to be replaced or repaired by a fencing contractor in the short to medium term.

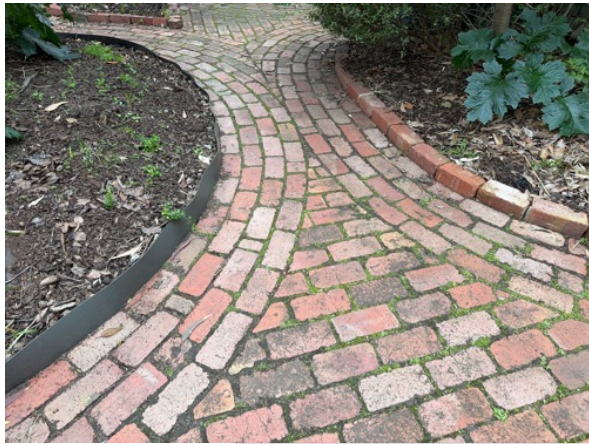
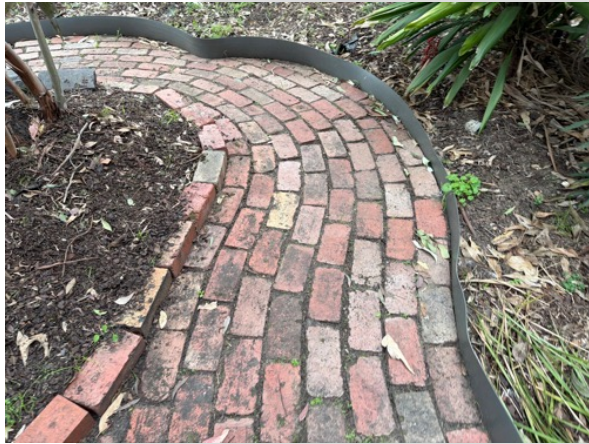
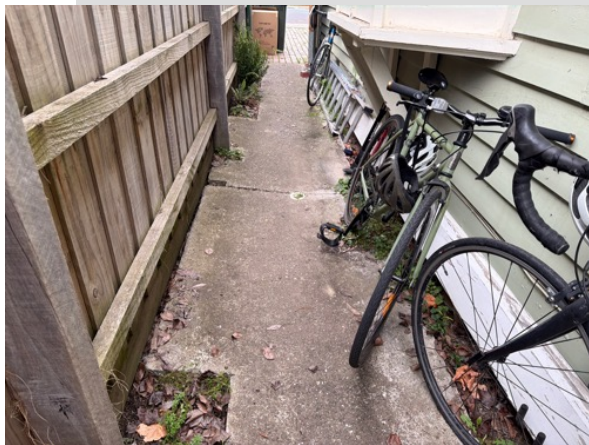
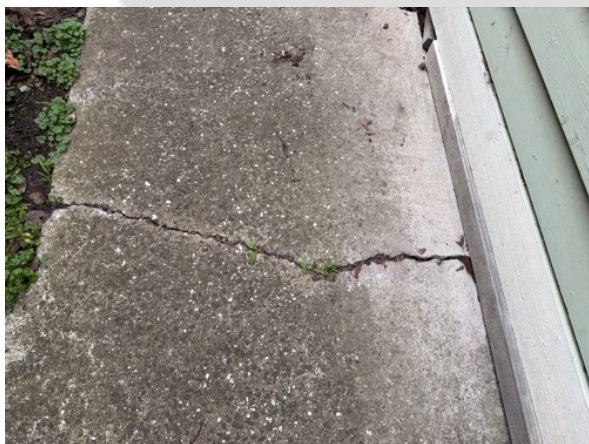
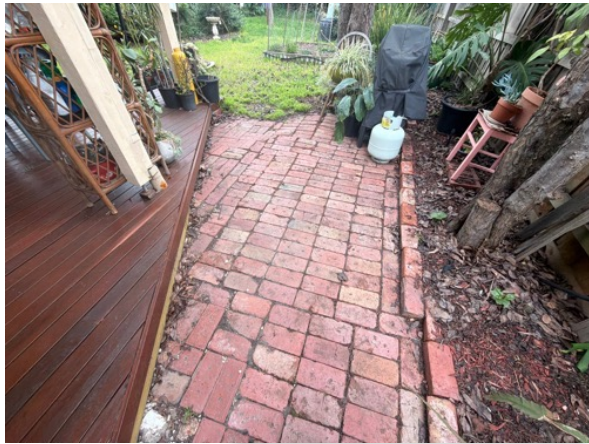
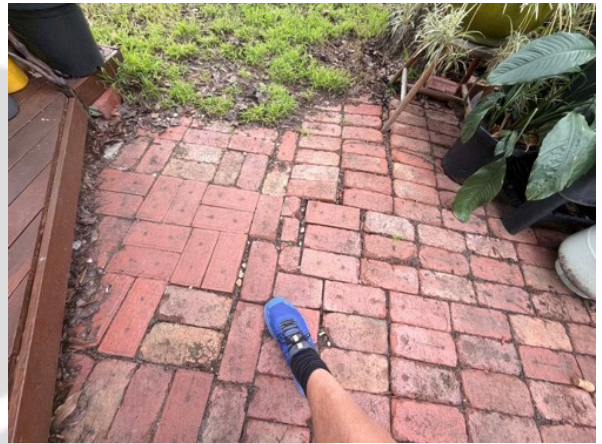
## Minor Defect 1.02

Settlement cracks were observed in the concrete slab of the paths. It is recommended that these cracks be sealed and maintained by a qualified concreter.

Tripping hazards were observed through the paths. These should be repaired for safety. It is suggested that a qualified paver be contacted for further evaluation and repair.

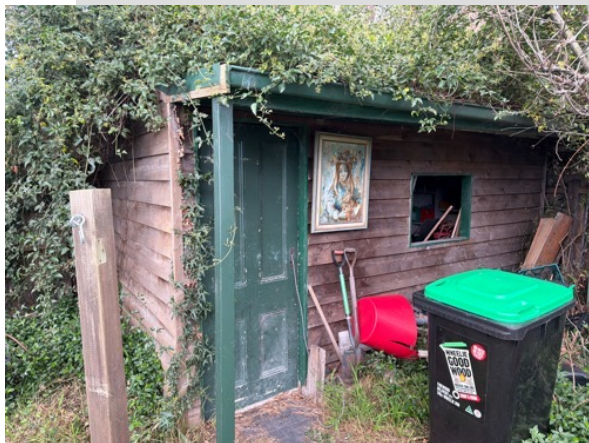
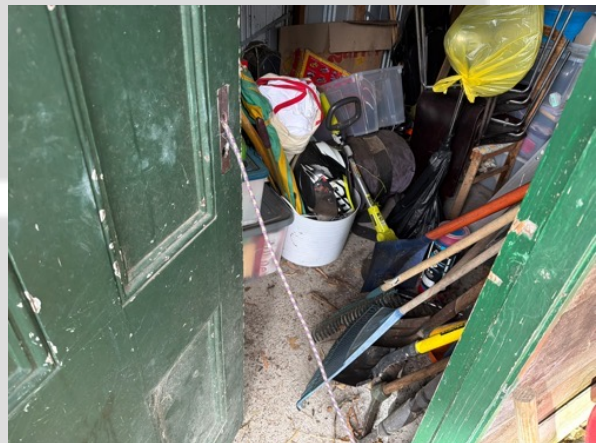
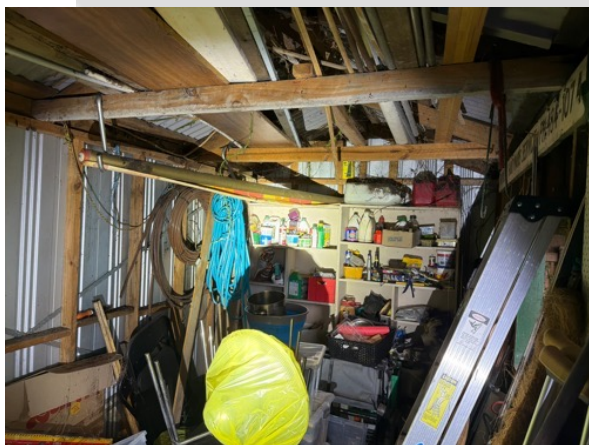
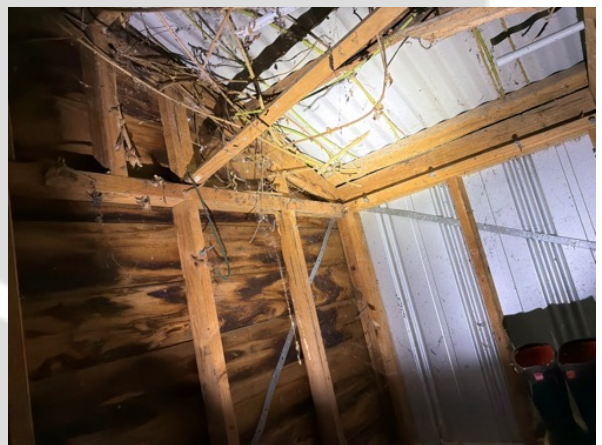
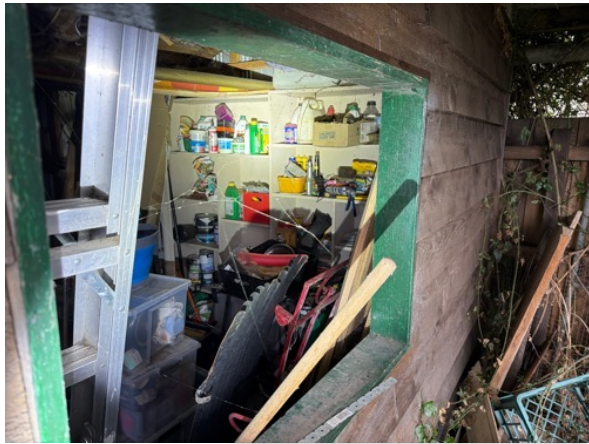
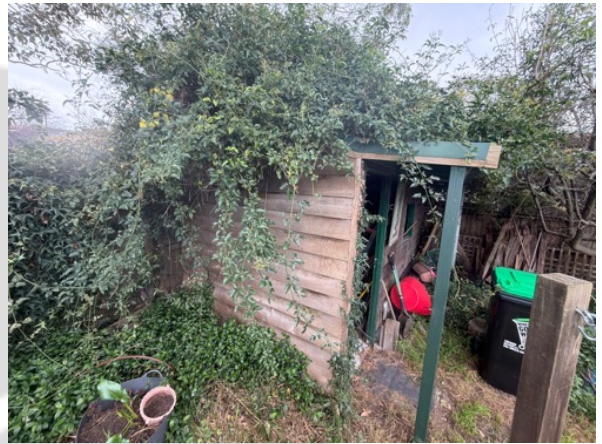
## Minor Defect 1.03

**Finding:** Garden shed - deterioration

The garden shed is showing signs of minor deterioration. It is recommended that these sections of the garden shed be rectified by a qualified shed builder or carpenter.

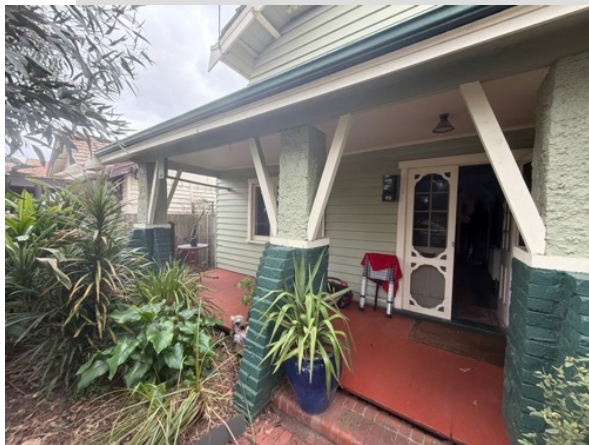
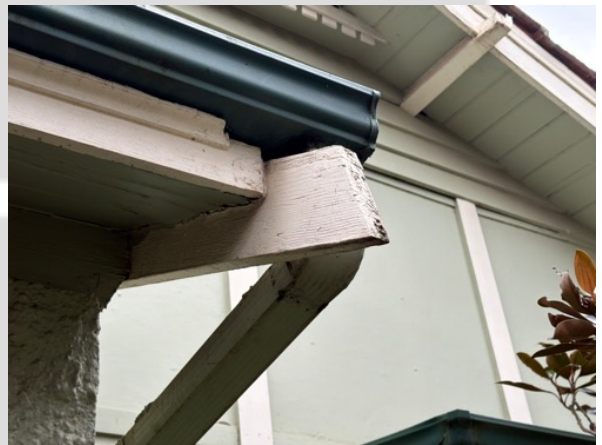
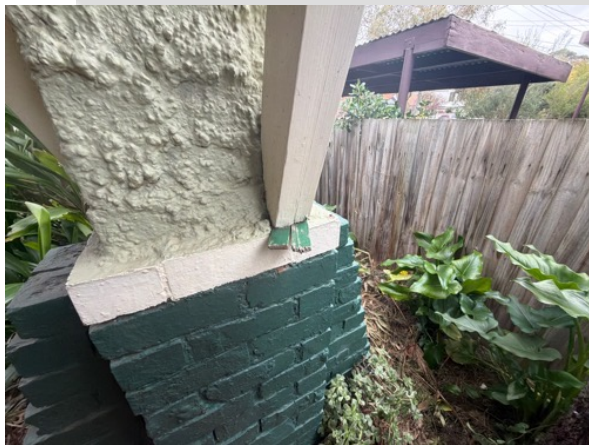
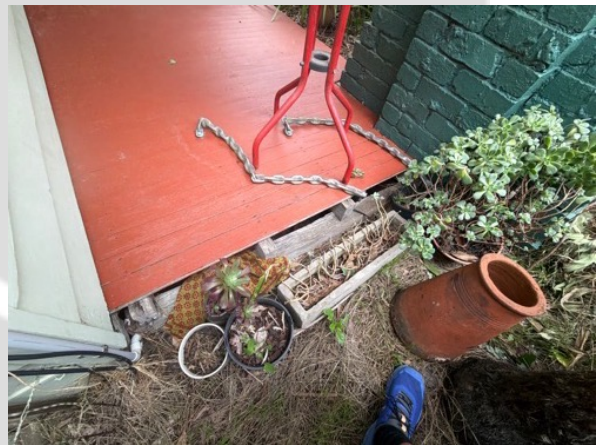
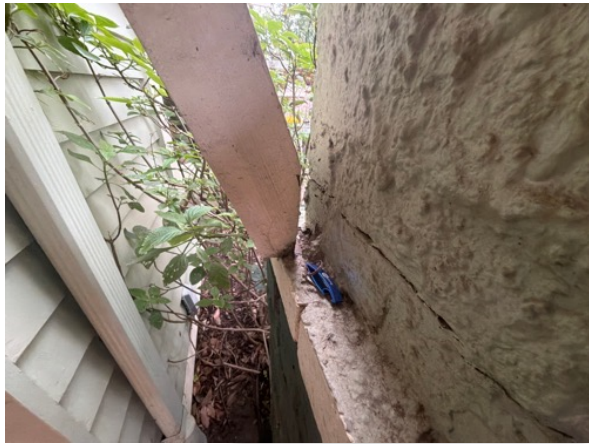
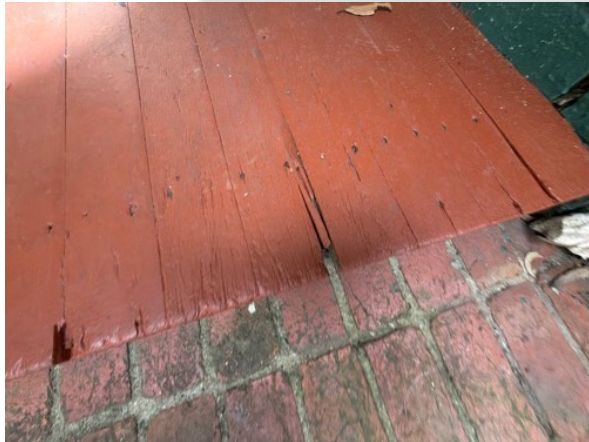
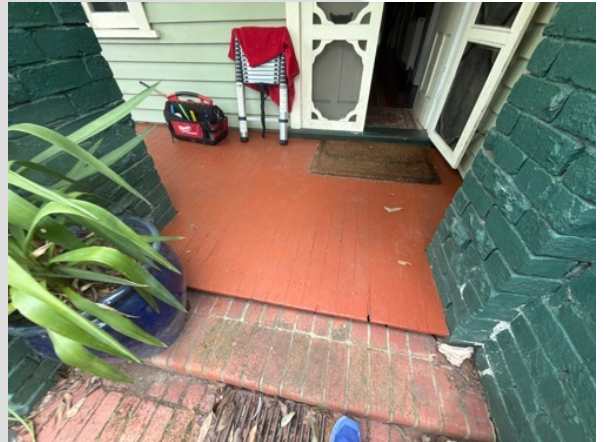
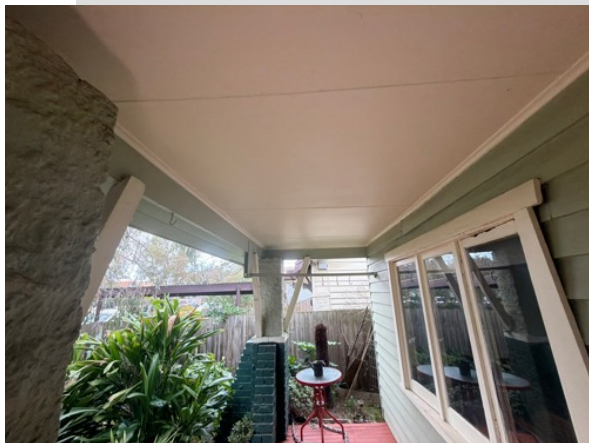
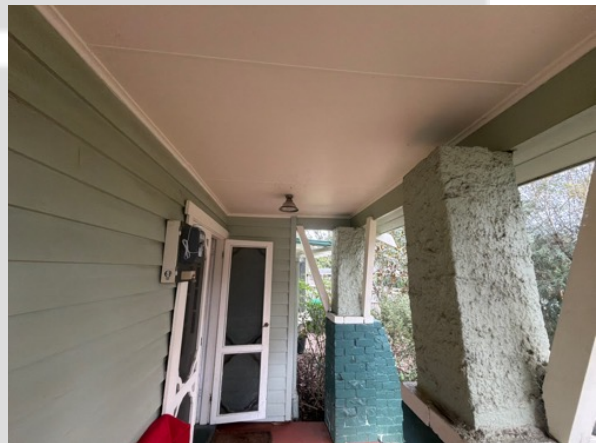
## Minor Defect 1.04

**Finding:** Verandah Timbers - rot/deteriorating

There are verandah Timbers that have rot and deterioration. A carpenter should be engaged for further advice and recommendations for rectification.

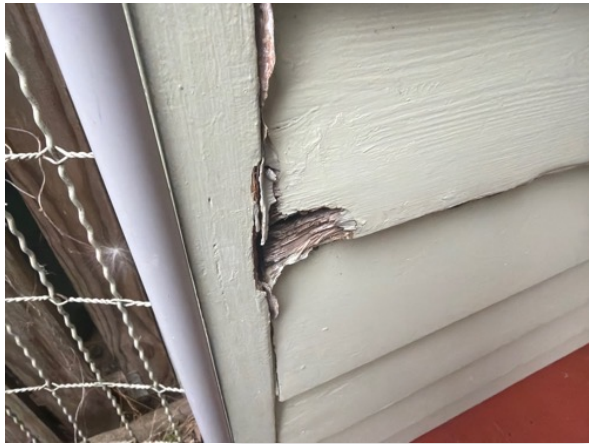
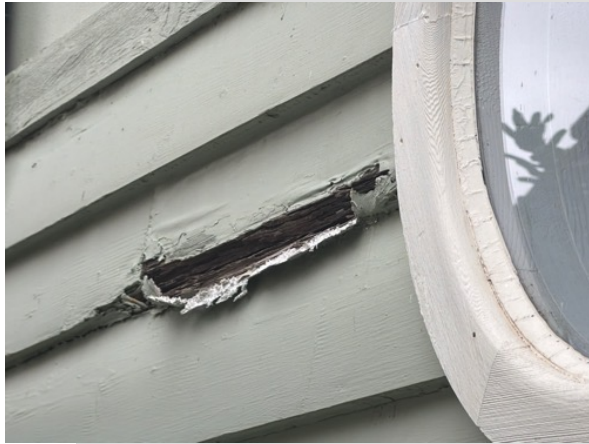
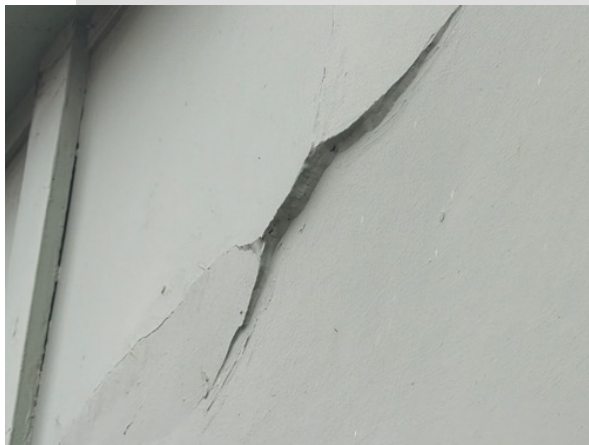
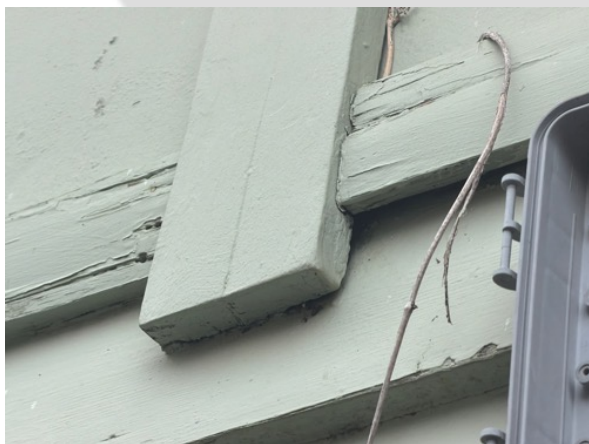
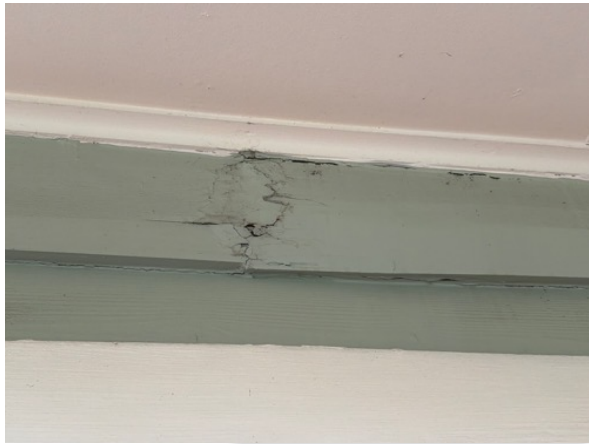
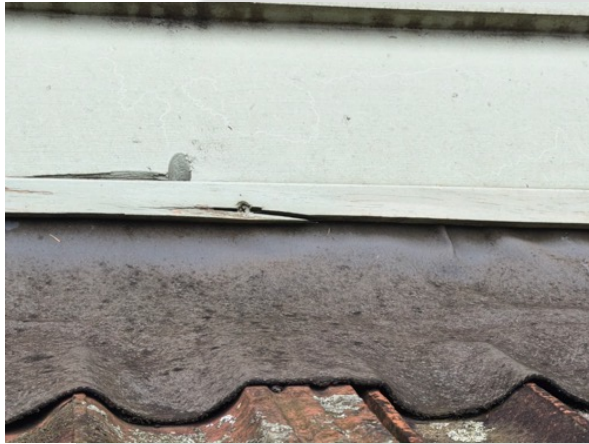
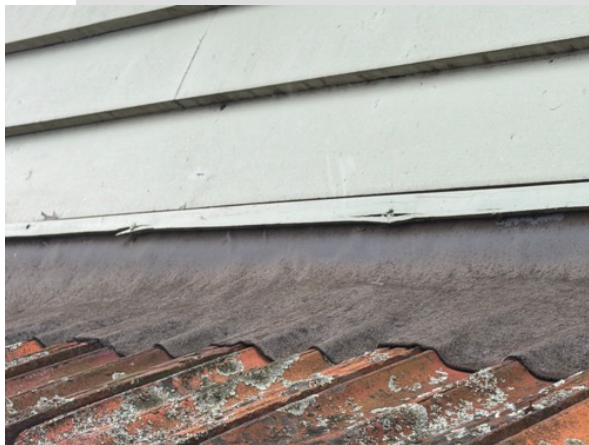
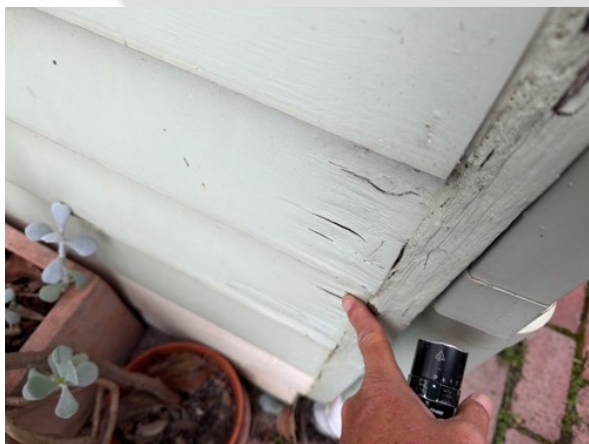
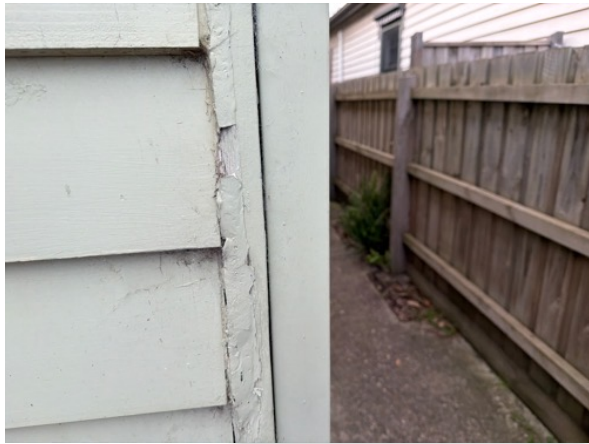
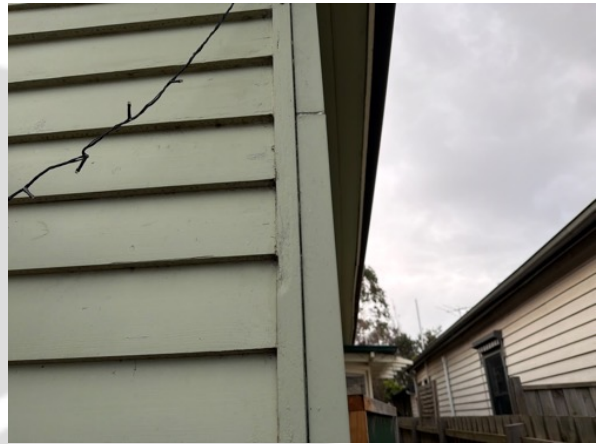
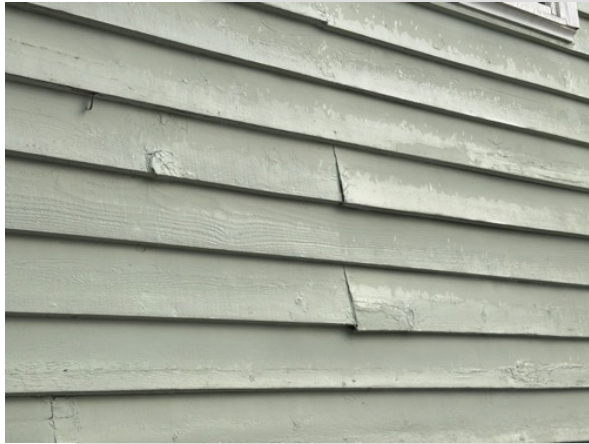
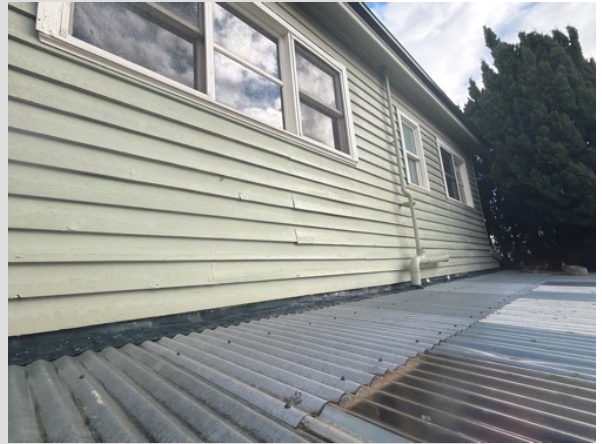
**Finding:** Cladding and Timbers - rot and deterioration

There is rot and deterioration through the external cladding and Timbers. It is strongly recommended that the affected areas be painted, and sections replaced by a qualified painter and carpenter. This should be done to ensure further rot doesn't occur.

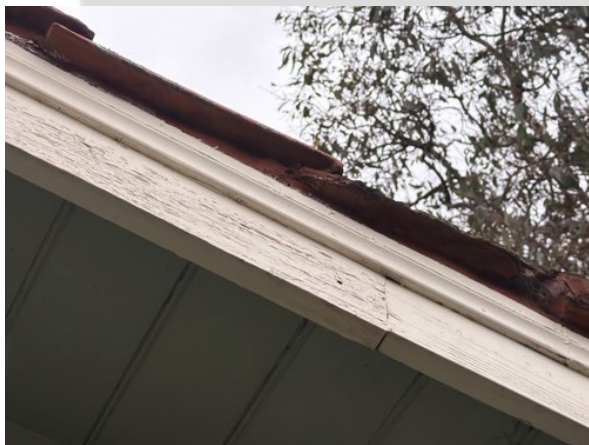
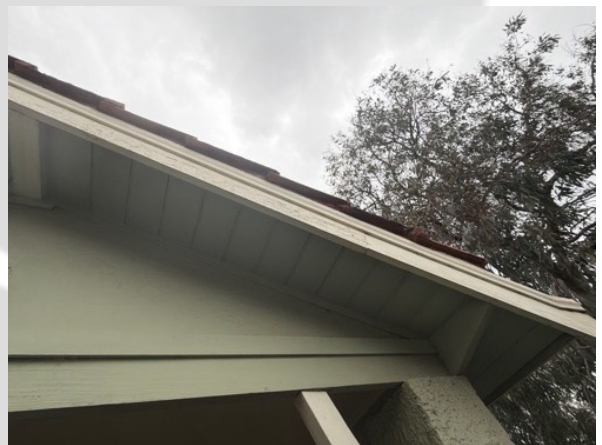
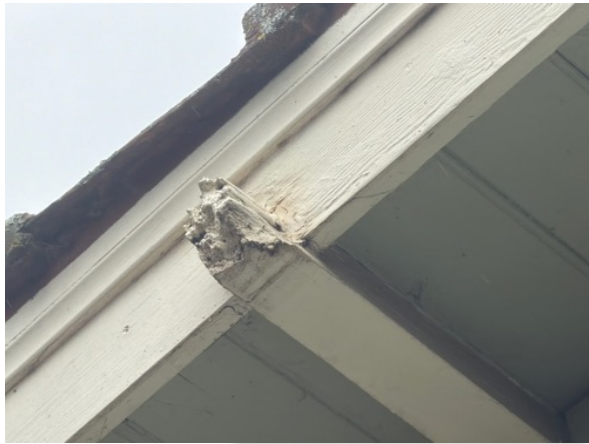
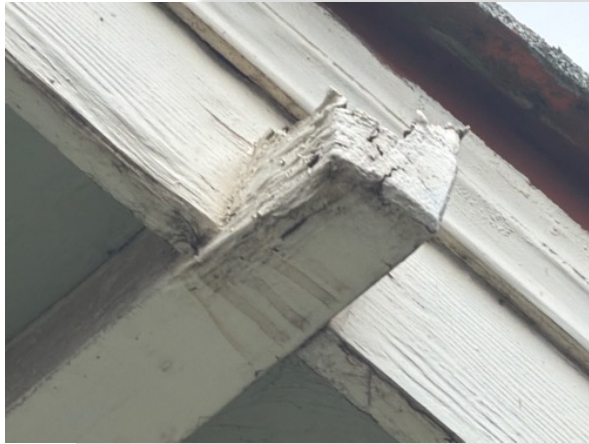
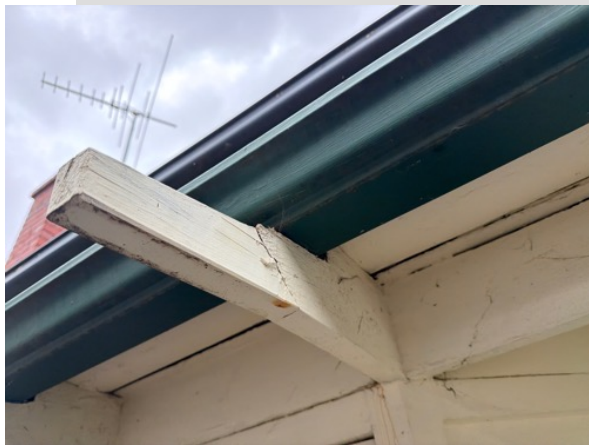
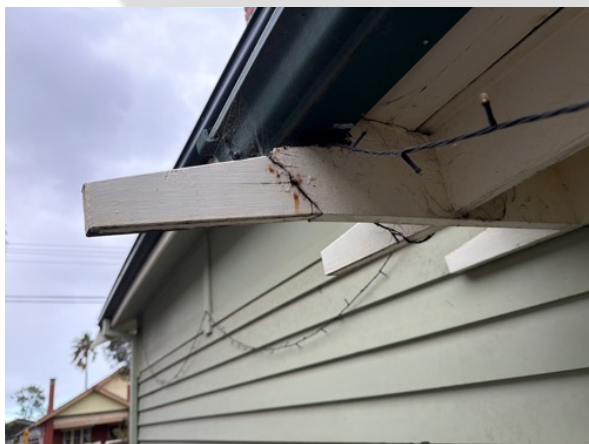
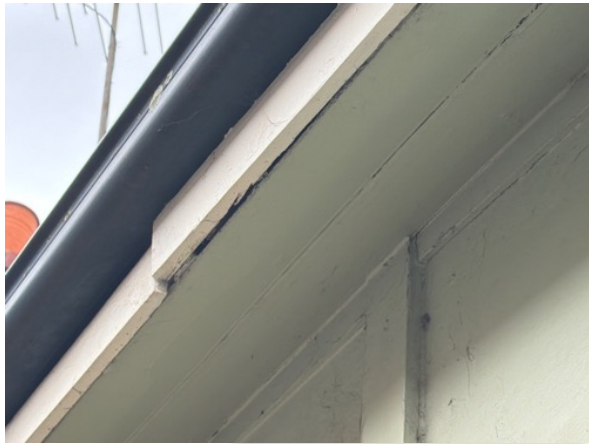
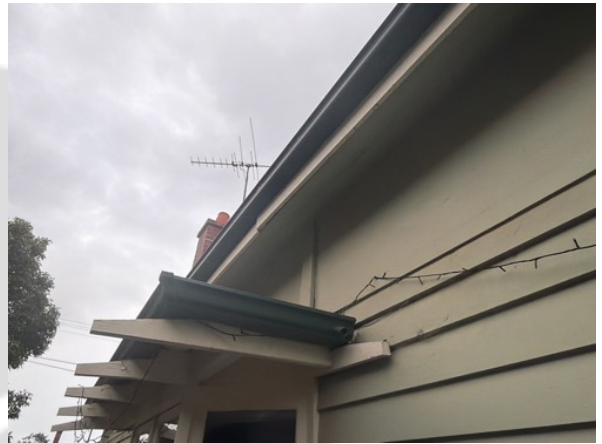
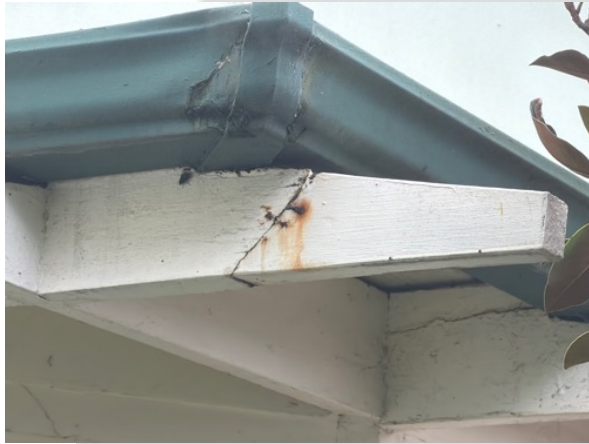
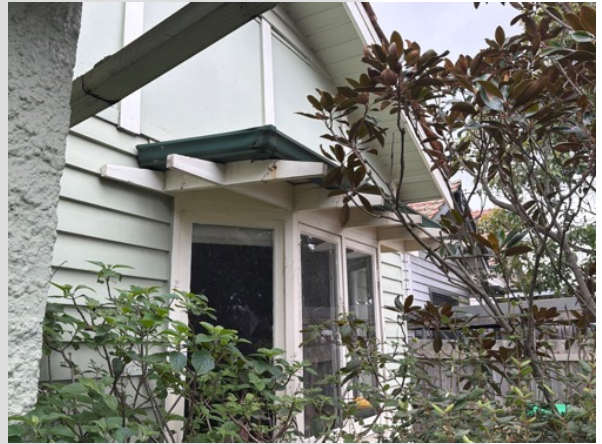
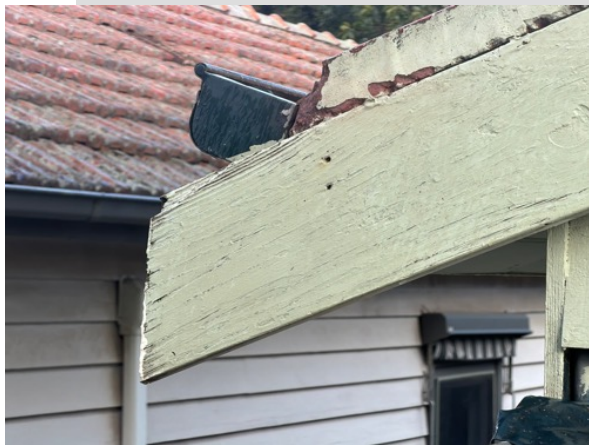
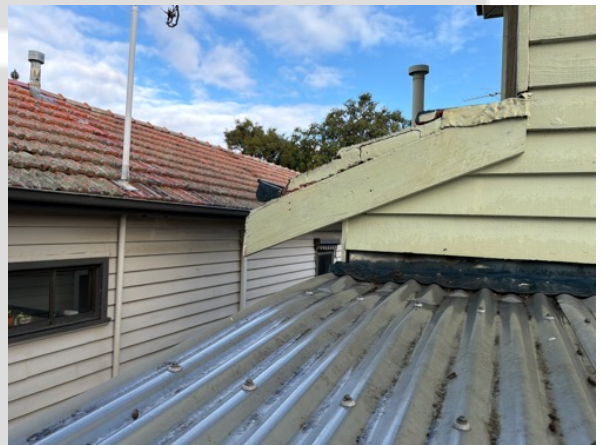
## Minor Defect 1.06

Fascia boards and feature Timbers -rot,deterioration

Sections of the fascia boards and feature Timbers are in poor condition as rot and deterioration is present. It is suggested that a "Licensed Builder/ Carpenter and Painter" be contacted for further evaluation and repair.

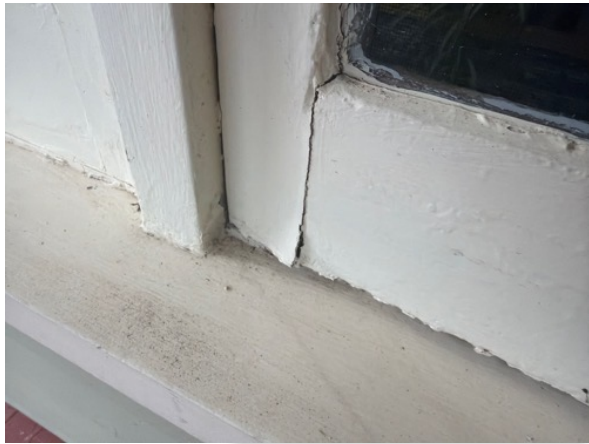
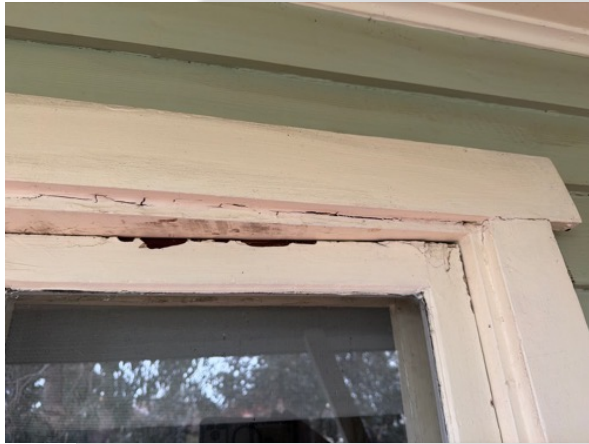
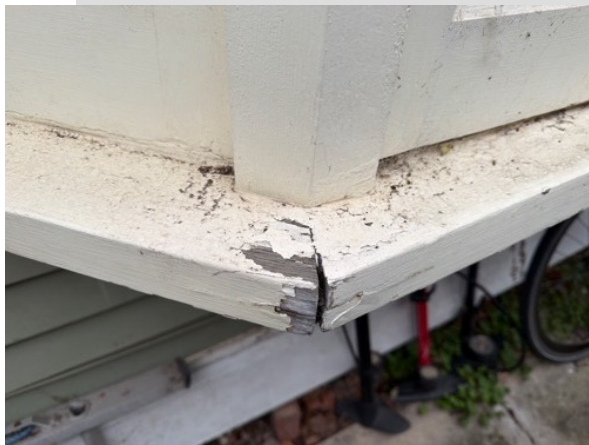
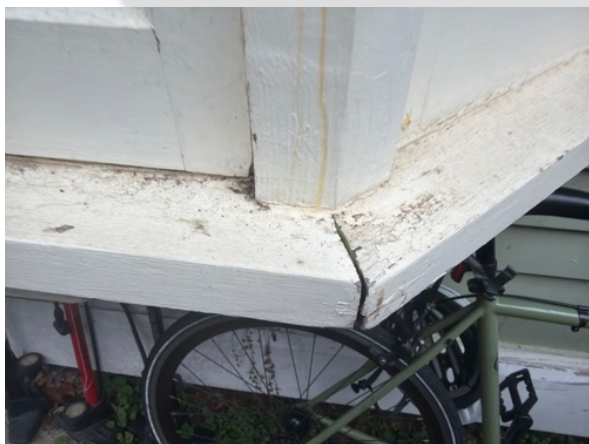
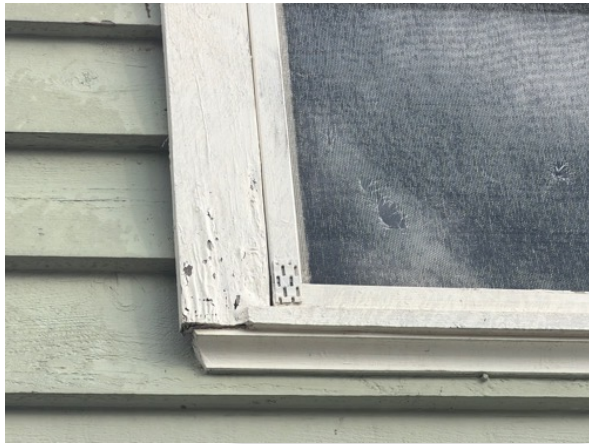
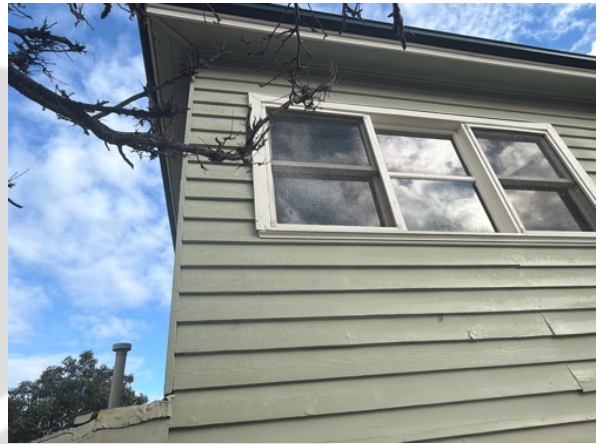
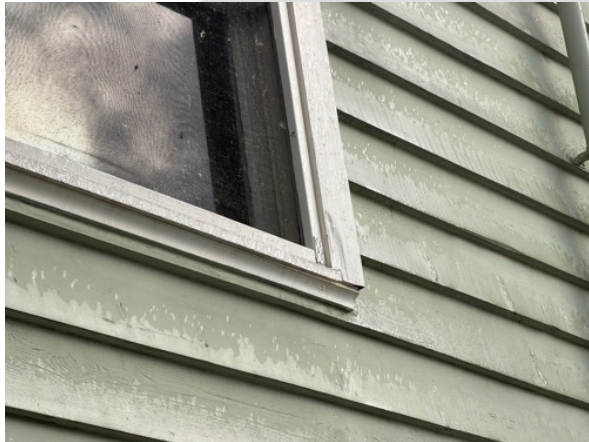
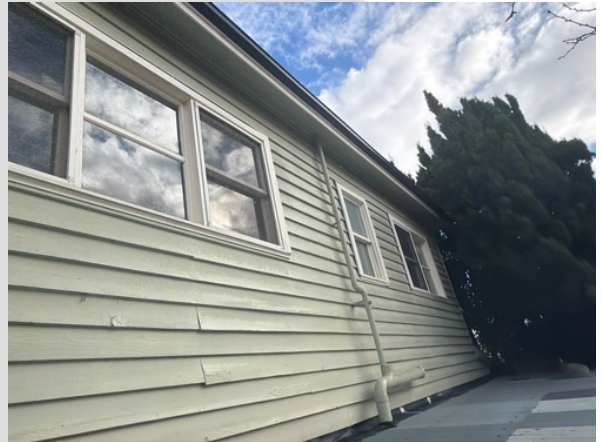
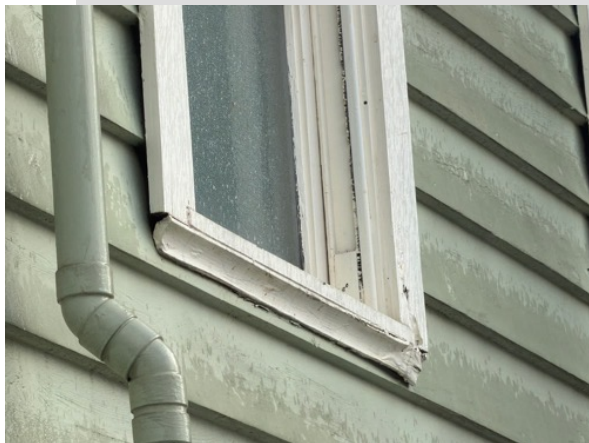
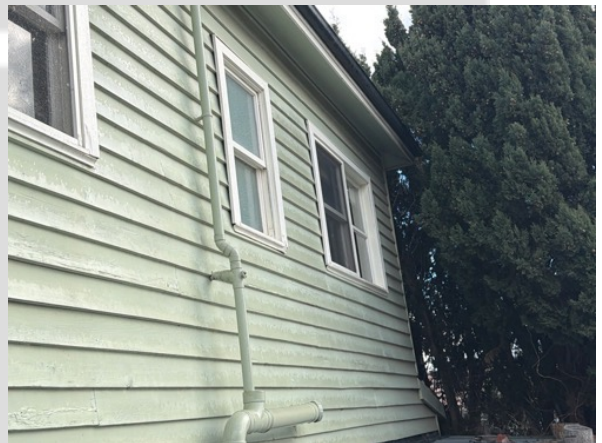
## Minor Defect 1.07

**Finding:** Windows - rot, deterioration

There are windows that are aging and deterioration is present. These windows and window jamb/frame needs to be urgently rectified by a qualified painter and carpenter. The timber needs to be sanded right back (remove rotting areas) and appropriately filled/repared and sealed to remove any further more significant rotting and deterioration occurring.

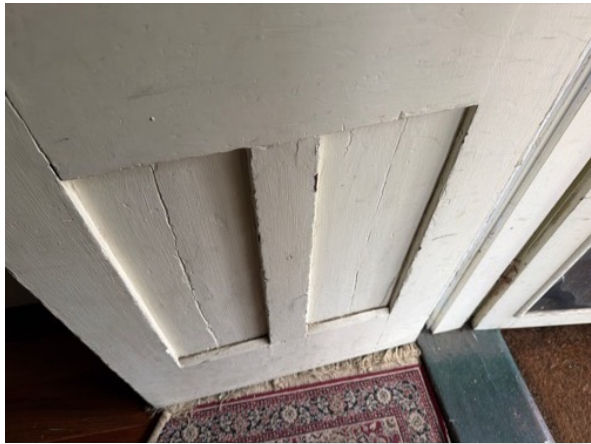
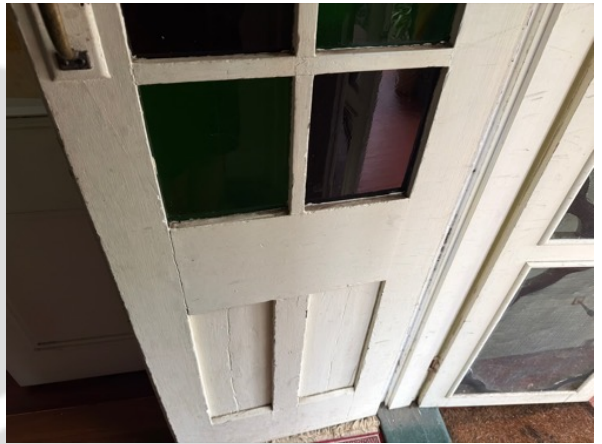
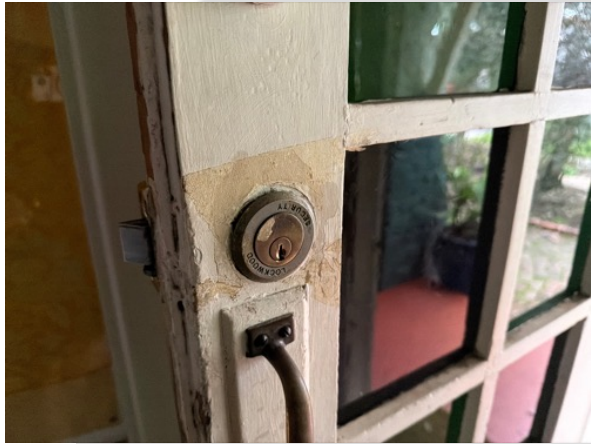
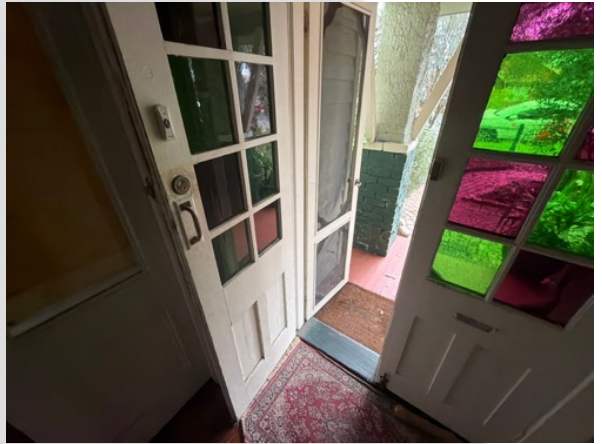
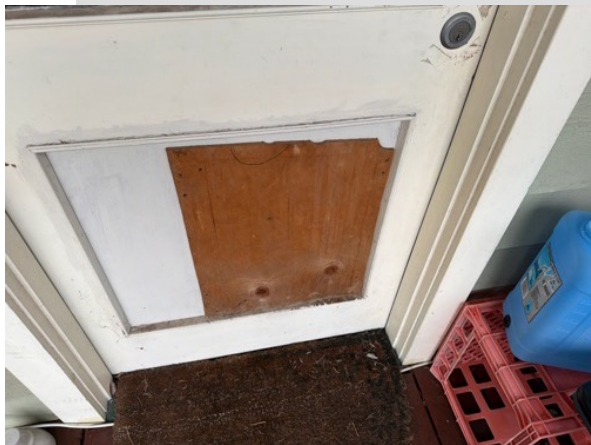
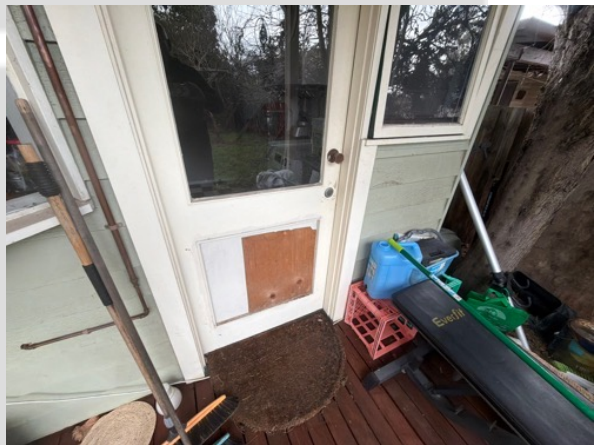
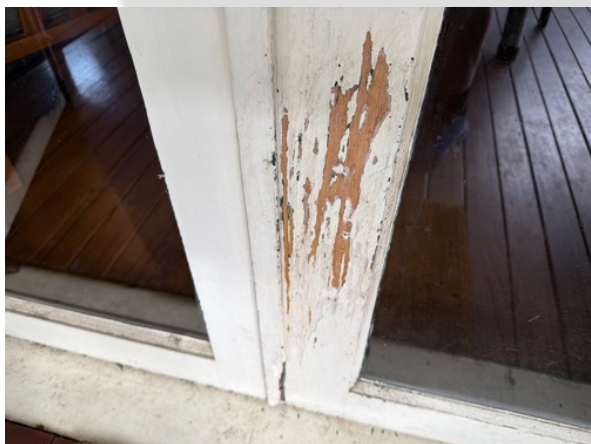
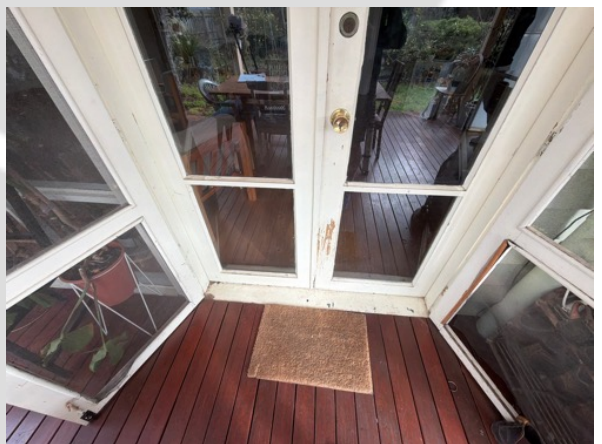
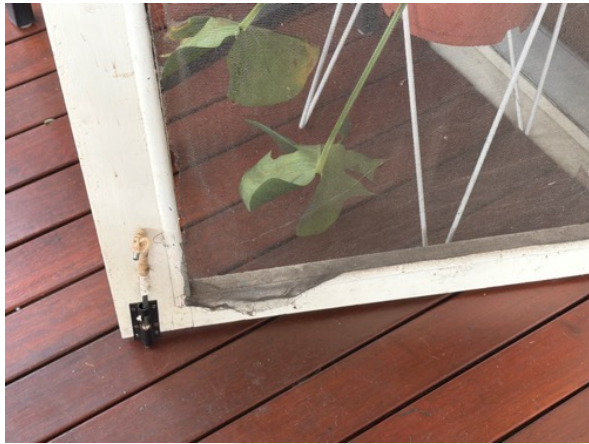
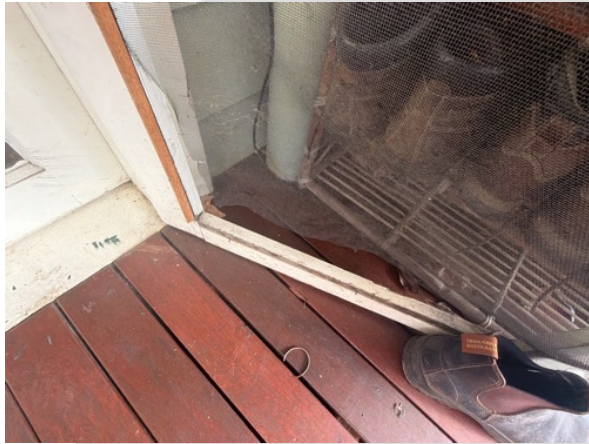
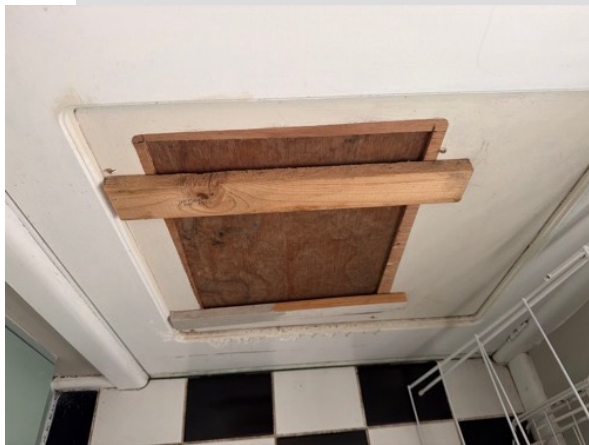
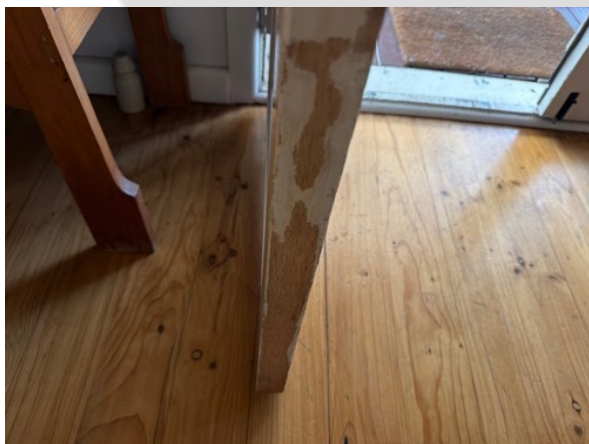
**Finding:** Doors-repaint/fill/damage/flywire

The door(s) are in need of sanding, filling/repairing and repainting. This should be undertaken by a qualified painter to prevent further deterioration occurring.

The rear door has been damaged/poorly repaired. Recommend repair or replacement as needed by a qualified carpenter.

The flywire screens need replacing to prevent insects entering the house. This should be done to also continue to enable good cross flow ventilation throughout the house during the warmer months.
