# Building And Timber Pest Report

Property Address: 84 Hutton Street Thornbury 3071

Inspection Date: 3 Aug 2026

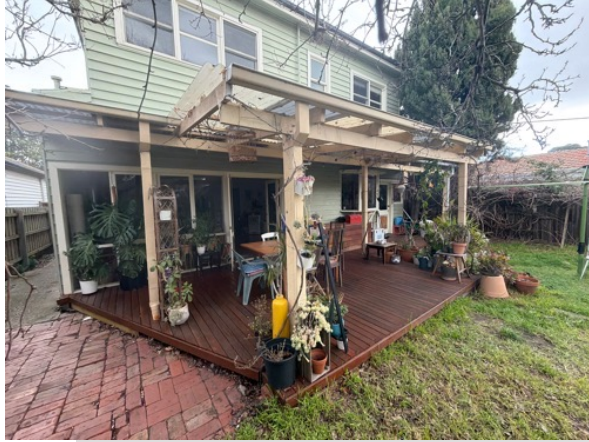
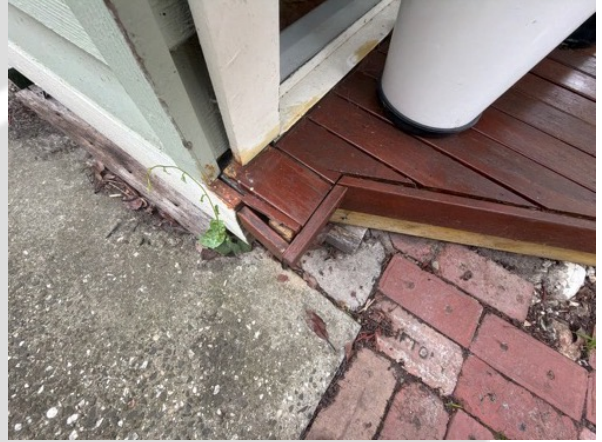
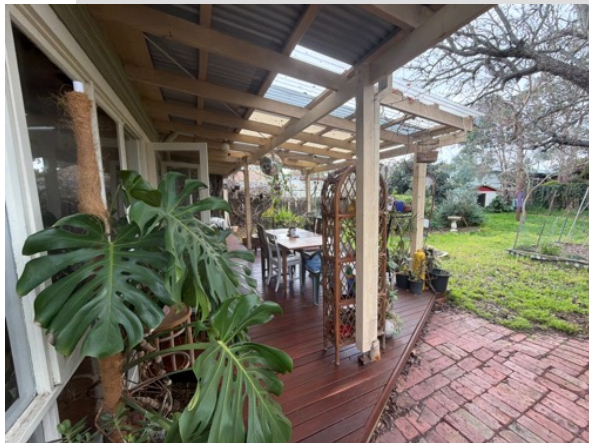
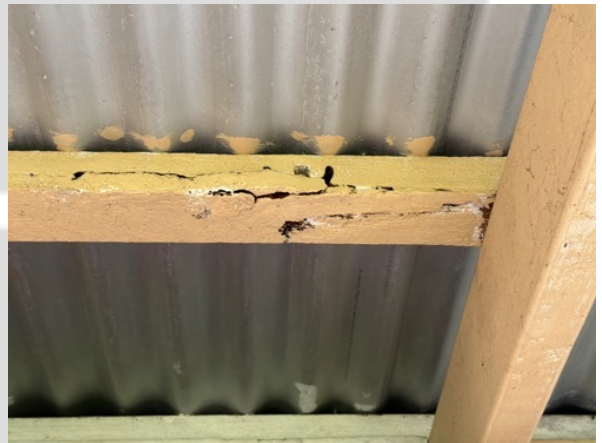
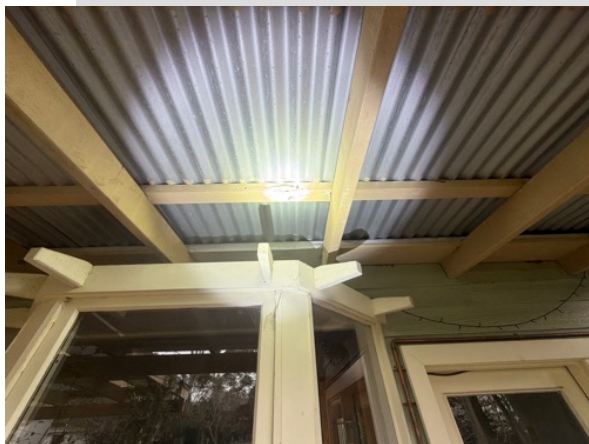
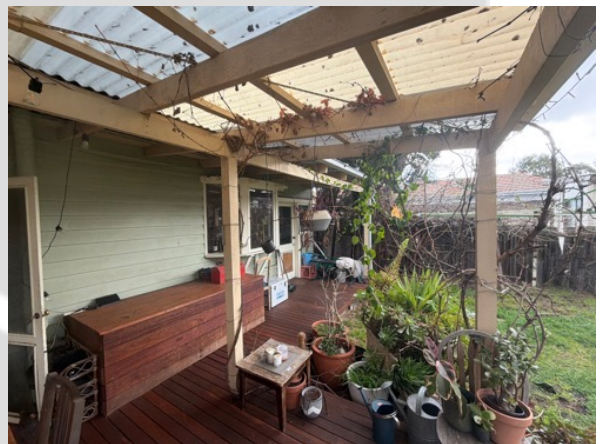
## Minor Defect 1.09

**Finding:** Timber structure, pergola- installation

The timber structure and deck has rot/deterioration to minor areas and requires rectification by a qualified carpenter.

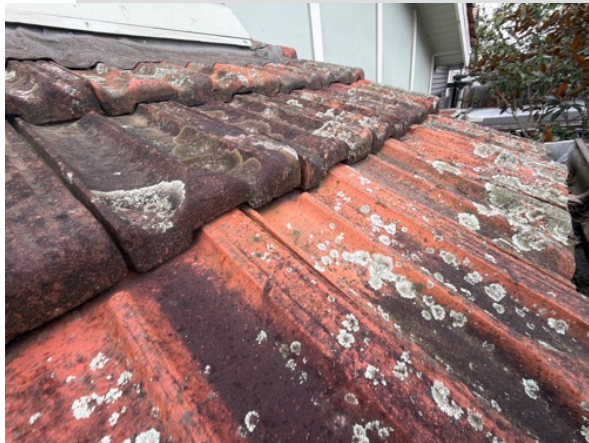
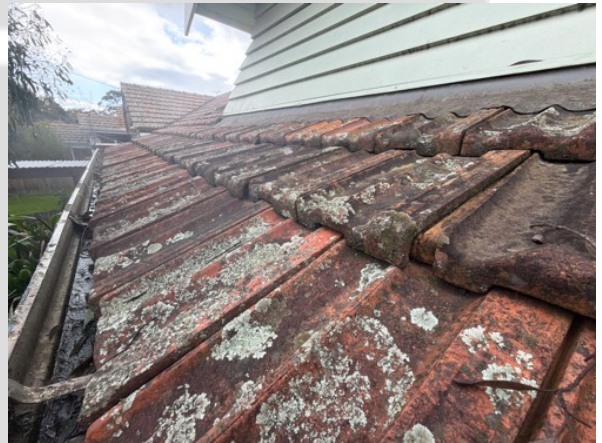
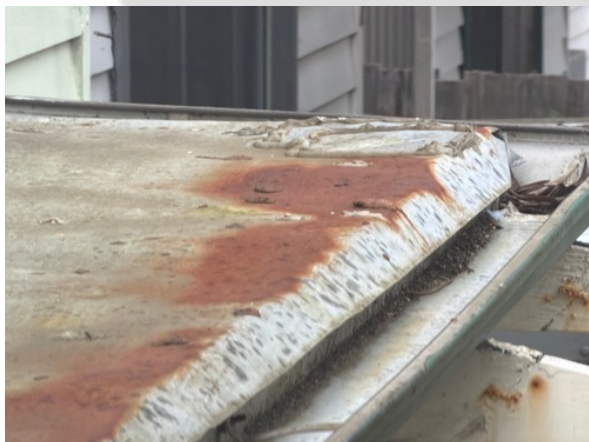
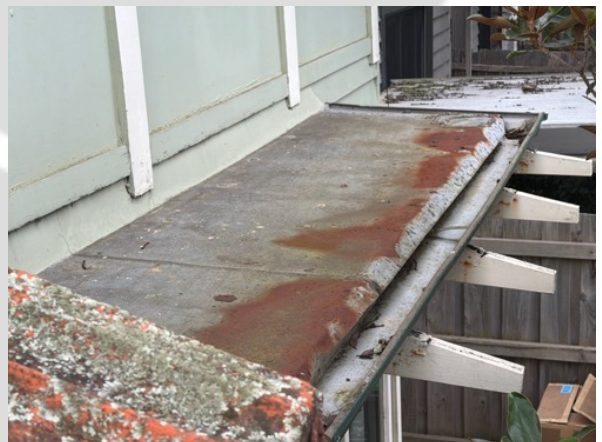
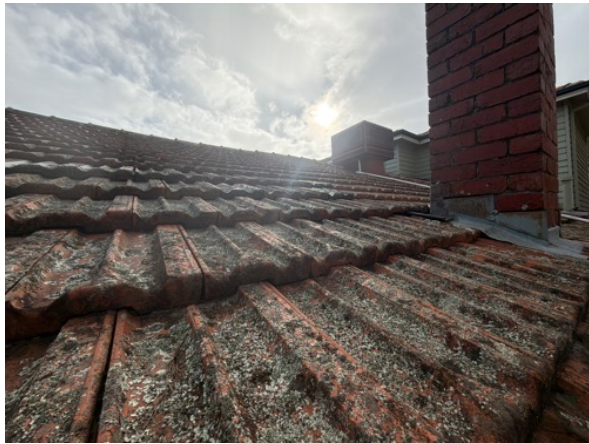
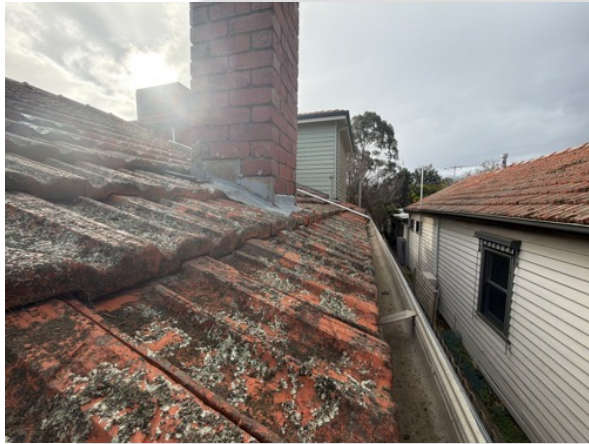
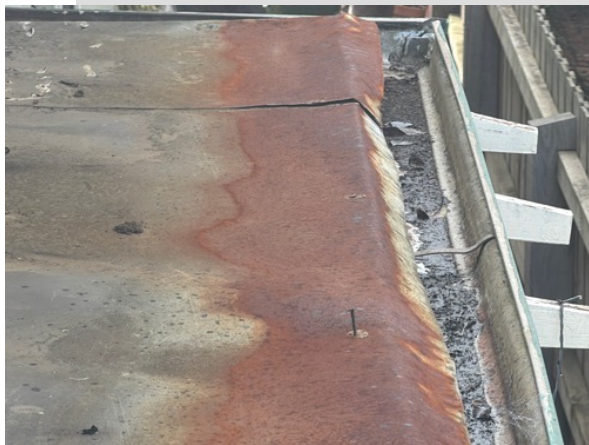
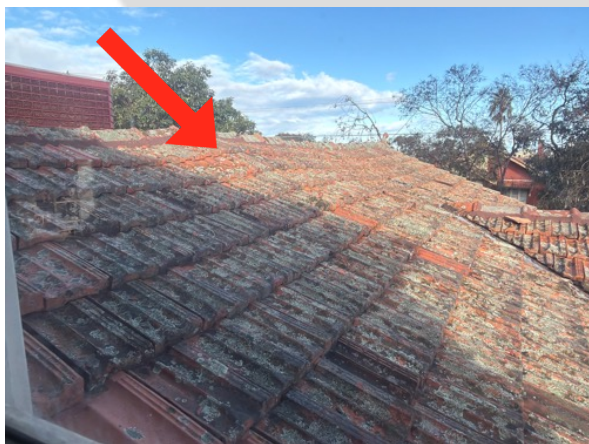
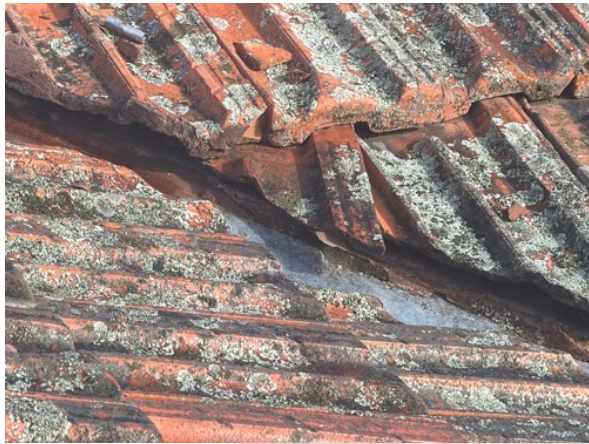
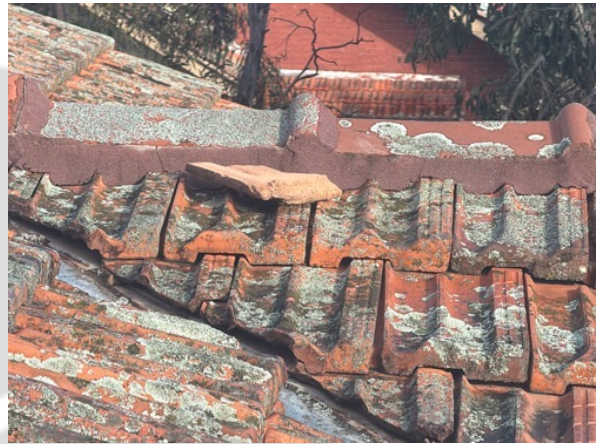
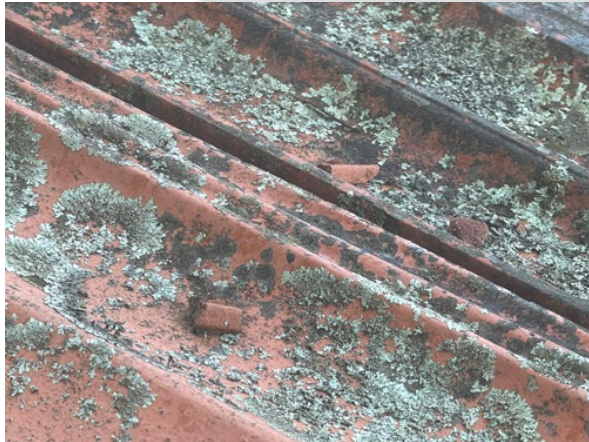
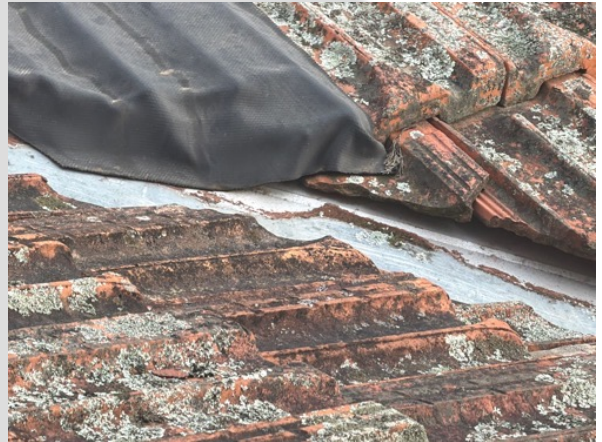
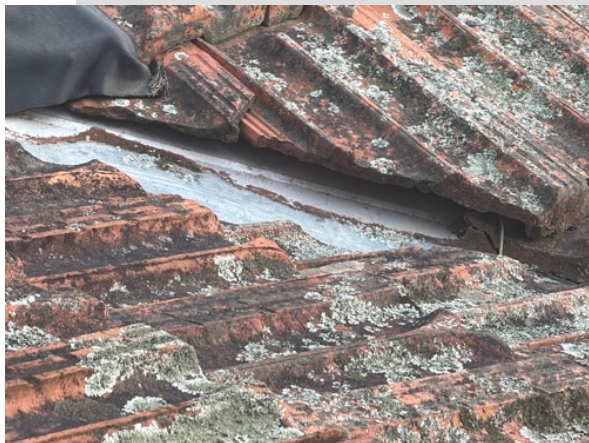
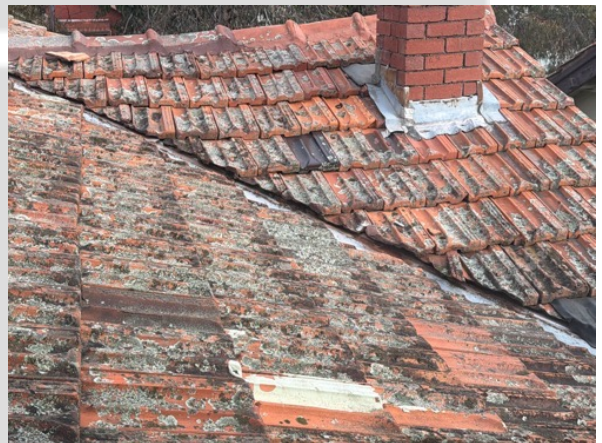
## Minor Defect 1.10

**Finding:** Roof Coverings-Sagging/ Rust / Loose / Cracked / Moss

There is minor sagging or depressions that were observed in the roof covering being caused by the lack of timber framing support or movement. It is recommended that you seek the advice and assistance from a qualified carpenter to rectify.

Sections of the exposed metal coverings have deteriorated (rusty) and in need of repair and/or replacement. It is recommended that this be undertaken by a qualified/licensed roof plumber.

There are loose and cracked tiles located through minor sections of the roof covering. These will need to be refitted by a qualified roof tiler to ensure moisture/water doesn't enter the roof interior causing damage.

There is a significant amount of moss that was observed throughout the roof covering. While mostly cosmetic and not immediately harmful, this condition can indicate a moisture related condition. This condition may also be seasonal depending on tree/leaf coverage and the position of the sun during the changing seasons. Client should consult a roofing contractor or roofing supply company regarding maintenance related issues and products that can reduce this condition.

There are early stages of rusting throughout the metal valleys that need to be sealed with a non-corrosive product. It is recommended that this be undertaken to prevent further rusting occurring and potential moisture penetration and/or damage throughout the roof interior.

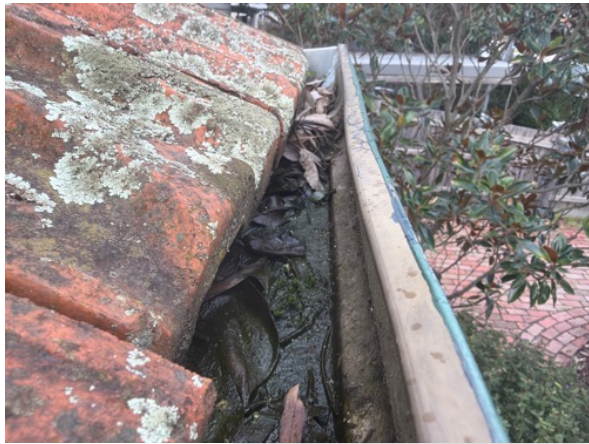
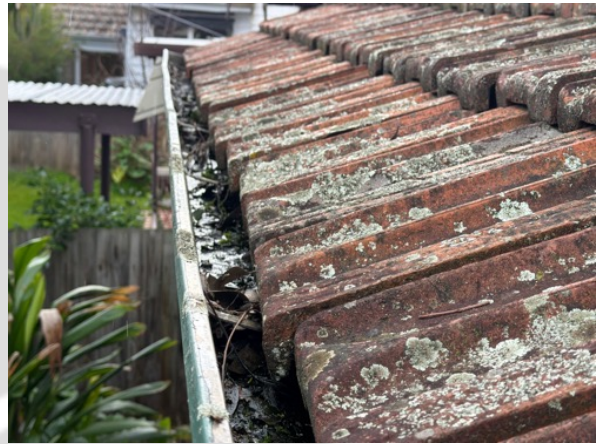
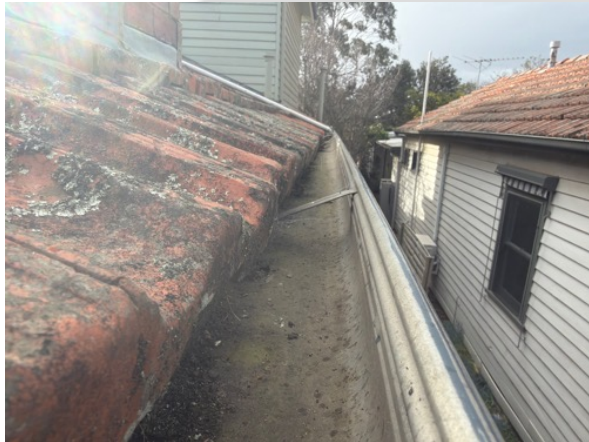
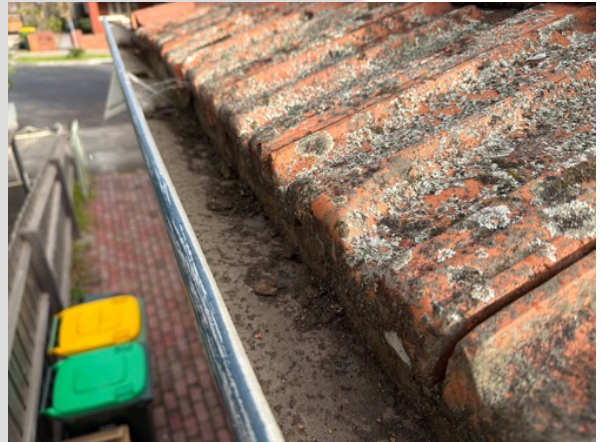
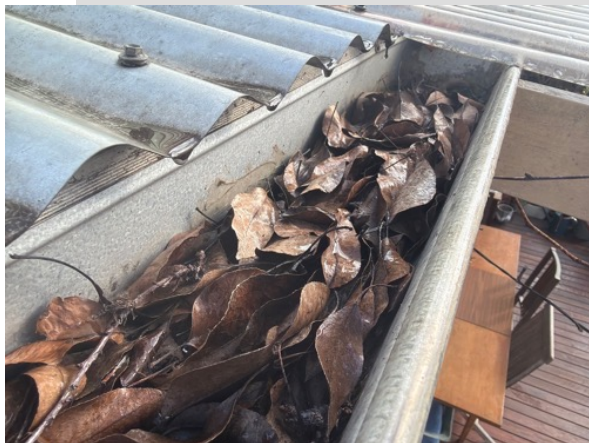
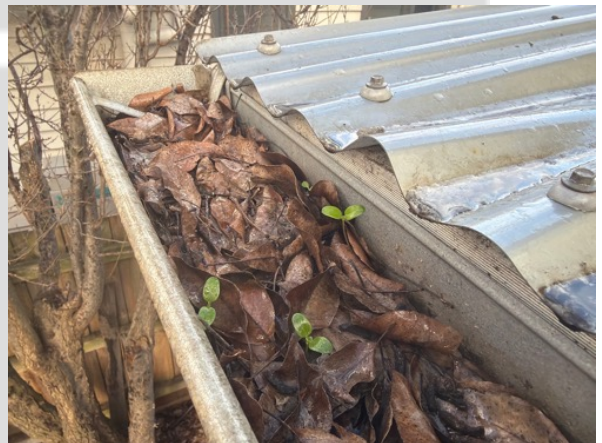
## Minor Defect 1.11

**Location:** Roof Exterior  
**Finding:** Gutters -debris

Some of the gutters/downpipes were filled with debris at the time of the inspection. It is essential that cleaning and removal of debris be immediately undertaken and on a regular basis. This condition can cause water build up and water damage throughout the roof interior and ceiling.

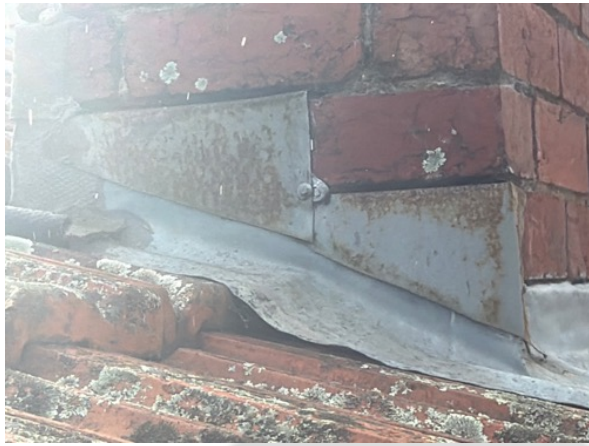
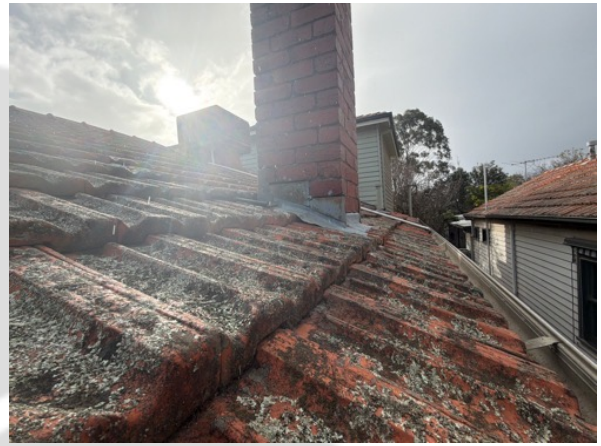
## Minor Defect 1.12

Chimney flashing-rusted

There is rusting in the metal flashing surrounding the chimney. This needs to be replaced/rectified by a qualified roof plumber to prevent moisture penetration occurring throughout the roof interior.

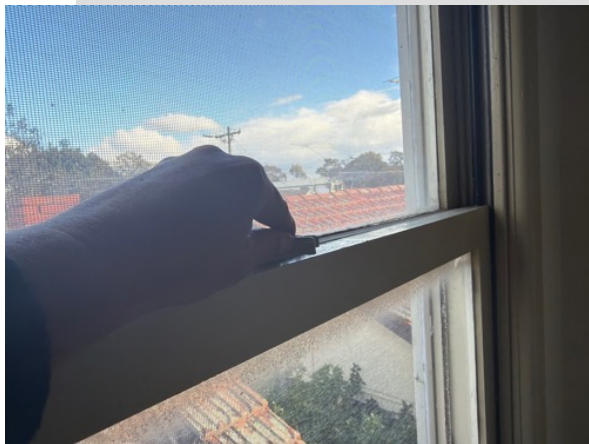
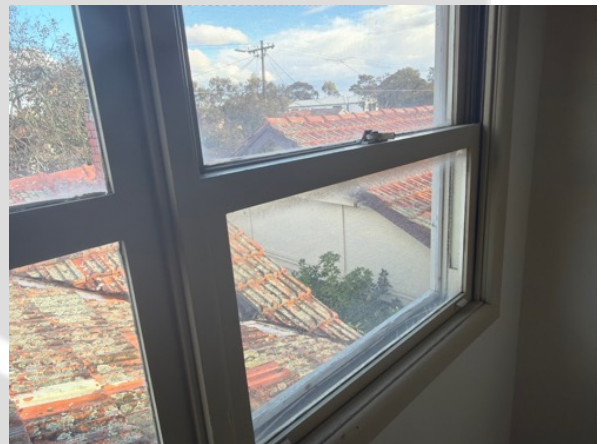
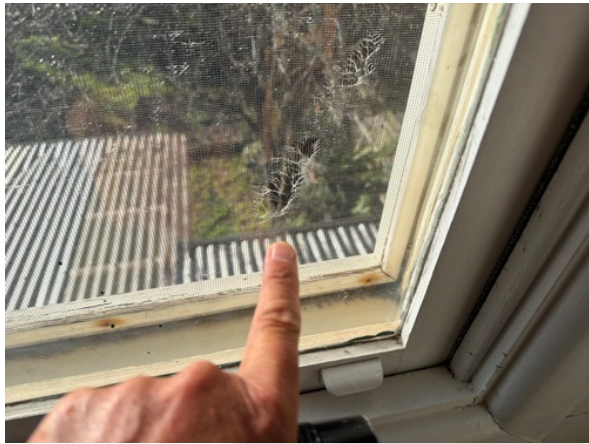
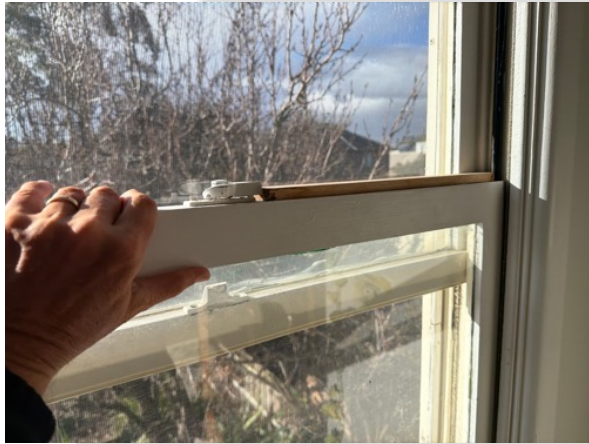
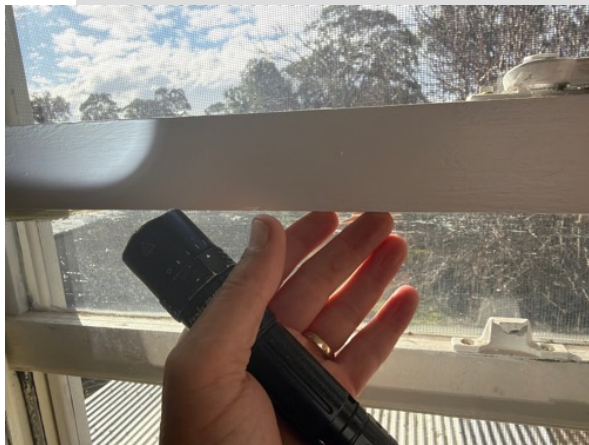
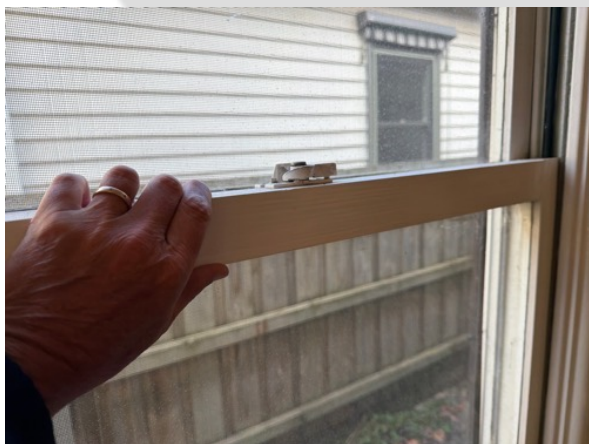
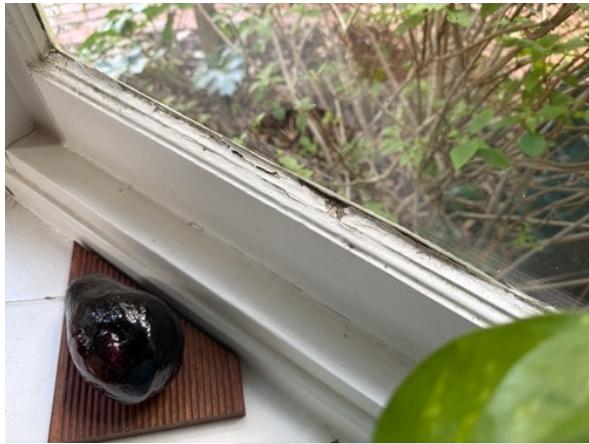
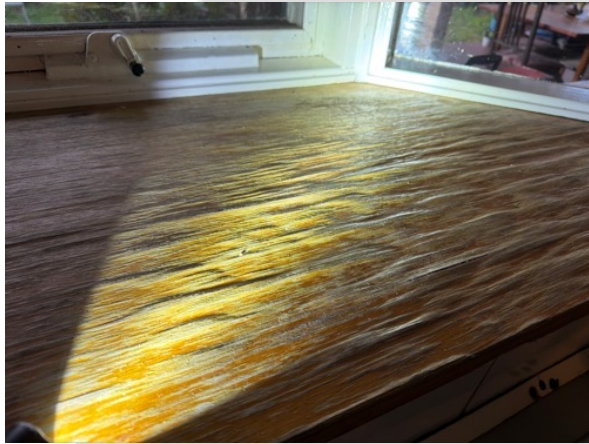
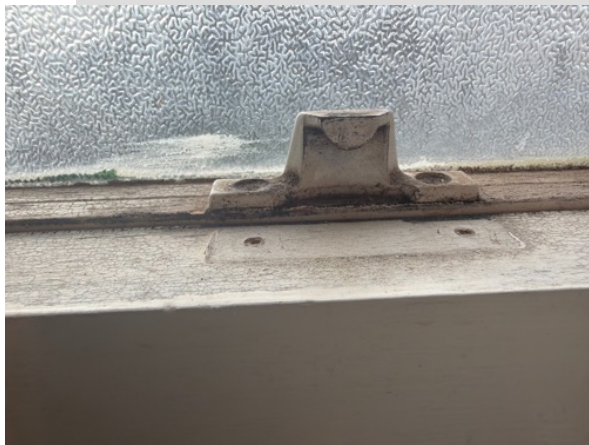
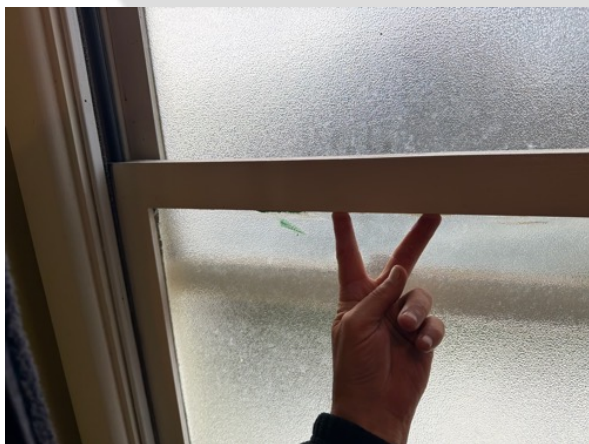
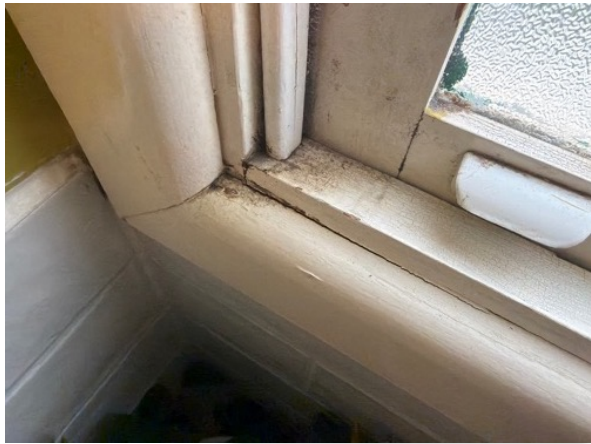
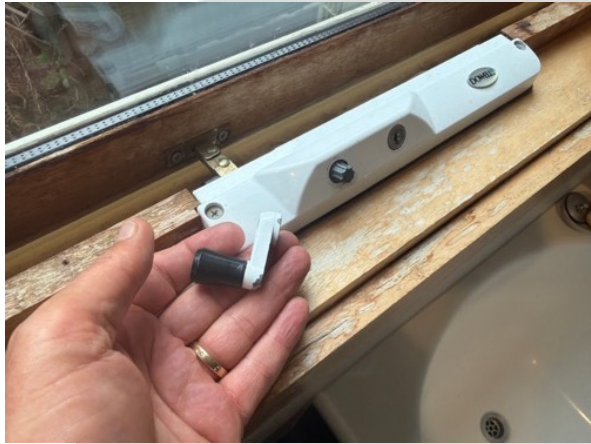
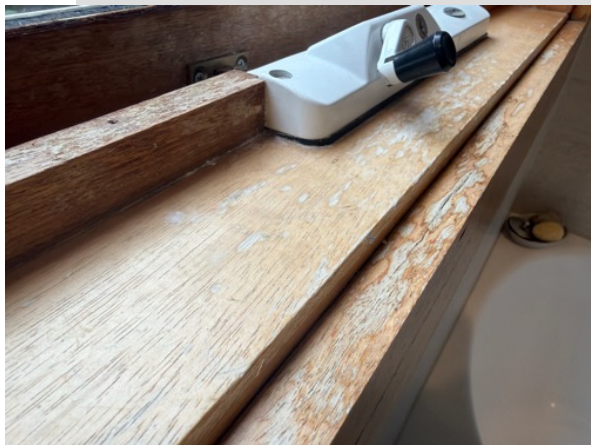
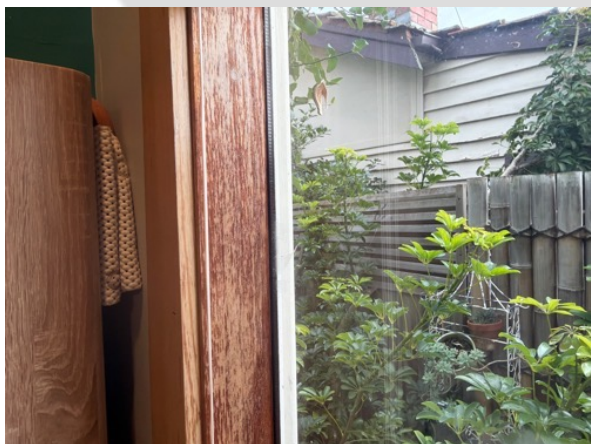
## Minor Defect 1.13

**Finding:** Windows-operation/missing lock/sand/seal/missing handle

There are windows that are difficult to or do not operate. It is recommended that adjustment and/or repairs be undertaken by a "Licensed Builder/ Carpenter".

The sash windows needs repairing as the spring balance or is not functional. This needs to be undertaken by a qualified carpenter to ensure that the window functions as originally intended.

There is a window lock that is missing or broken. For security reasons, it is recommended that the lock be repaired/replaced. It is suggested that a "Licensed Builder/ Carpenter" be contacted for further evaluation and repair.

There are a number of windows and surrounds that are in need of sanding back and sealing by a qualified painter to ensure deterioration doesn't occur.

There is a loose winder handle that will need rectification or replacement by a qualified carpenter.

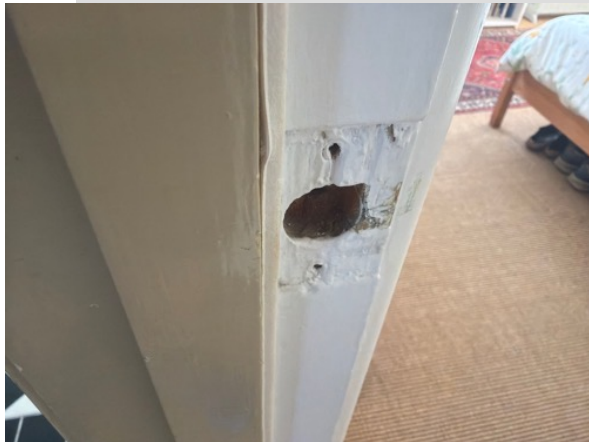
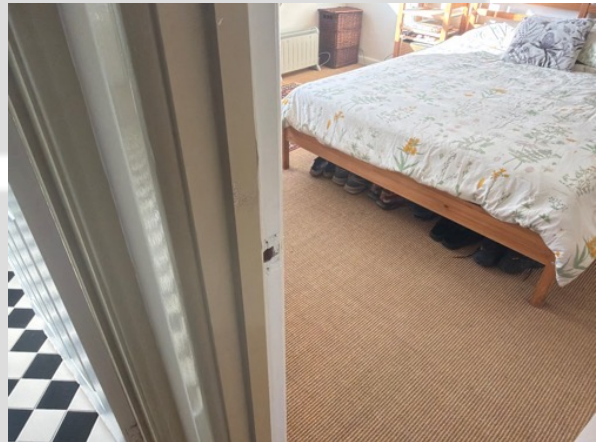
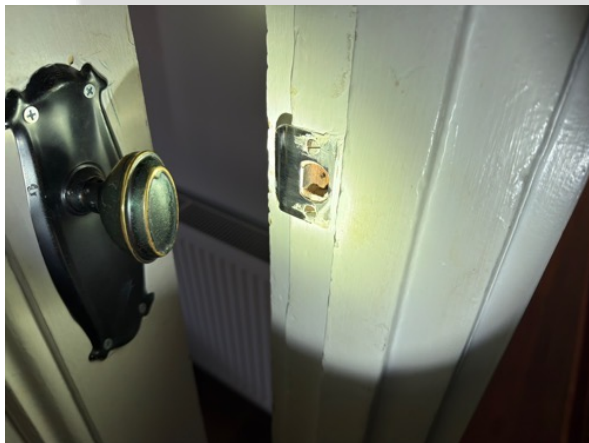
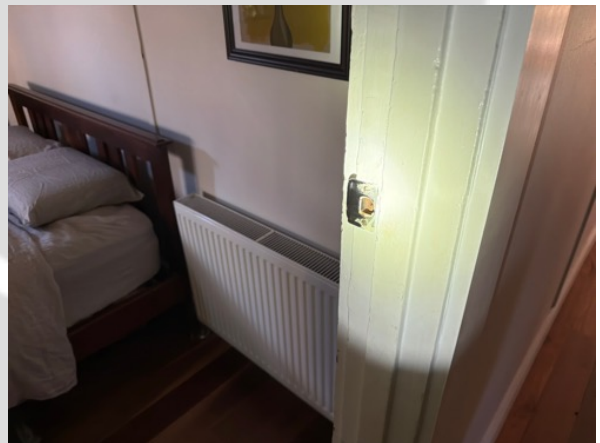
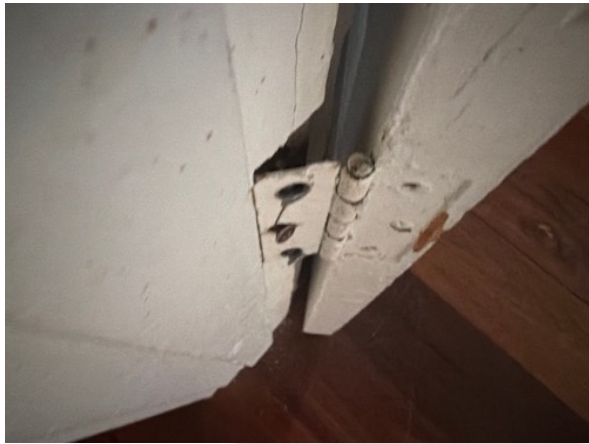
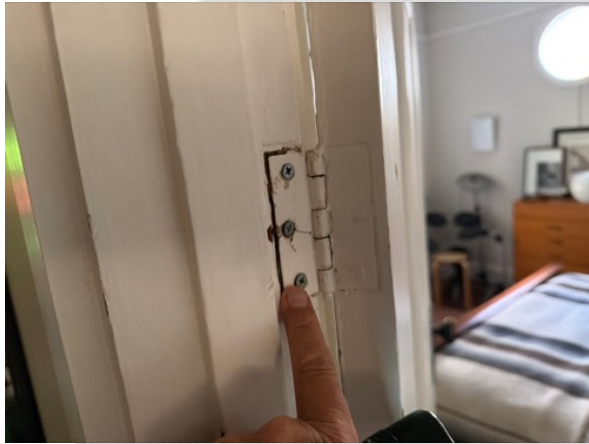
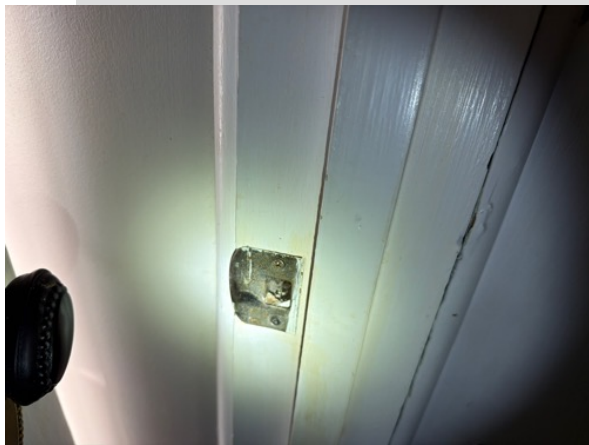
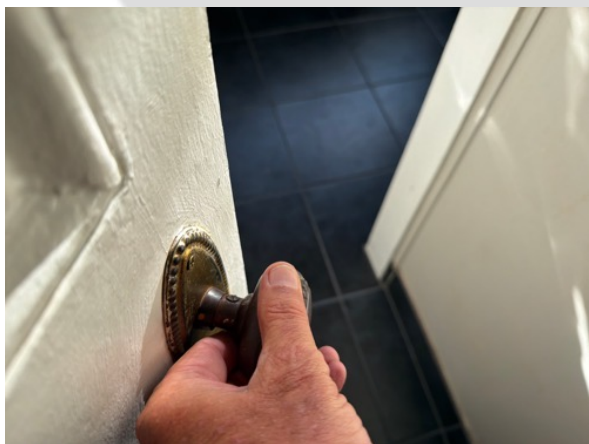
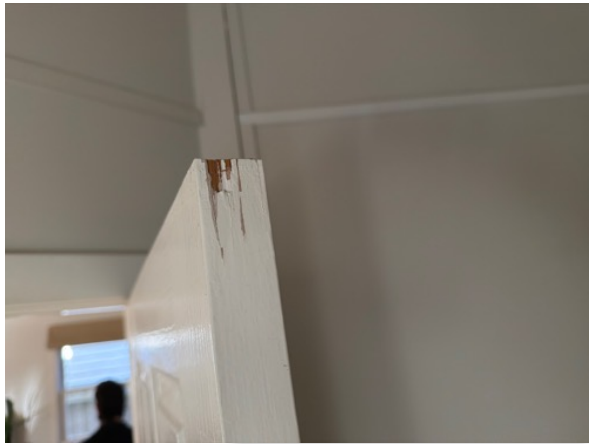
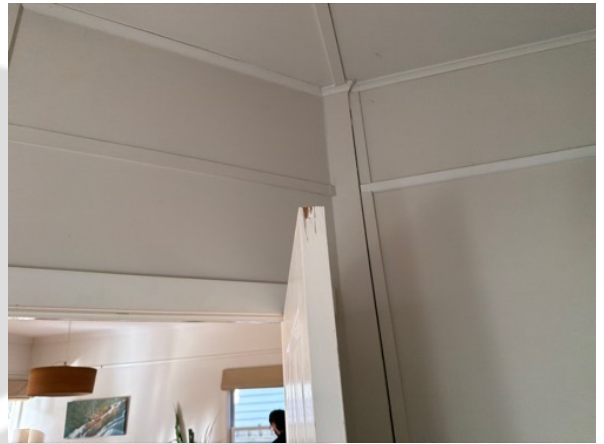
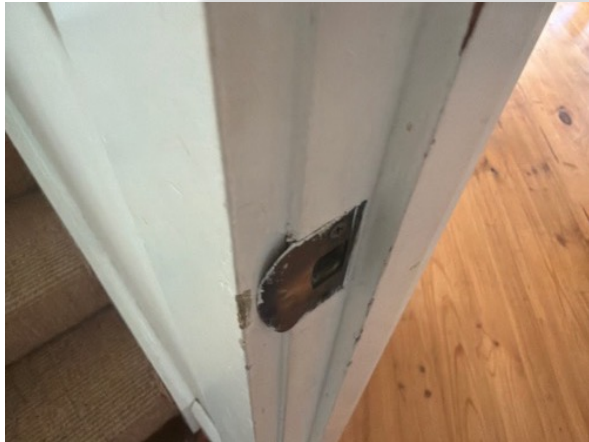
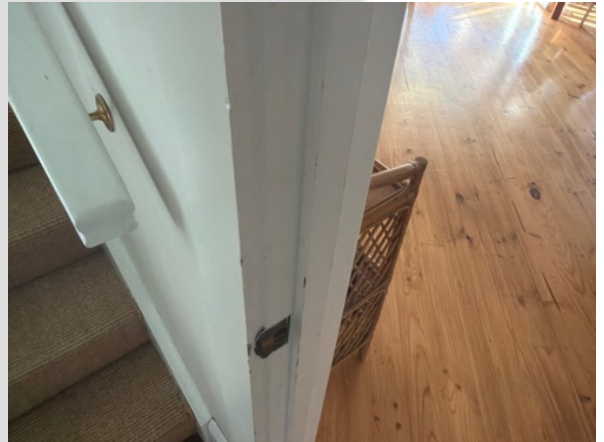
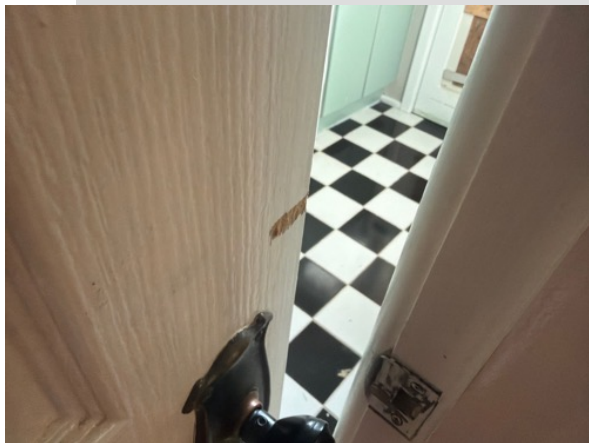
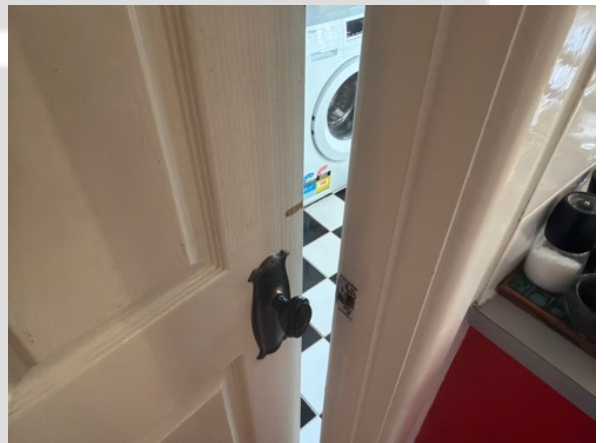
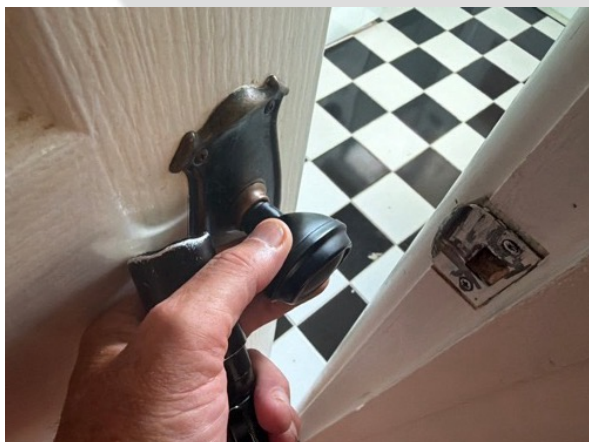
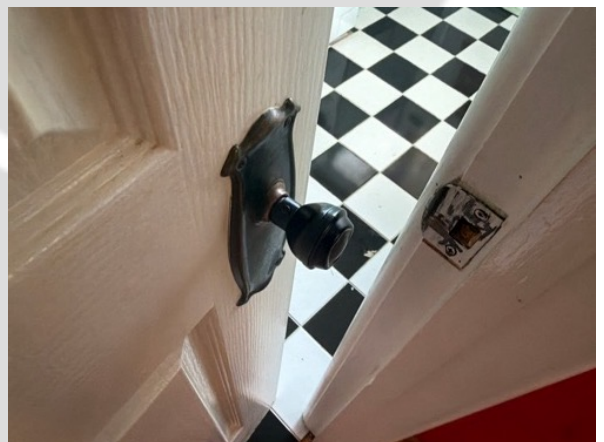
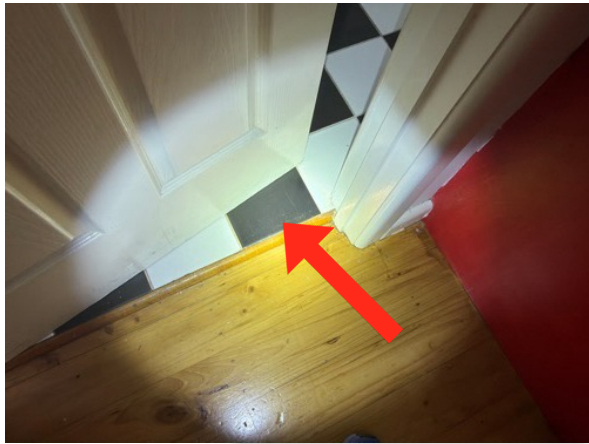
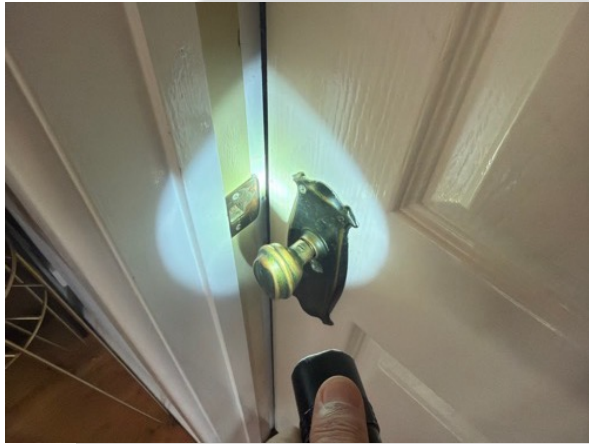
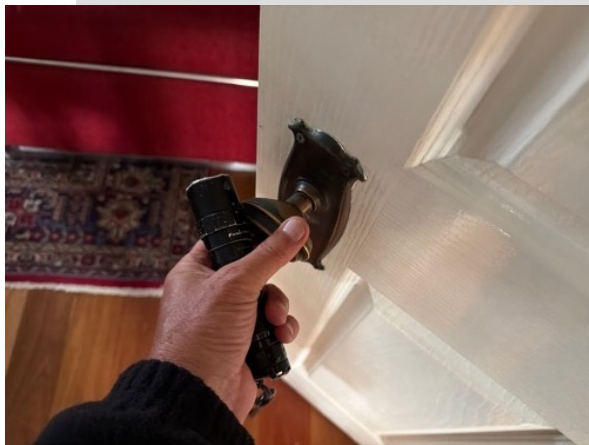
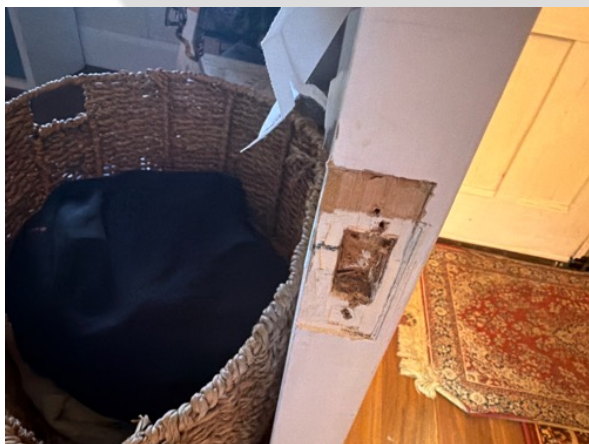
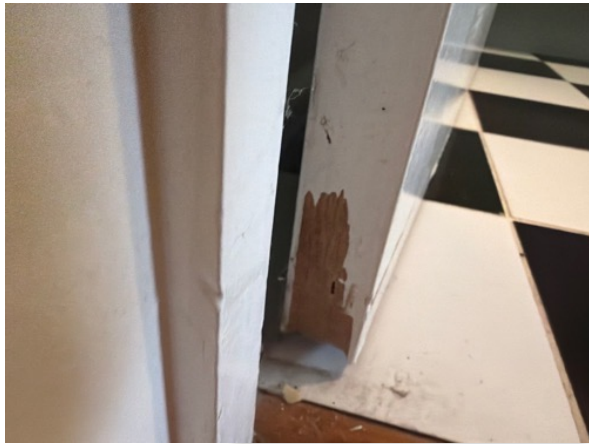
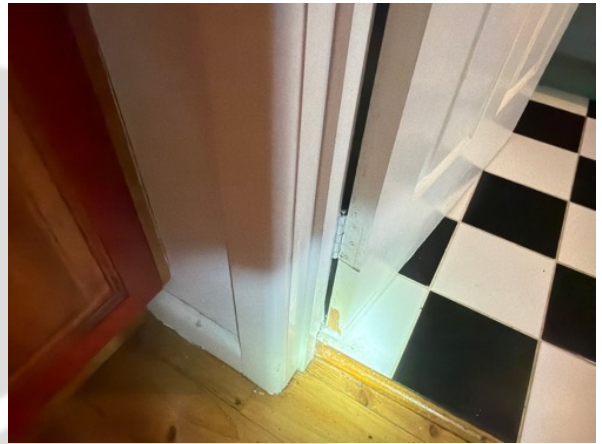
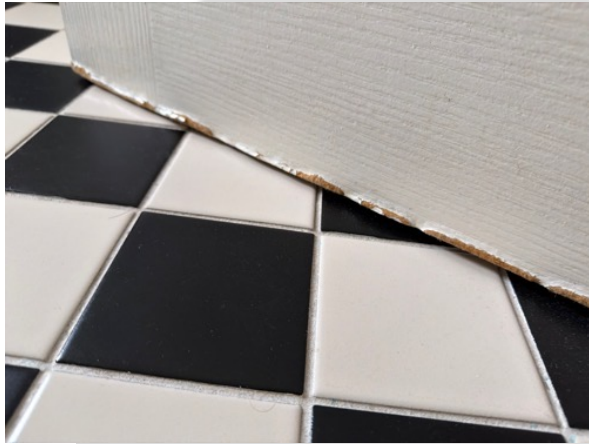
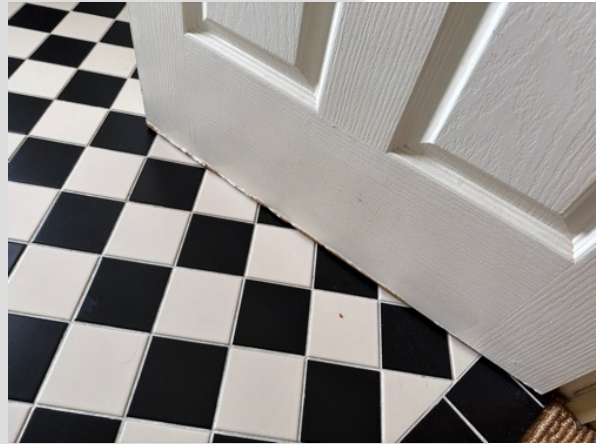
## Minor Defect 1.14

**Location:** General Interior

**Finding:** Door-damage, strike plates/latching/handles/paint/rubbing

The door latch/striker plate/s are missing. It is suggested that a "Licensed Builder/ Carpenter" be contacted for further evaluation and installation.

The door hinges are loose and requires refixing to the door frame/jamb. It is recommended that a qualified carpenter undertake this to enable the door to function properly.

There are door handles that need to be adjusted/reinstalled/replaced by a qualified carpenter or locksmith.

The door(s) are in need of repainting. This should be undertaken by a qualified painter to prevent further deterioration occurring.

The door rubs on the floor covering. Repairs and/or adjustments (planing) are recommended by a qualified carpenter to prevent potential deterioration.

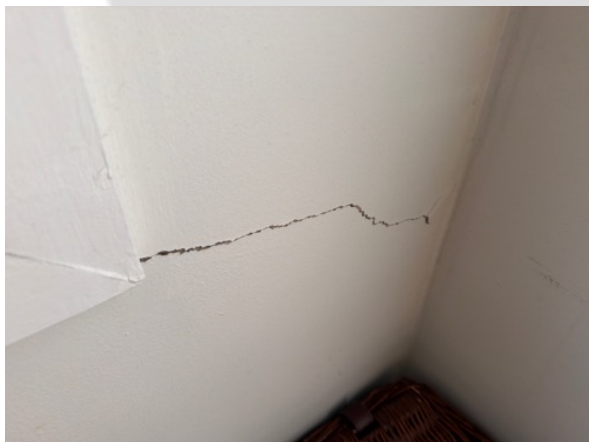
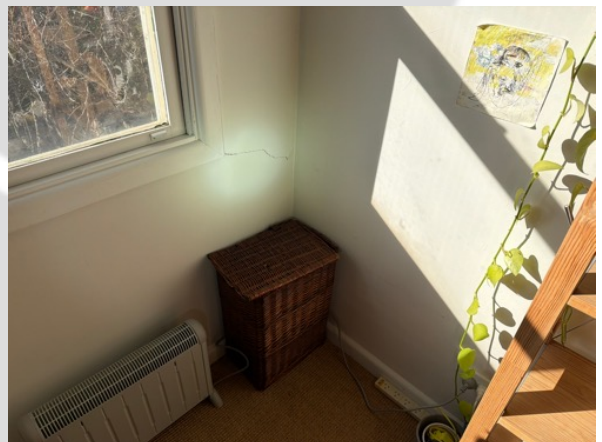
## Minor Defect 1.15

Wall and Ceiling covering- cracking

There is extensive movement cracking to the wall and ceiling linings throughout. Much of the movement is from wall and ceiling frame likely related to the subfloor structure. The subfloor will need to be attended to (refer other notes) and timber wall frames and ceilings may need to be braced further and reinstated by a qualified carpenter. Once all structures are rectified a qualified plasterer should be engaged to re-plaster, fill, and or replace all affected walls, ceilings and cornices.
