# Building And Timber Pest Report

Property Address: 84 Hutton Street Thornbury 3071

Inspection Date: 3 Aug 2026

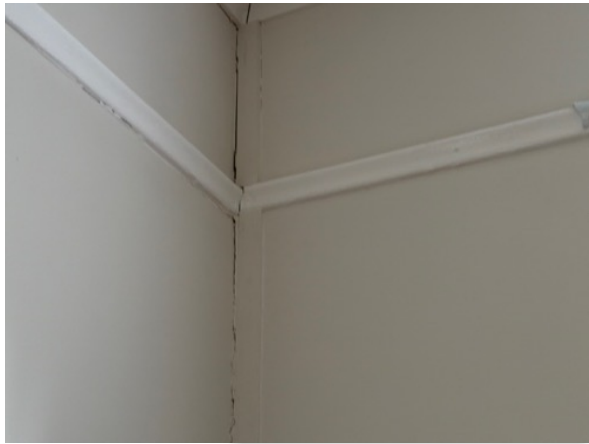
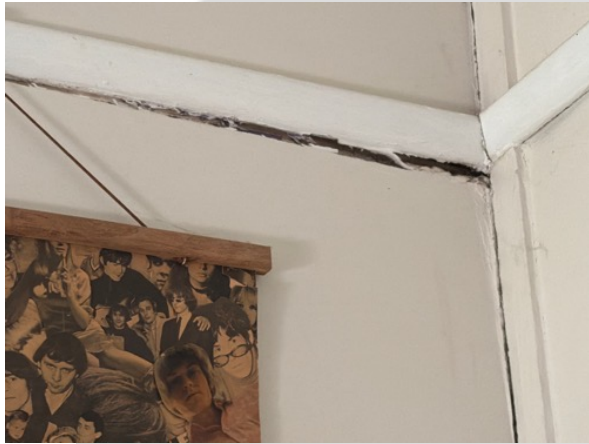
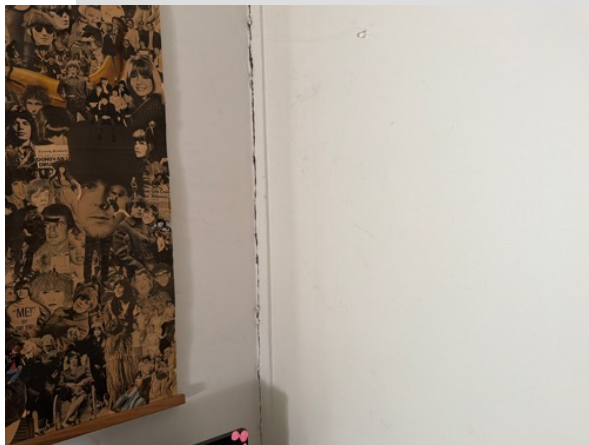
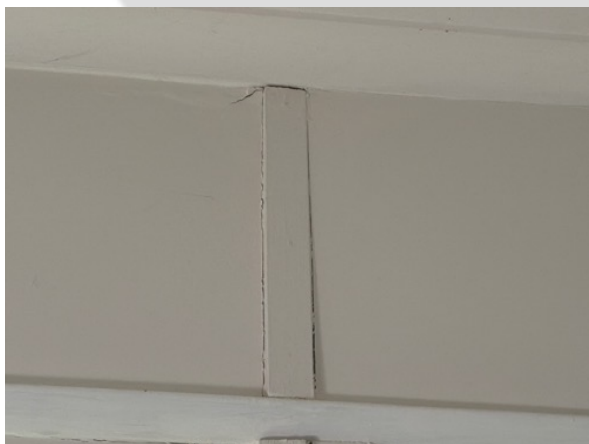
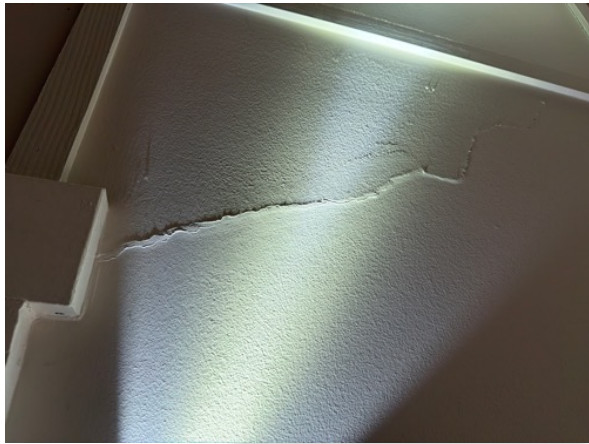
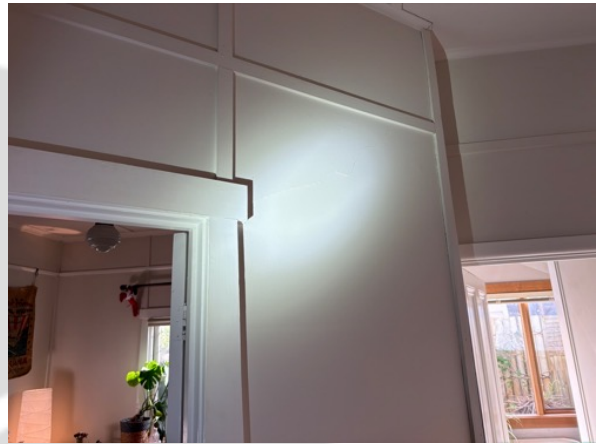
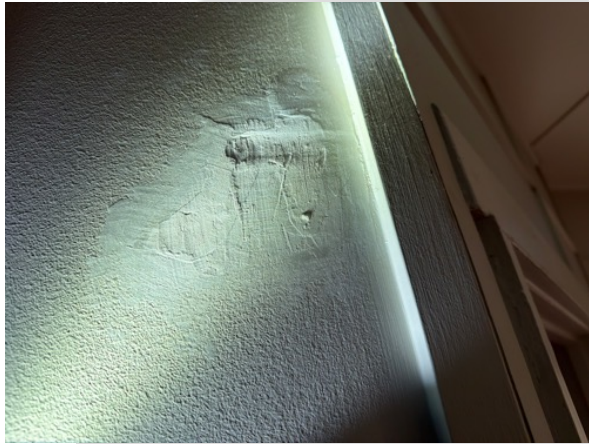
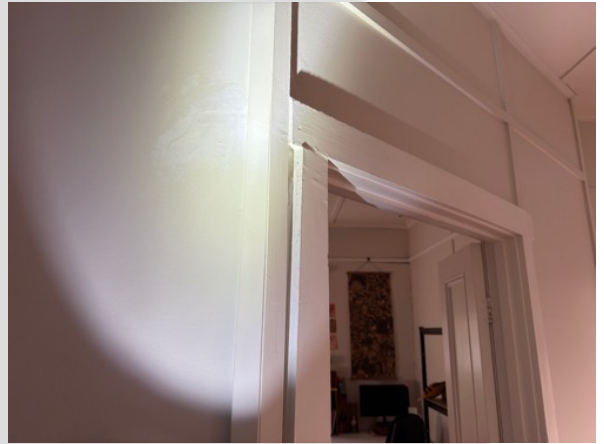
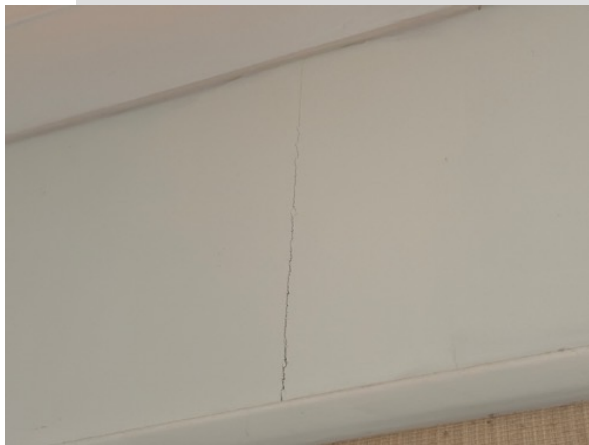
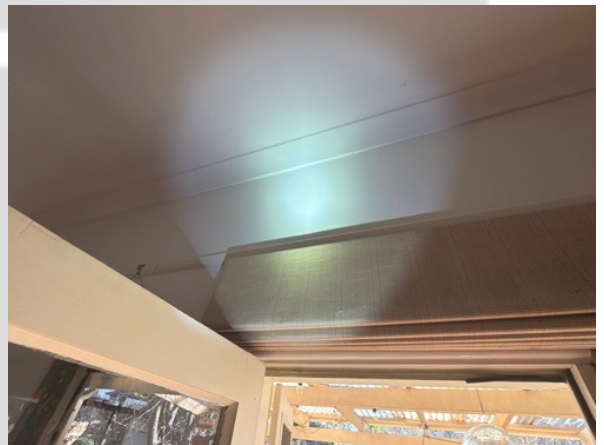
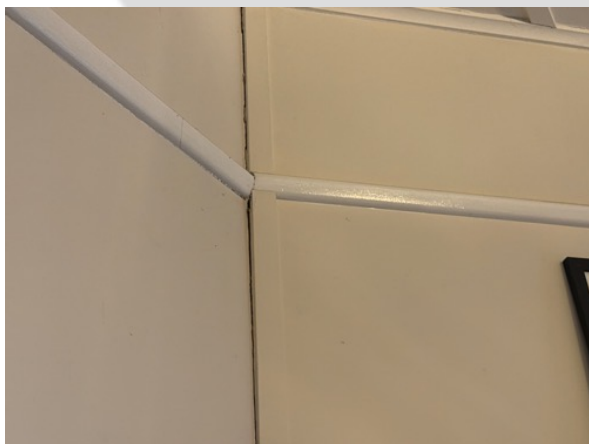
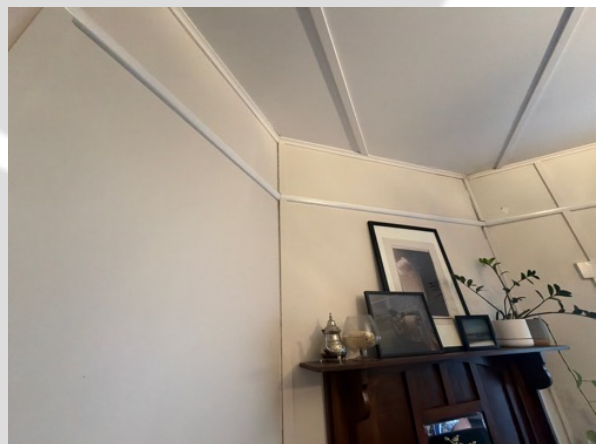
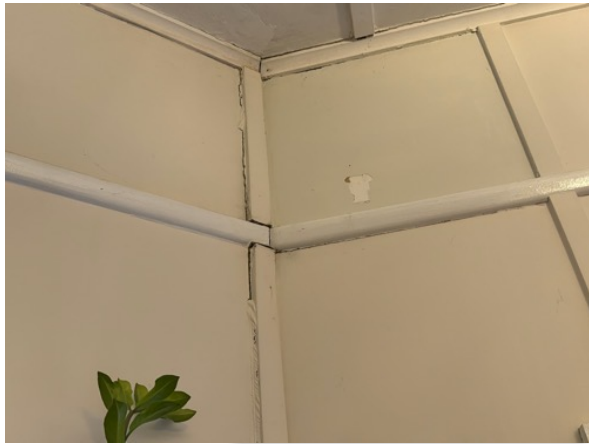
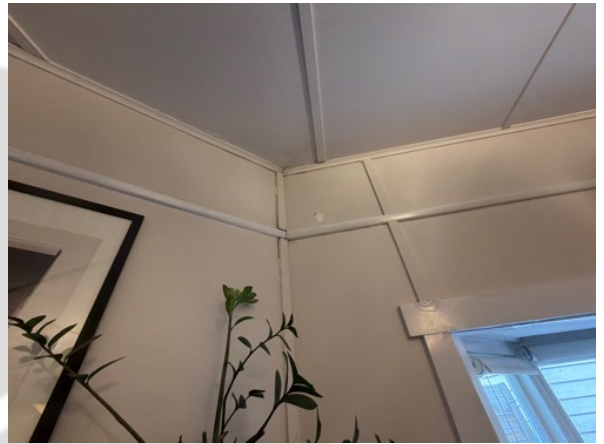
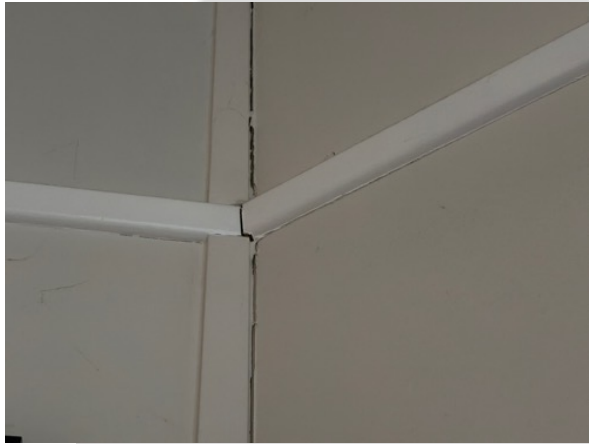
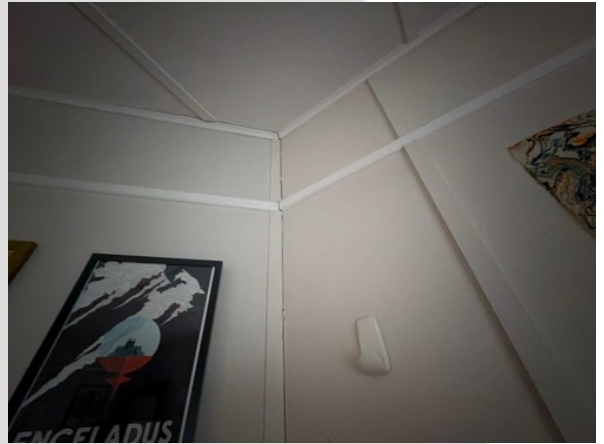
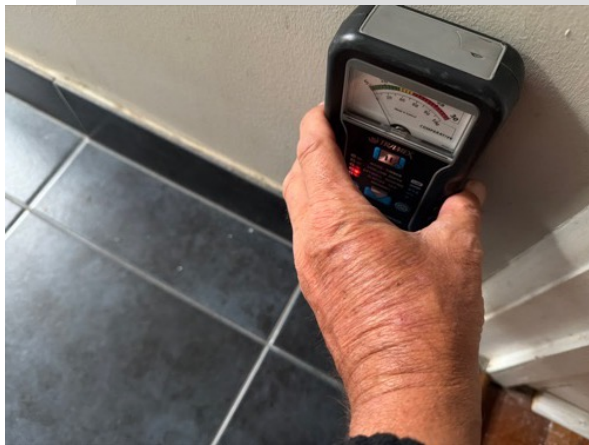
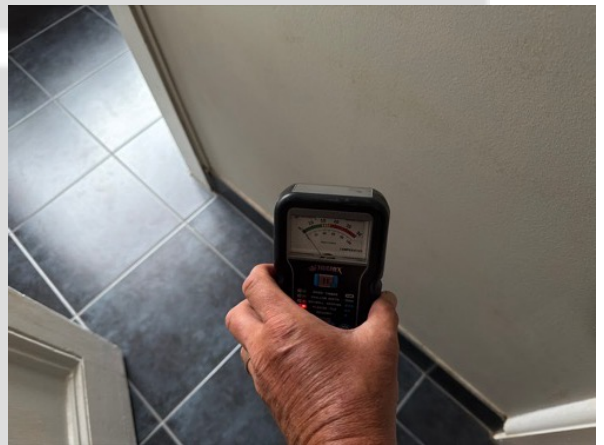
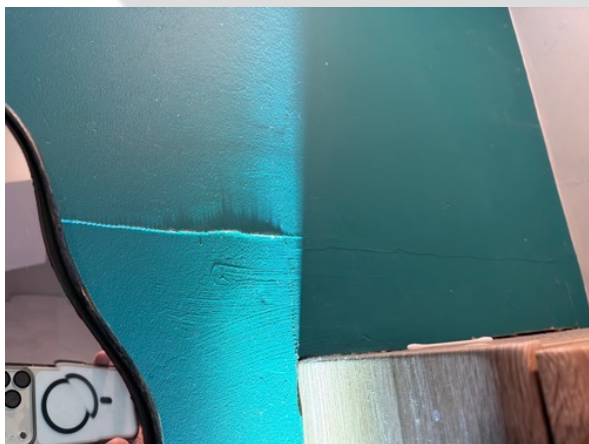
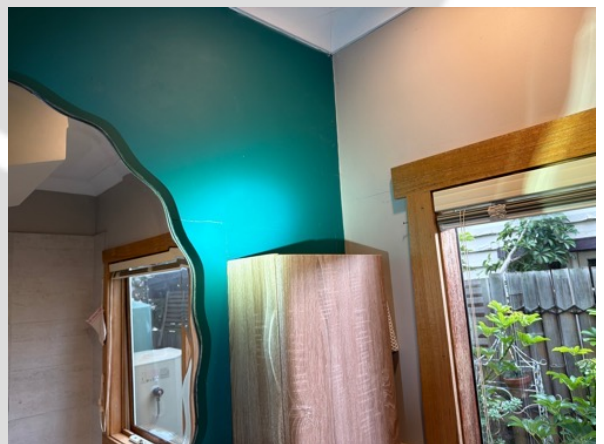
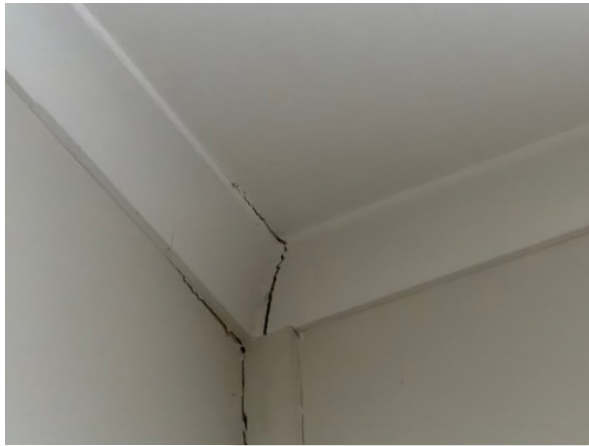
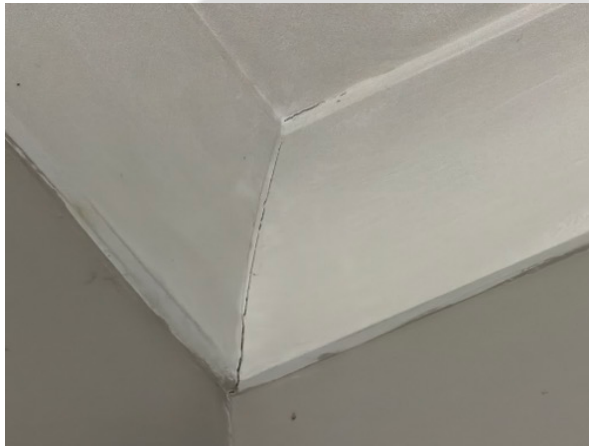
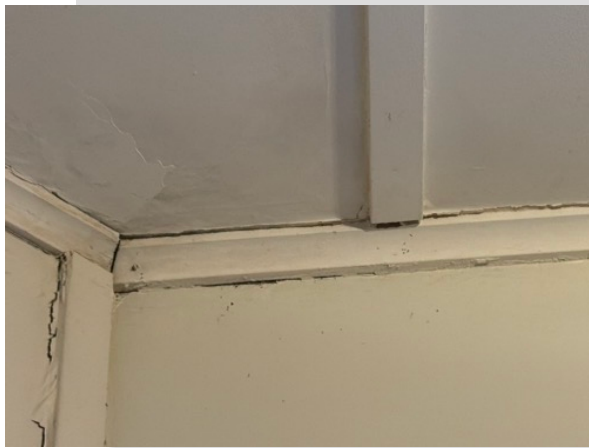
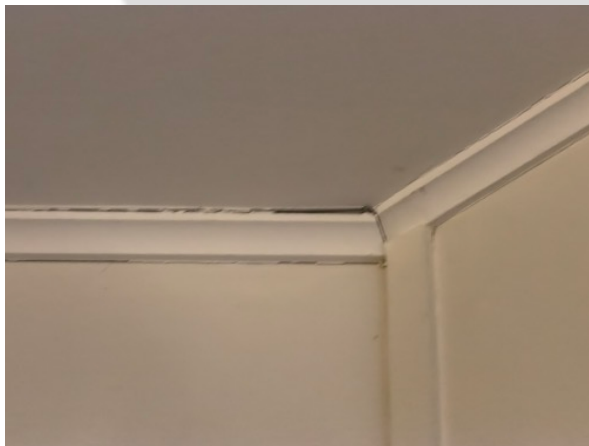
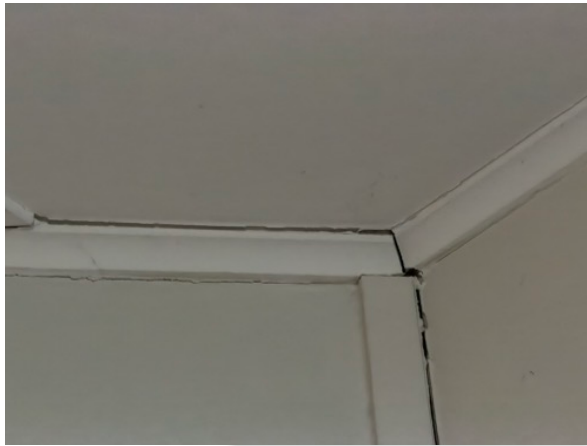
## Minor Defect 1.15

Wall and Ceiling covering- cracking

There is extensive movement cracking to the wall and ceiling linings throughout. Much of the movement is from wall and ceiling frame likely related to the subfloor structure. The subfloor will need to be attended to (refer other notes) and timber wall frames and ceilings may need to be braced further and reinstated by a qualified carpenter. Once all structures are rectified a qualified plasterer should be engaged to re-plaster, fill, and or replace all affected walls, ceilings and cornices.

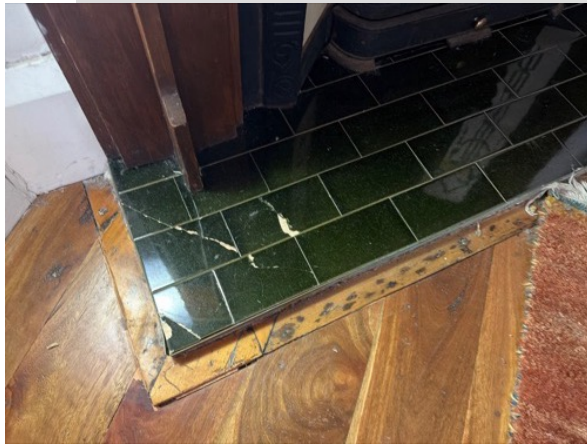
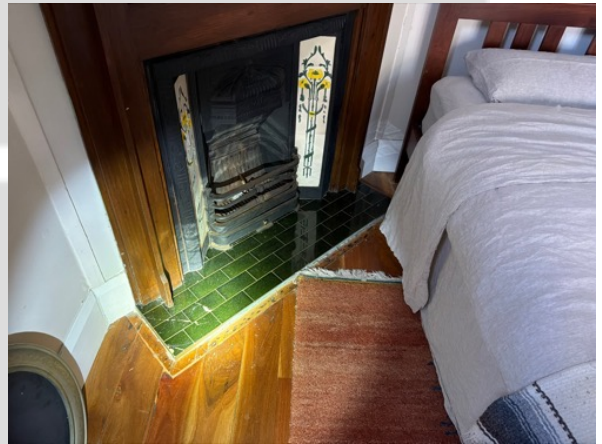
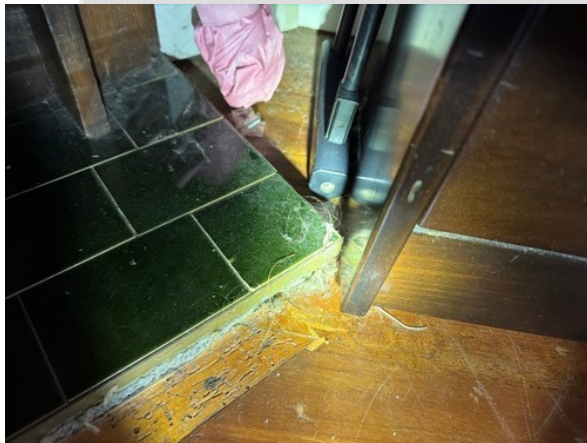
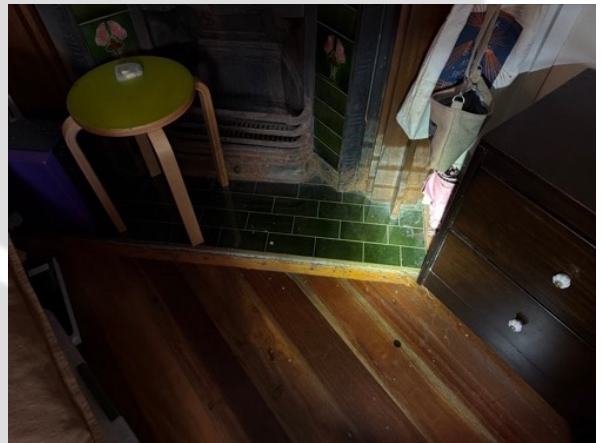
## Minor Defect 1.16

**Finding:** Floor tiles-cracked

There are cracked and uneven hearth floor tiles. These need to be closely monitored. If cracking gets worse, it is strongly recommended that the affected tiles/area be replaced/relayed by a qualified tiler to prevent moisture or other damage.

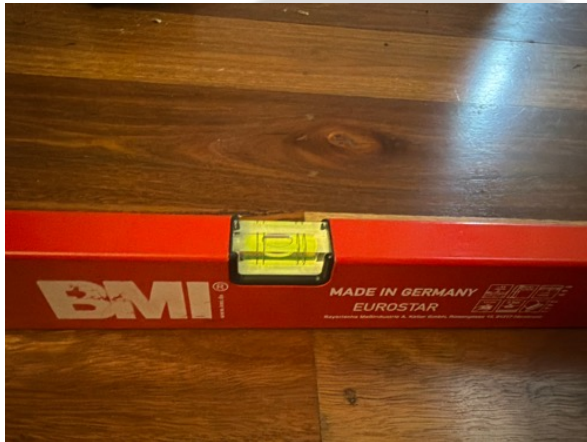
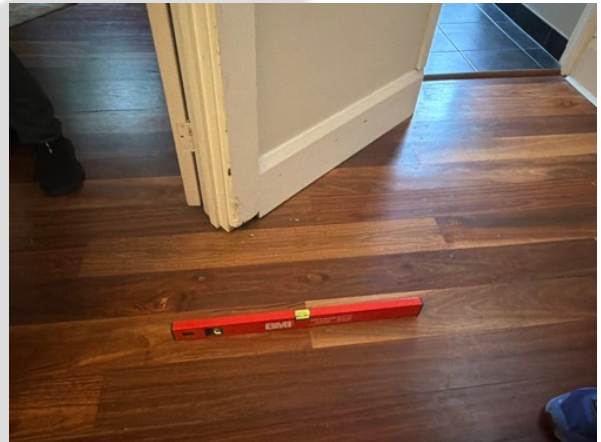
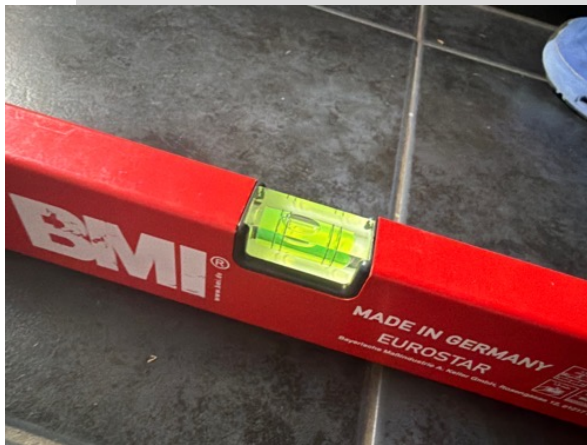
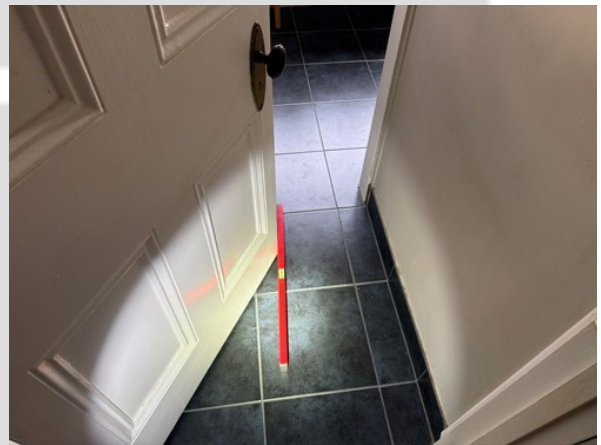
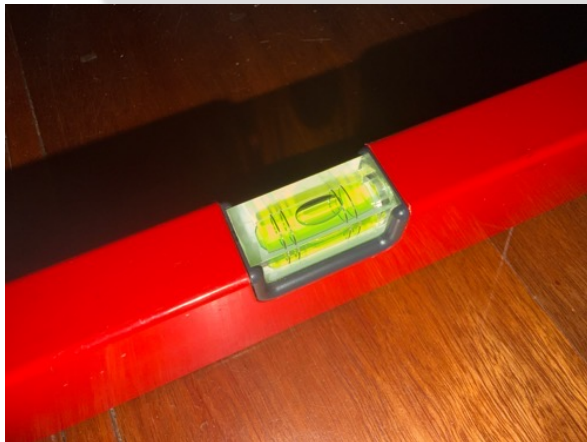
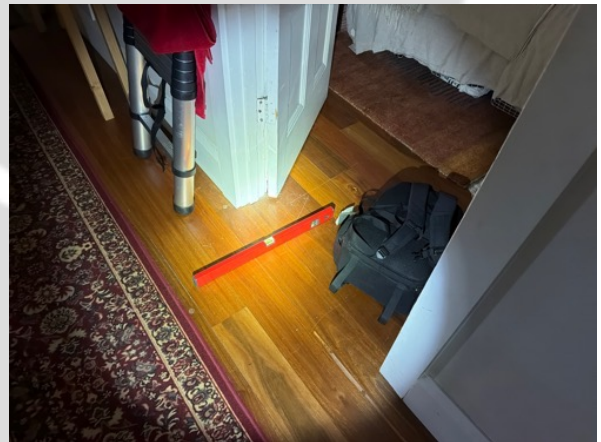
## Minor Defect 1.17

There is slight unevenness in the flooring indicating that the bearers/joists/stumps need to be rectified and/or pack and chock between the bearers or adjusted.

It is recommended that you seek the advice from a qualified Re-stumper to determine level of rectification required.

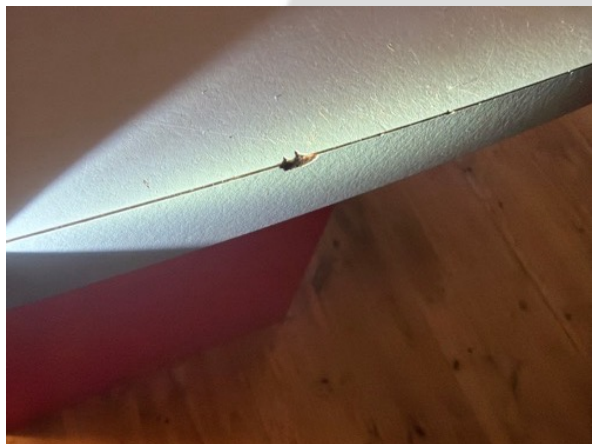
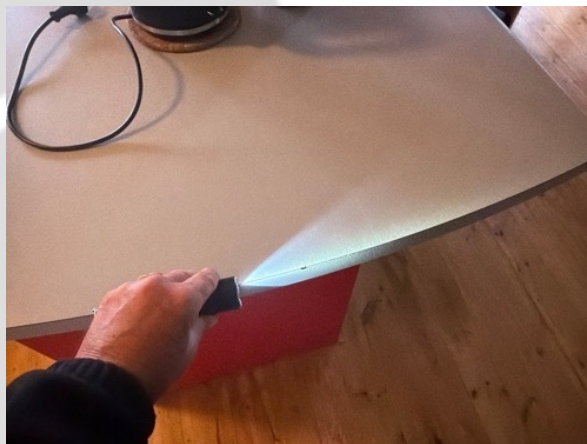
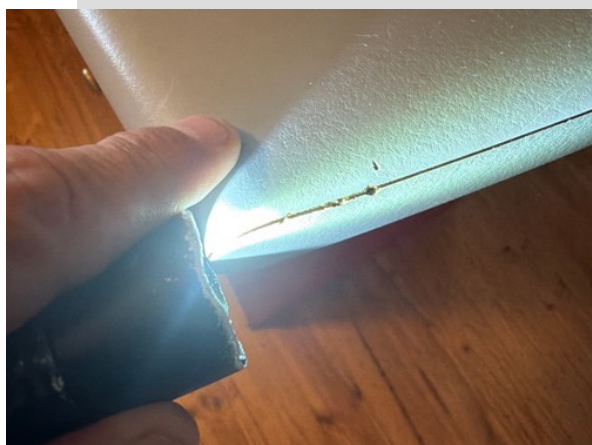
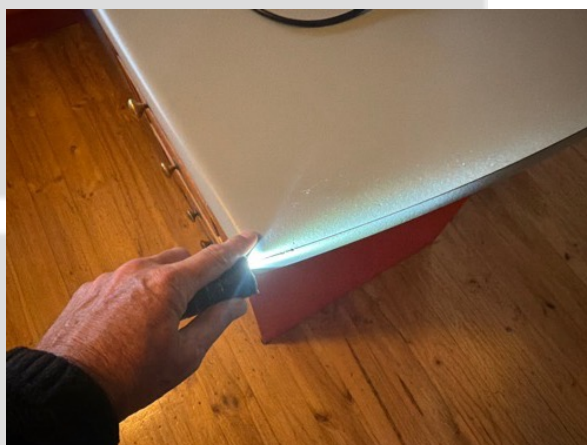
## Minor Defect 1.18

**Location:** Kitchen

**Finding:** Bench tops- chips/ mark

The kitchen bench tops showed evidence of chips. Repair or replacement could be a consideration at some stage.

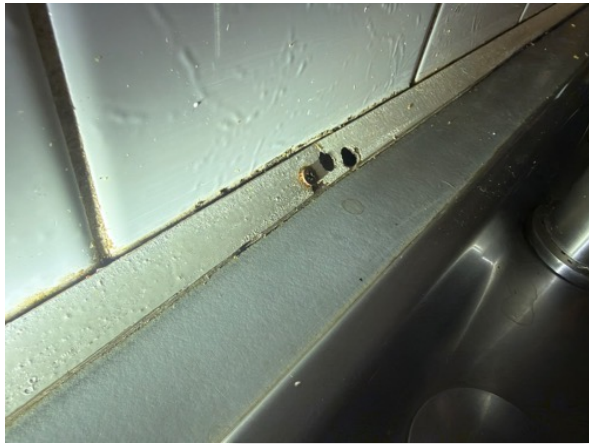
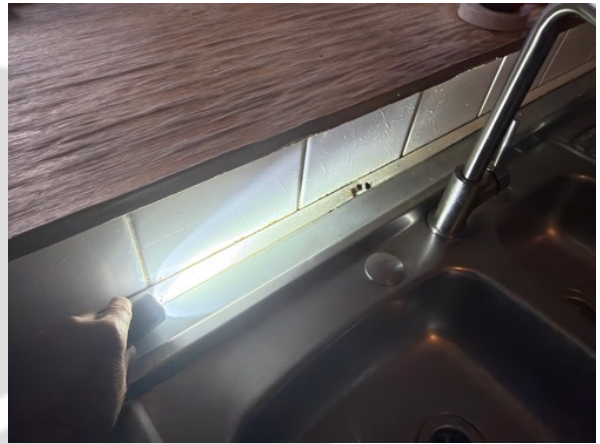
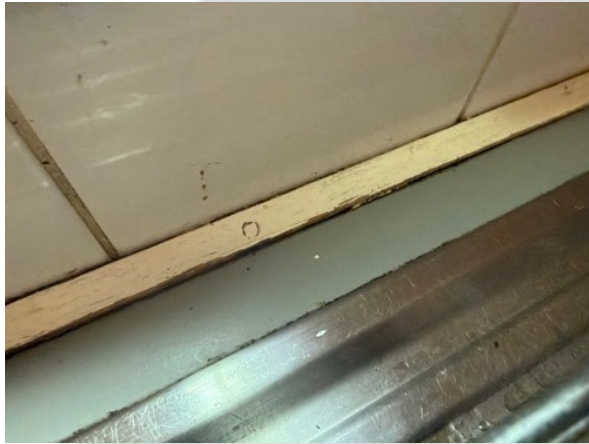
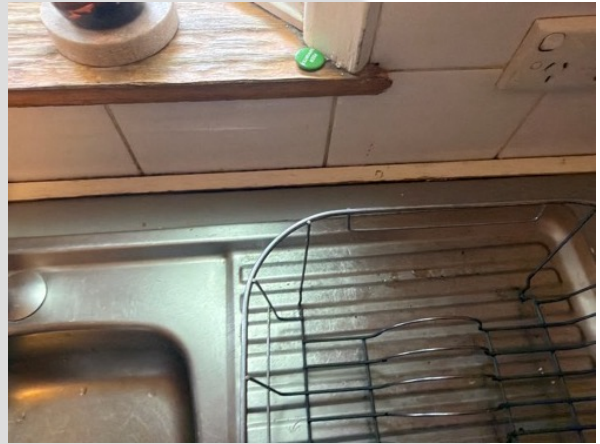
## Minor Defect 1.19

**Location:** Kitchen

Splashback wall tile grouting/caulking requires repairs. It is recommended that this be undertaken by a qualified tiler.

Consideration should be given to removing the timber cornice prior, by a qualified carpenter.

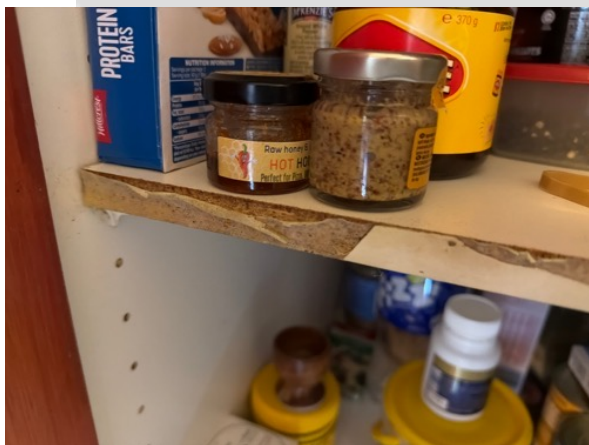
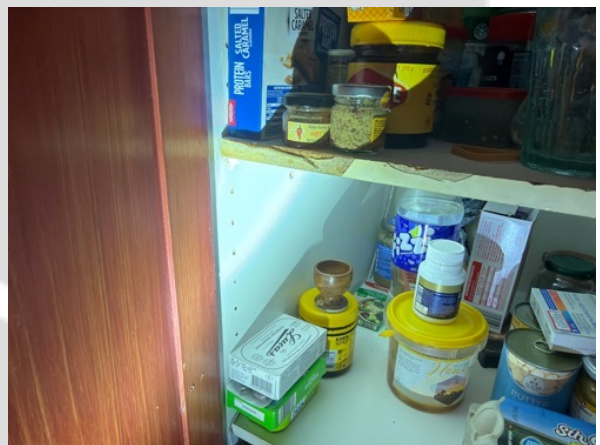
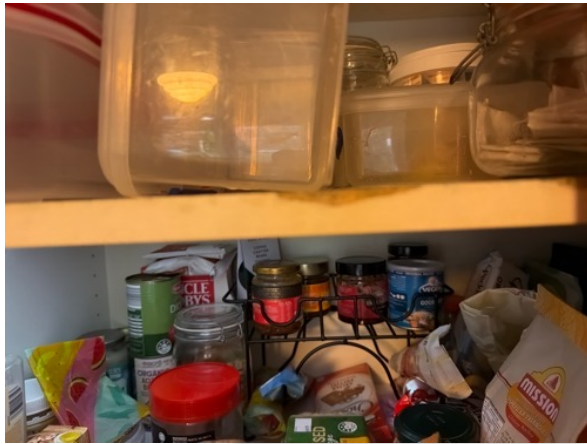
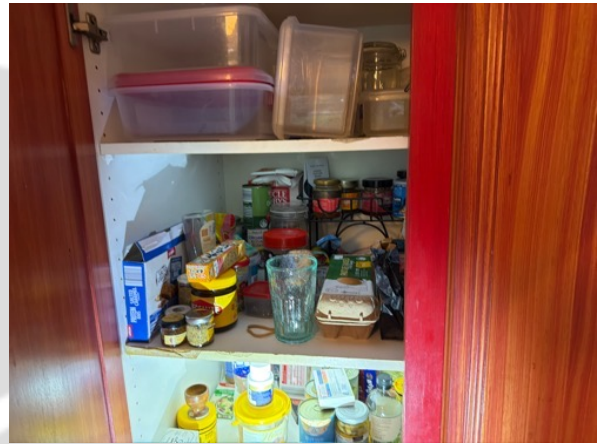
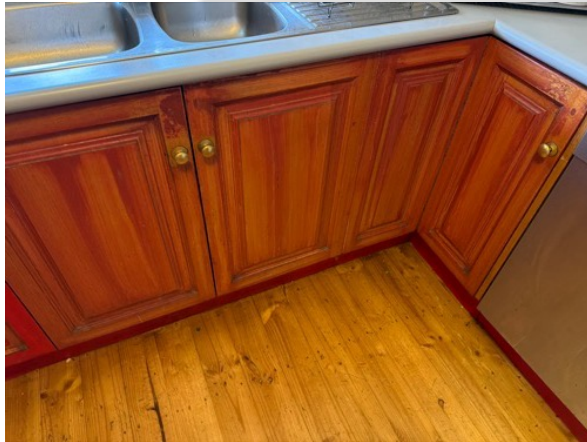
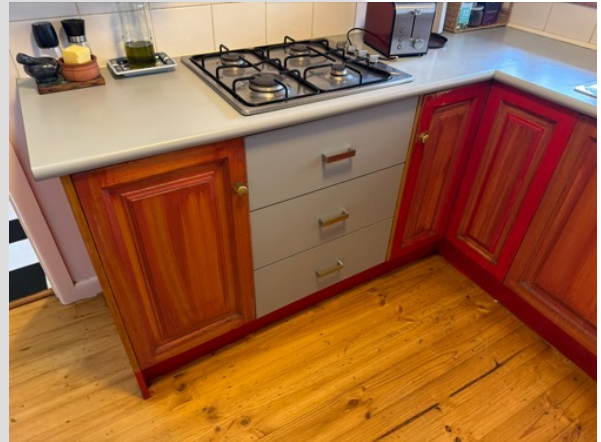
## Minor Defect 1.20

Cabinets -wear

The cabinets showed evidence of minor wear. Replacement may be a consideration at some stage.

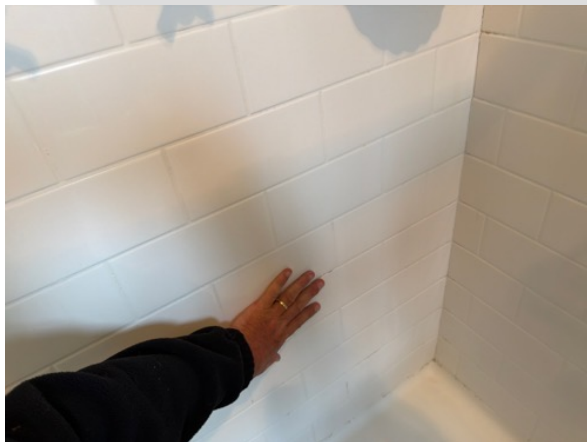
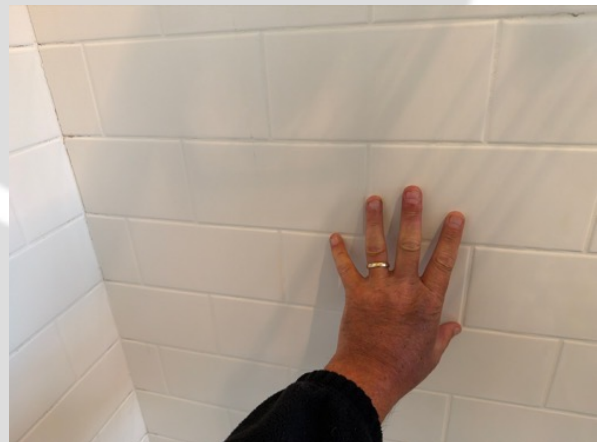
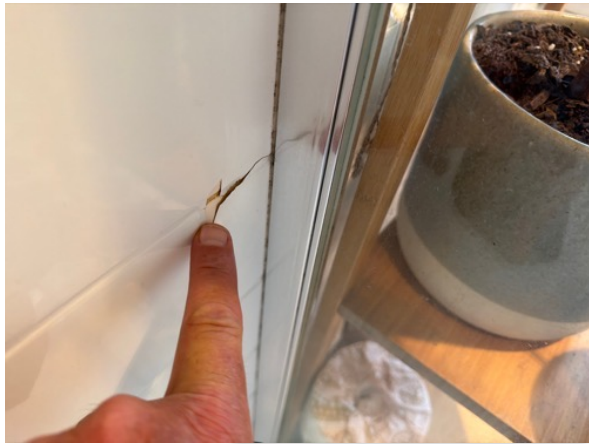
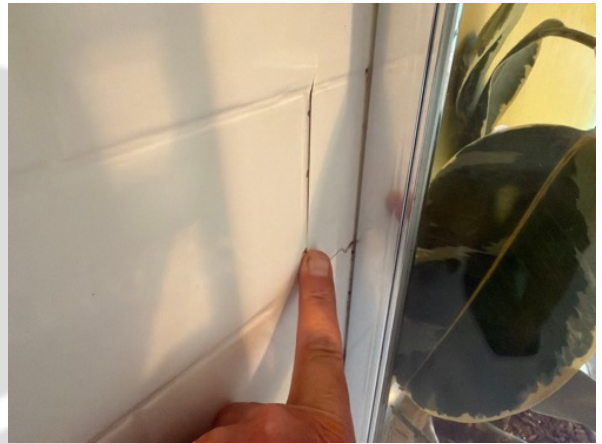
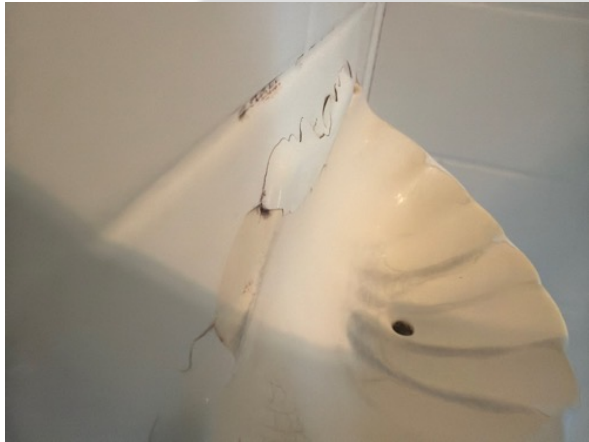
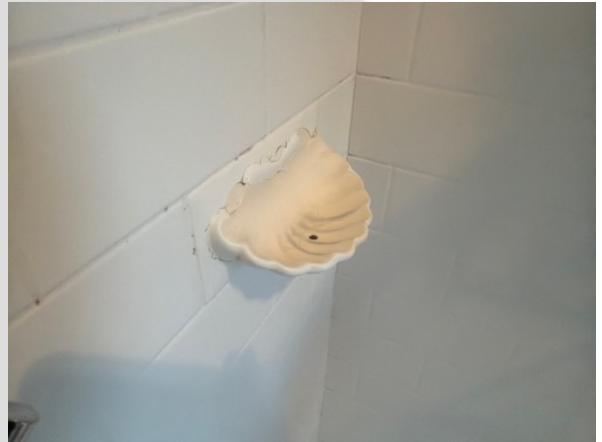
## Minor Defect 1.21

**Location:** Bathroom, WC, and En-suite

**Finding:** Wall tiles-painted

The wall tiles have been painted. Generally painting tiles does not create a durable finish, the paint will eventually chip or wear off. It is strongly recommended that the affected tiles/area be appropriately waterproofed and the tiles be replaced/relayed by a qualified tiler to prevent moisture damage in the walls. Due to conditions observed, hidden damage may exist in areas not visible or readily accessible.

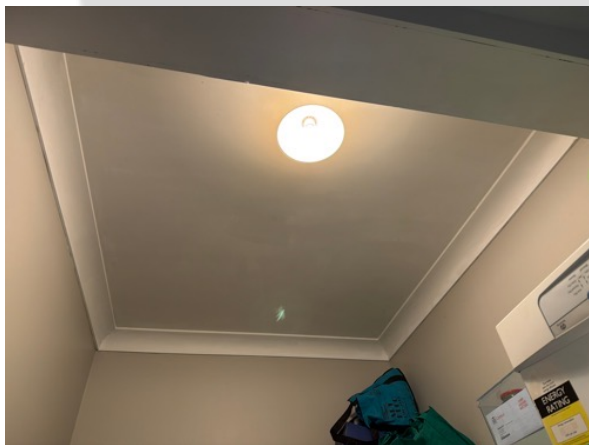
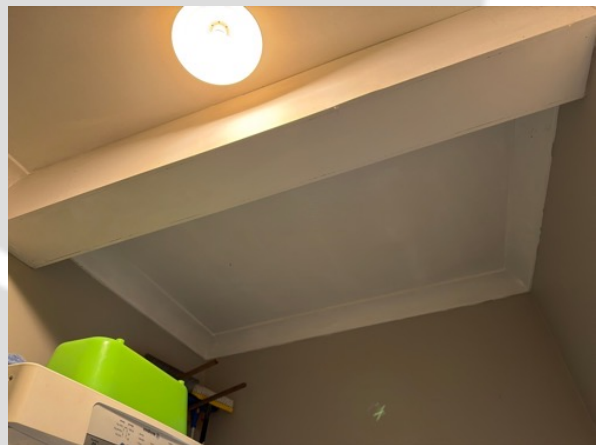
## Minor Defect 1.22

Ventilation-not installed

There is no mechanical ventilation installed. Ventilation is achieved by opening the window and/or door. It is recommended that some form of mechanical ventilation be installed by a qualified electrician to reduce the chance of moisture build up throughout the ceiling and walls.

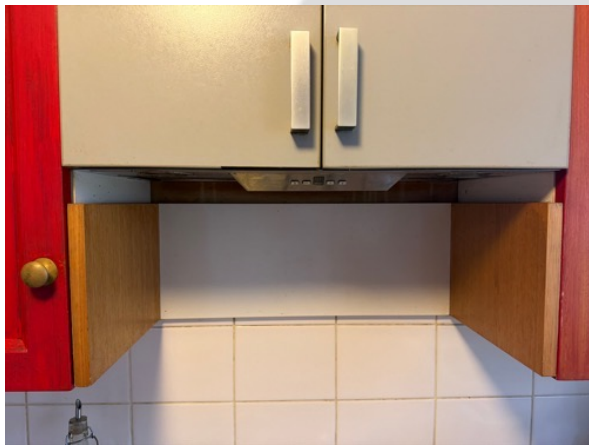
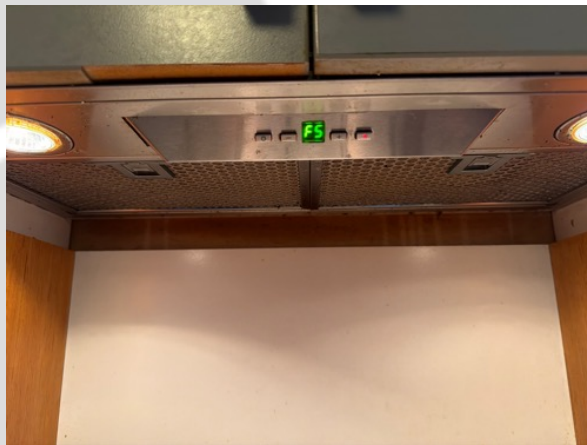
## For your information 2.10

**Location:** Kitchen

**Finding:** Kitchen Area  
These photos of the kitchen area have been included for reference only.

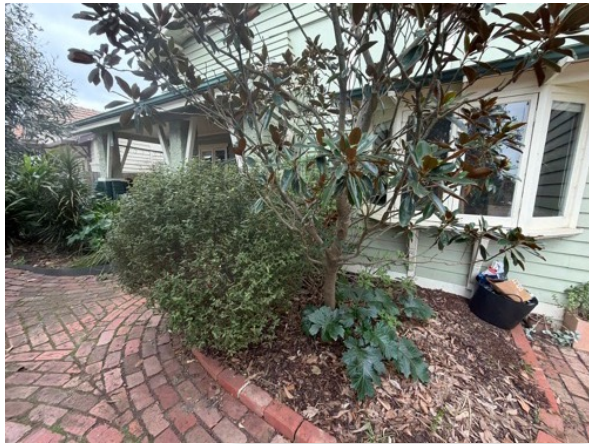
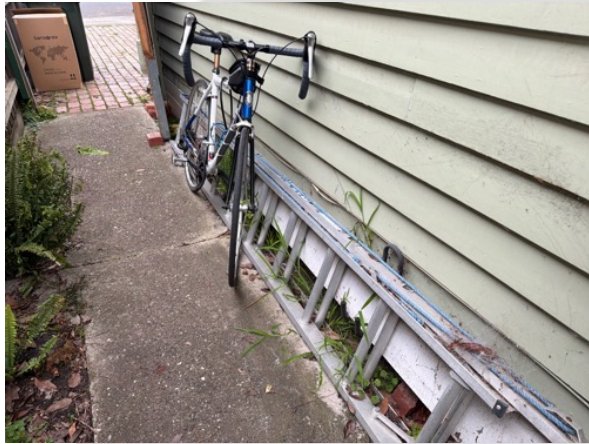
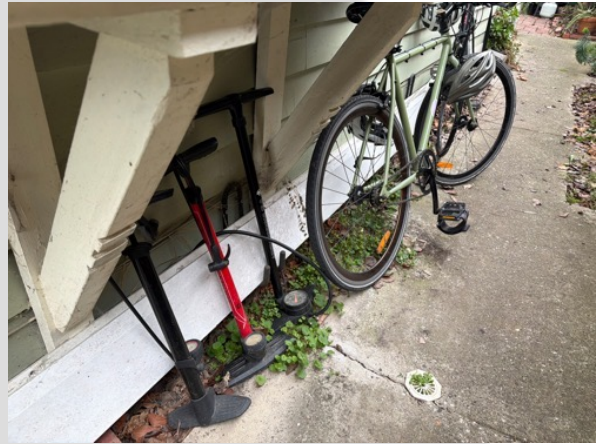
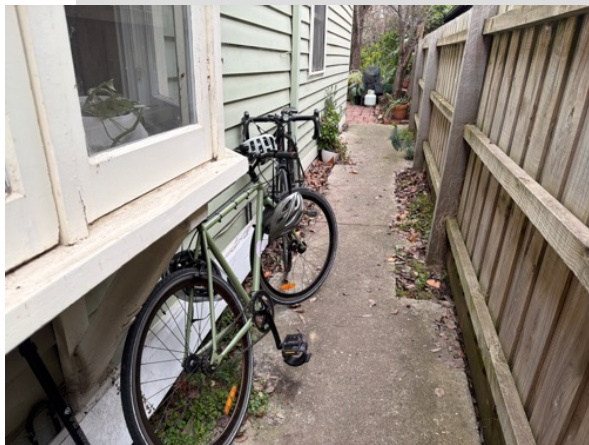
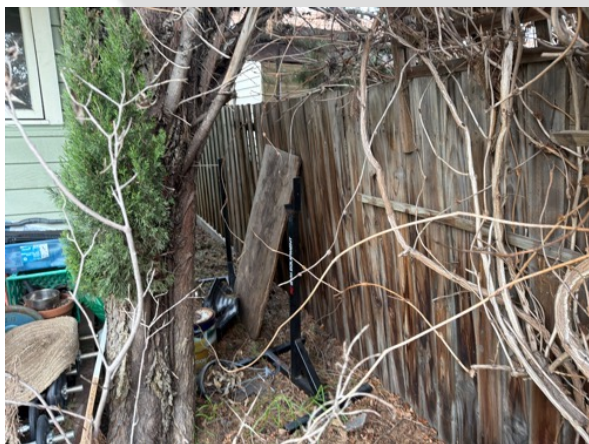
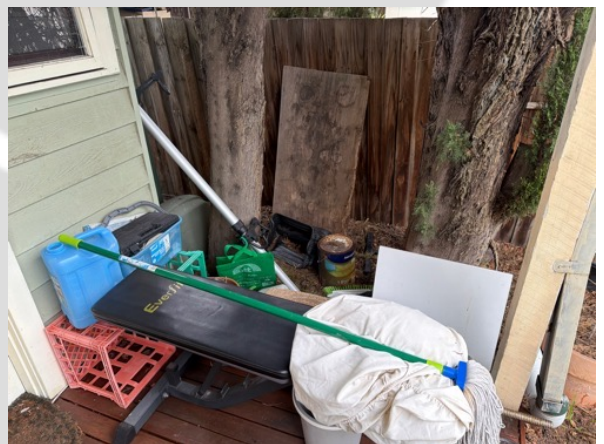
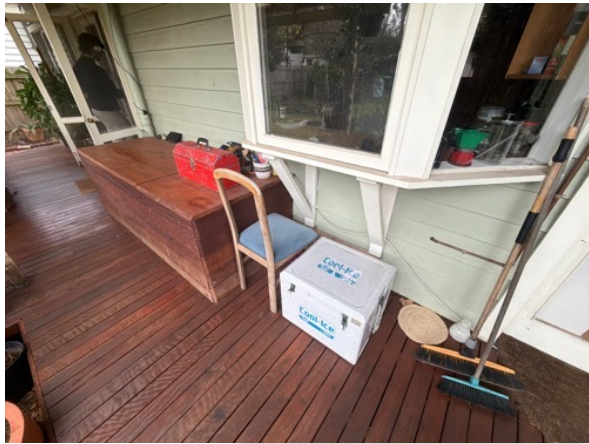
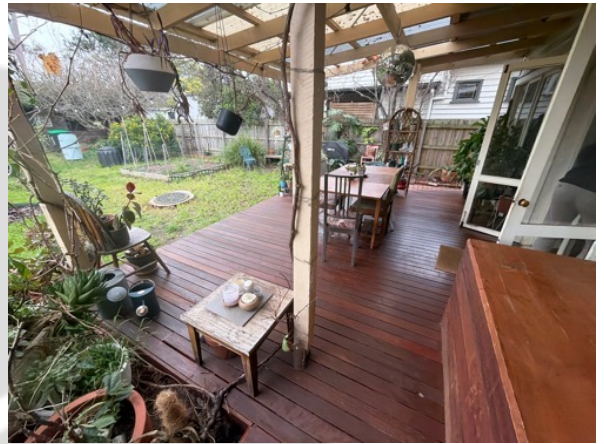
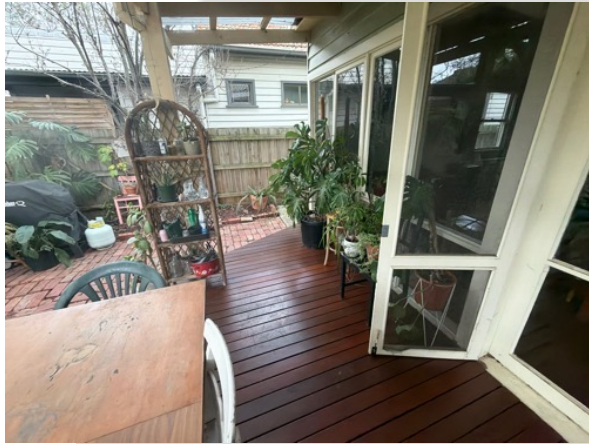
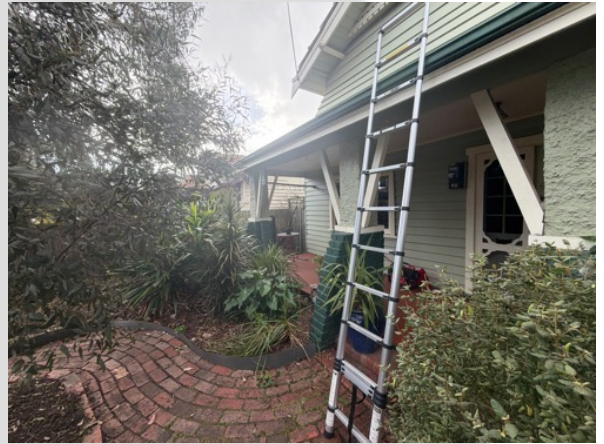
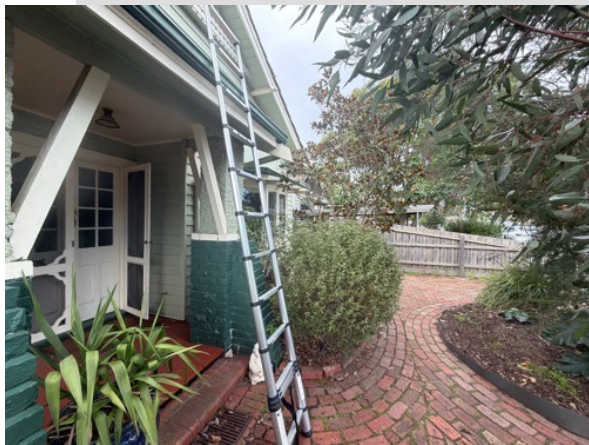
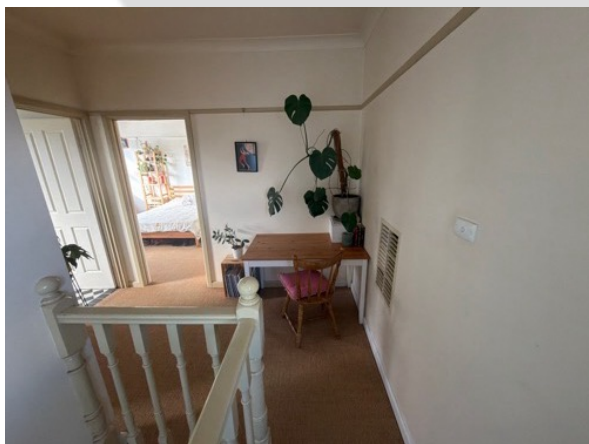
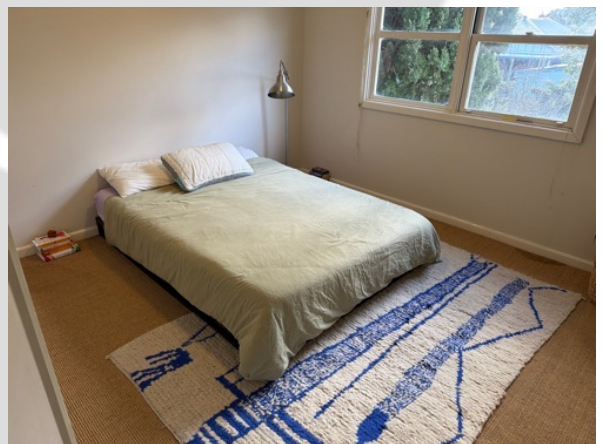
**Finding:** Additional Photos - Limitations and Obstructions

Additional photos are provided for your general reference. These photographs are an indication of the obstructions and limitations which impeded full inspection of the property at the time of inspection. These obstructions can hide an array of defects and should be removed to allow full inspection to be carried out. A re-inspection is recommended once the areas are made accessible.

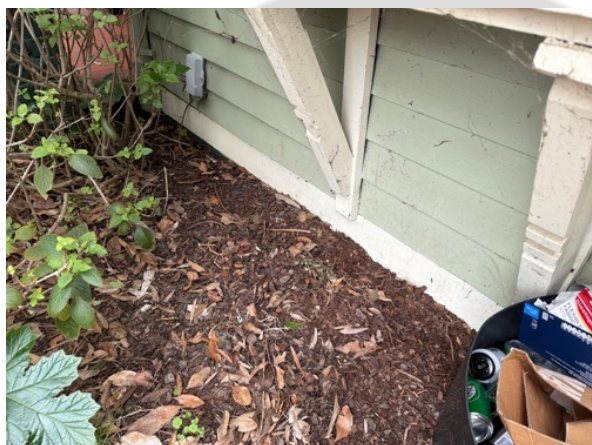
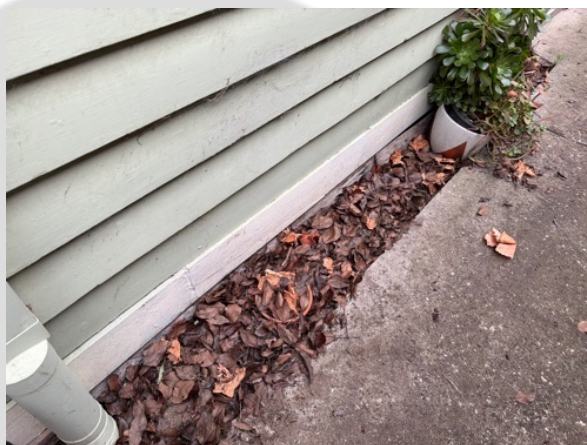
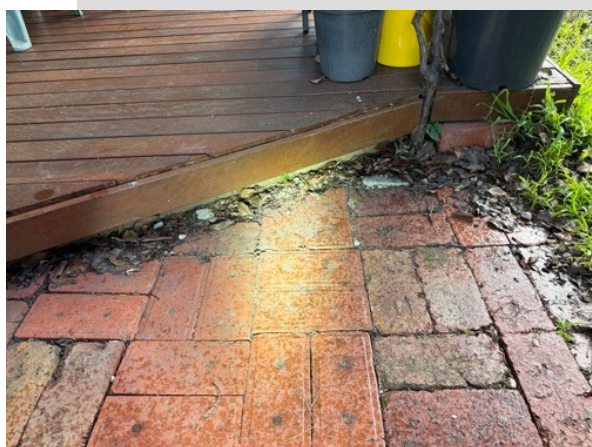
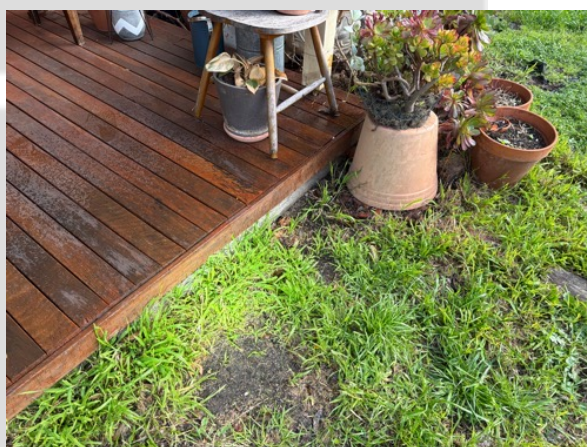
## Conditions conducive to timber pest attack 3.01

**Finding:** Timbers in ground - conducive condition

Timbers are in contact with the ground with the exterior Timbers. This may include steps/ stairs, weatherboards, retaining walls, landscape Timbers and decking structures etc. Timber members that are touching the ground provide easy and undetected access for termites to enter the building. It is strongly recommended that these timber members be replaced with a Termite resistant material (eg- concrete or treated timber). The degree of risk is moderate to high.

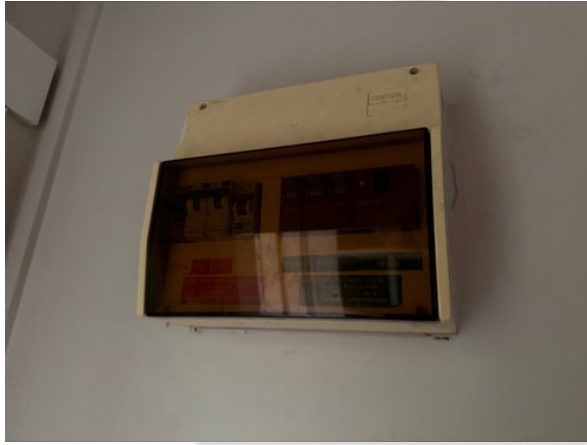
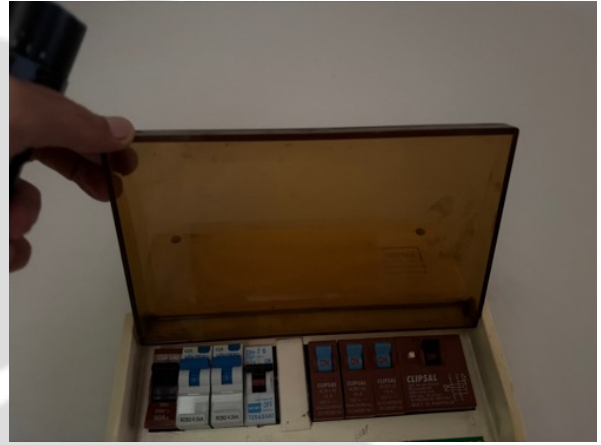
## Conditions conducive to timber pest attack 3.02

A durable notice should be placed in the switchboard unit to indicate current termite barriers. At the time of inspection, it appeared as though no termite management system has been installed, with no fevidence to suggest preventative works taking place. The client may consider gaining further advice from a pest controller as to the costs and procedures involved with this application. It is recommended that obtaining such advice be a short-term priority.

It should be noted, annual Timber Pest Inspections by a qualified Timber Pest Inspector are almost always specified for Termite Management Systems.

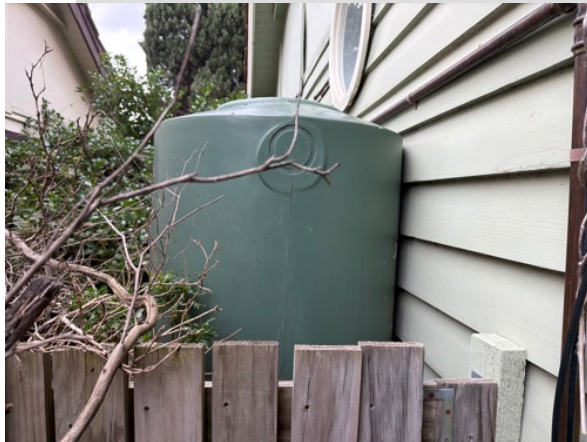
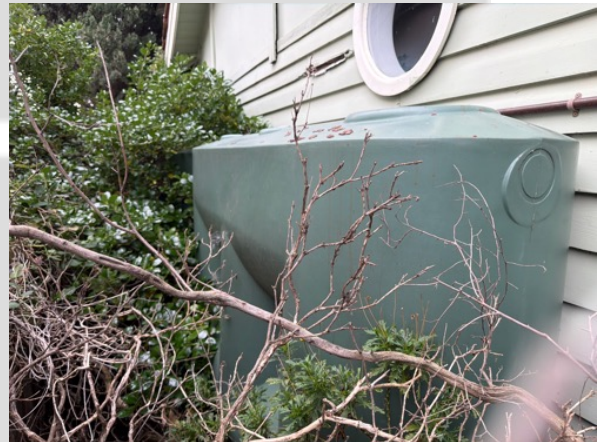
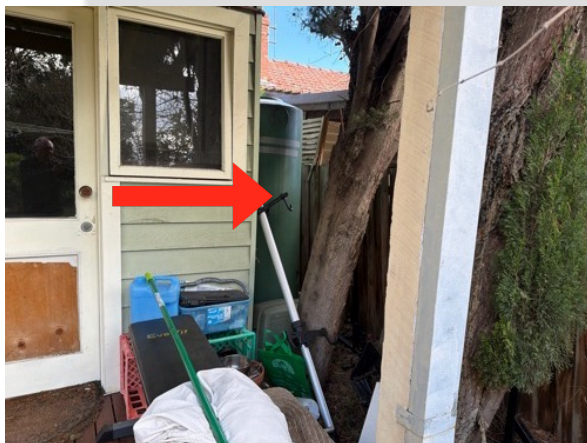
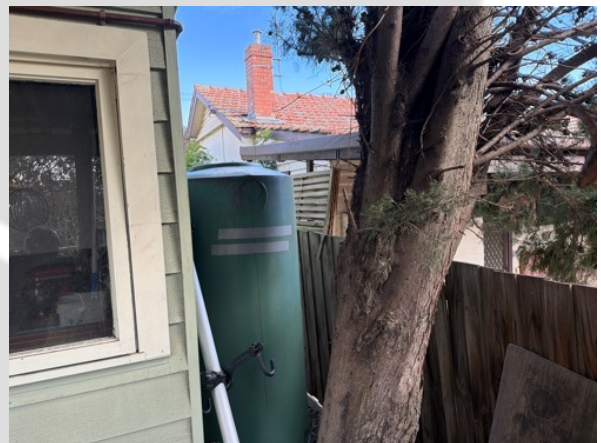
### Conditions conducive to timber pest attack 3.03

**Location:** Exterior

**Finding:** Water tank

There are water tanks located on the block. This potential storm water overflow and moisture are conducive conditions for termites. It is recommended that these be monitored for leaks and overflows. The degree of risk is moderate to high.
