# Building And Timber Pest Report

Property Address: 84 Hutton Street Thornbury 3071

Inspection Date: 3 Aug 2026

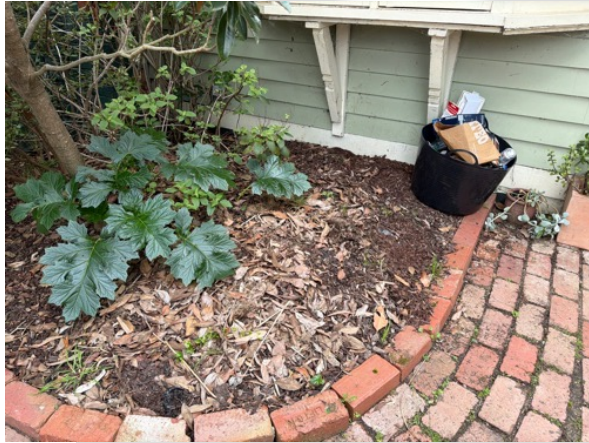
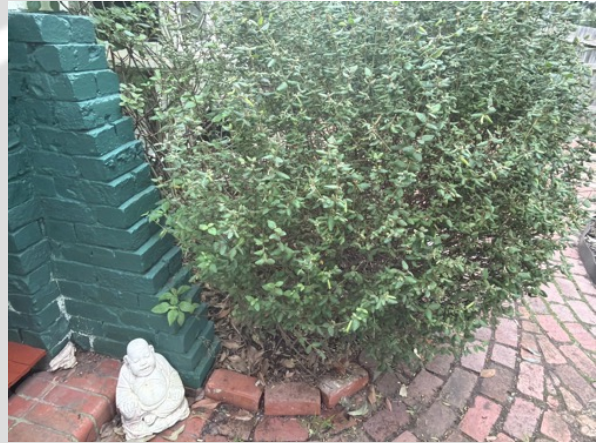
## Conditions conducive to timber pest attack 3.04

**Location:** Exterior

**Finding:** Garden beds

There is mulch and garden beds located close to the house throughout the site. These garden beds are regularly watered and provide conducive conditions for termites to nest. These garden beds should be removed or relocated further away from the house. The degree of risk is moderate to high.

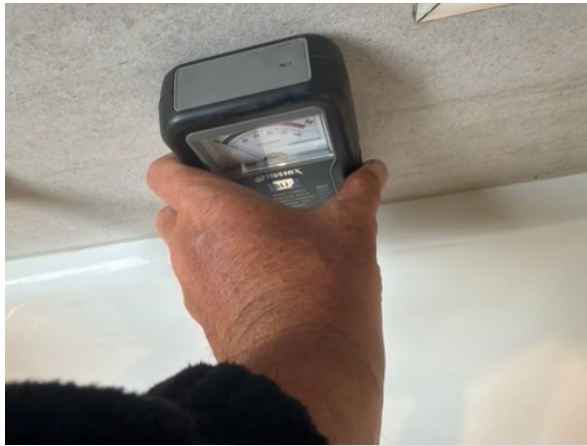
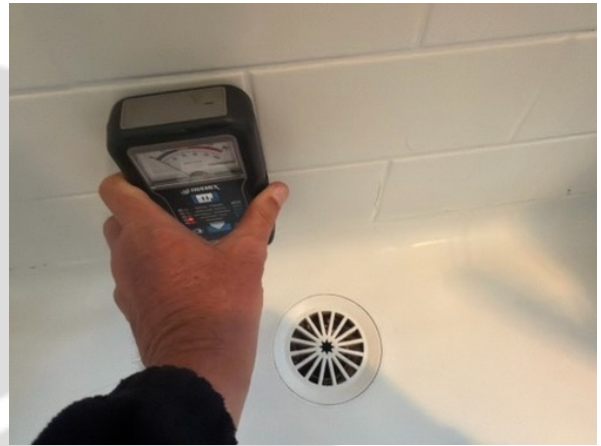
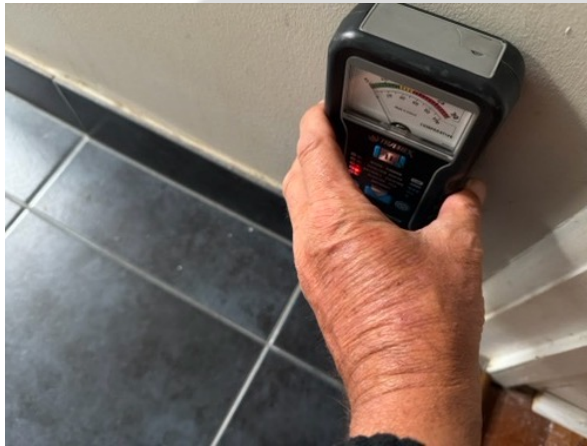
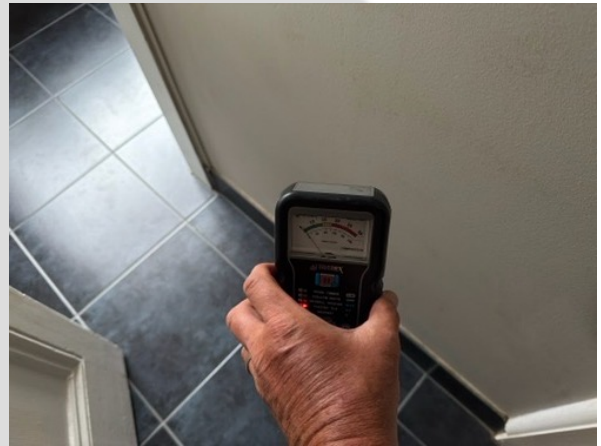
**Location:** General Interior

**Finding:** Moisture Reading  
Low reading throughout
